**BACKGROUND MATERIALS TO ACCOMPANY THE REPORT
OF THE SAFOD ENGINEERING SUBCOMMITTEE OF THE
ADVISORY COMMITTEE FOR GEOSCIENCES
MARCH 17, 2011**

BACKGROUND

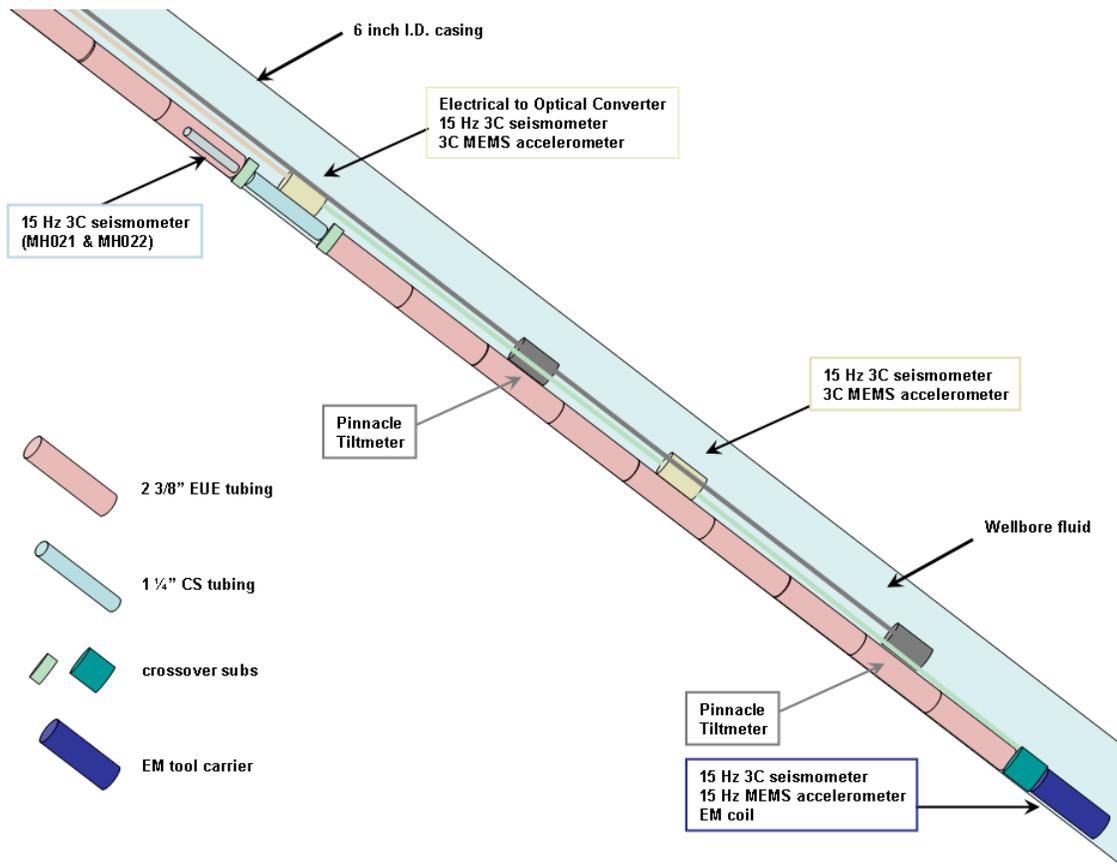
Figure 1. Layout of instrument section of the SAFOD observatory deployed in September 2008. The five instrument pods are rigidly attached to the supporting EUE tubing, and coupled to the inside of the casing by bow springs located on the top side of the pods. Oyo Geospace DS150 digital borehole seismometers are located in the 1st, 3rd and 5th pod. One DS150 contains 15 Hz geophones and the other Colybris MEMS accelerometers. Pod 5 also contains a 3rd DS150 connected to a large EM coil provided by funding from NASA. Pods 2 and 4 contain Pinnacle Technologies tiltmeters. Location of the currently operating analog seismometer (MH022) is shown.

The observatory as deployed in September 2008 consisted of two independent systems, one for the tiltmeters and one for the seismic and electromagnetic sensors attached to the outside of 2-3/8-in-diameter EUE tubing. It took over a week of operations with a small drill rig and large technical crew to install the system to a depth of 10,400 ft. The main risk of failure during installation was judged to be damage to the control lines during the lowering of the system into the well. These parts are particularly vulnerable because they had to be attached to the outside of the EUE tubing, and as such were subject to abrasion as the system slid down the well. We used best industry practice to protect the control lines, including the use of protective clamps at every joint between pieces of EUE tubing (30 ft), and at every mid-joint. We also used centralizers to keep the control lines away

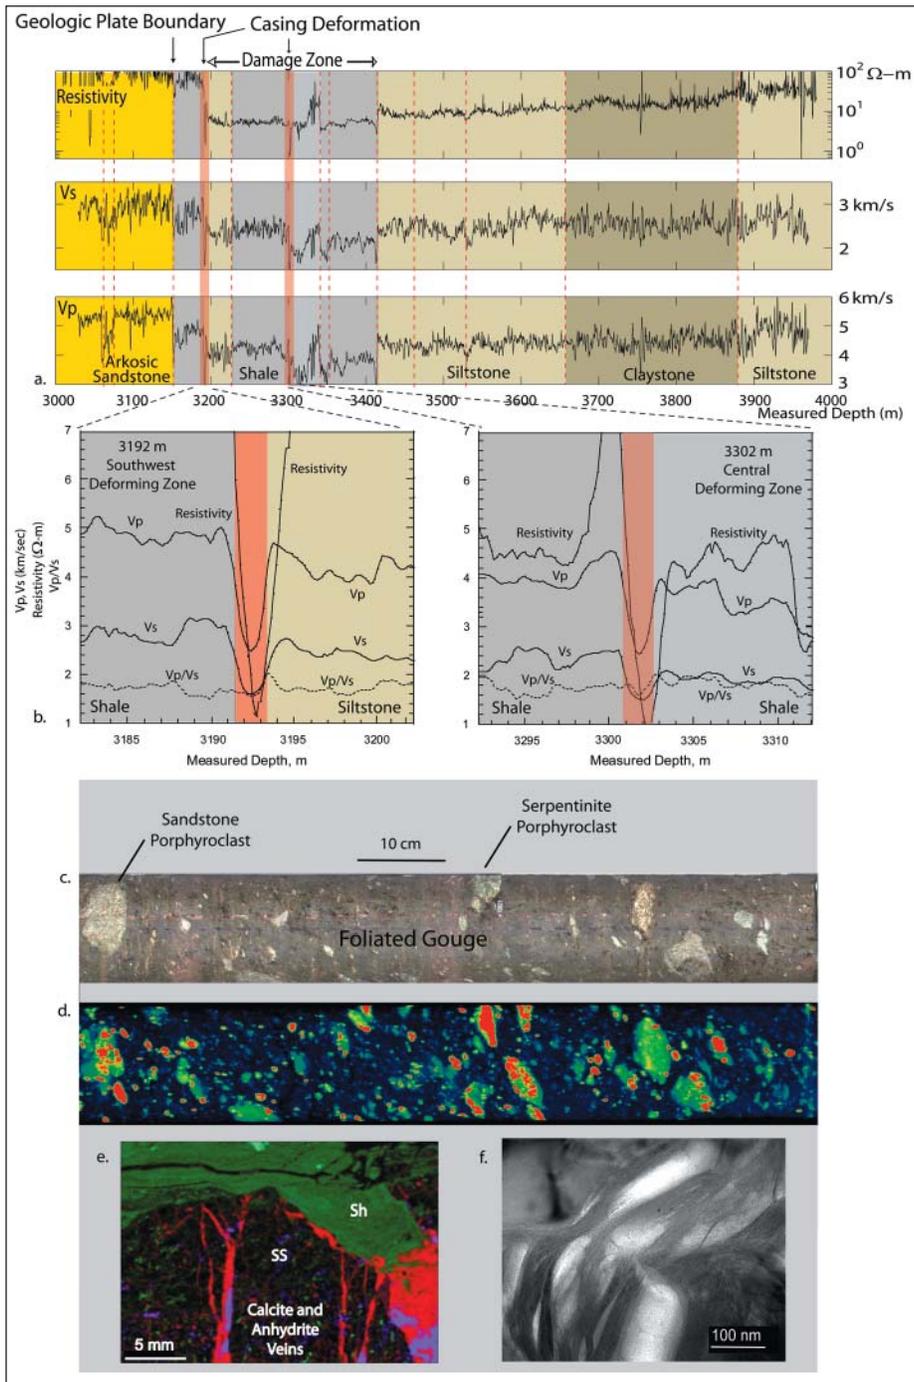
Fig. 2. (a) Selected geophysical logs and generalized geology as a function of measured depth along the Phase 2 SAFOD borehole. The dashed red lines indicate some of the many faults encountered. The thick red lines indicate where fault creep deformed the Phase 2 cased borehole at the SDZ and CDZ. (b) The SDZ and CDZ correlate with localized zones (shown in red) where the geophysical log properties from Phase 2 are even more anomalous than in the surrounding damage zone. (c) A photo of a section of Phase 3 core containing a foliated fault gouge from the CDZ. (d) A colorized three-dimensional maximum intensity projection of X-ray computed tomography from the section of the core in Figure 2c (courtesy of J. Chester). Note that the clasts define a shape-preferred orientation where the long axes are approximately parallel to the San Andreas Fault [Sills et al., 2009]. (e) False-color X-ray fluorescence chemical map of a sample collected from the northeast margin of the SDZ (red, calcium; green, iron; blue, sulfur; courtesy of S. Mittempergher, J. P. Gratier, and J. Richard), showing intrusion of highly sheared and foliated shale (Sh) into a relatively undeformed arkosic sandstone (SS). The sandstone contains cross-cutting anhydrite (magenta) and calcite (red) veins indicative of multiple crack opening and sealing episodes [Mittempergher et al., 2009]. (f) A transmission electron microscope photograph showing nanocoatings of smectite/illite and chlorite/illite clays from the CDZ (courtesy of A. Schleicher and B. van der Pluijm).

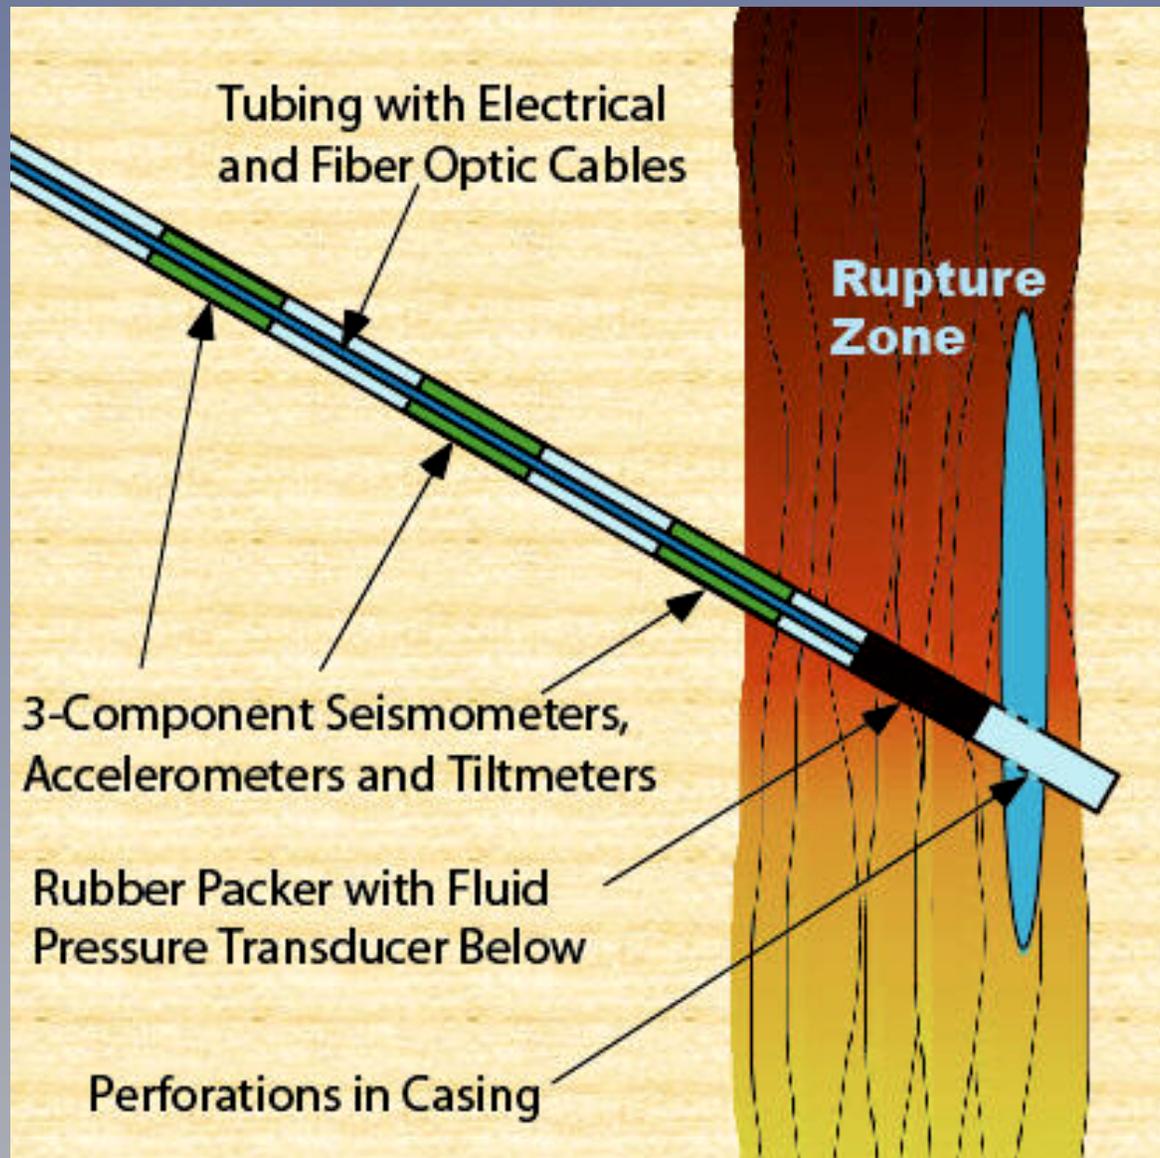
Permanent Observatory Monitoring Array

- Pipe deployed system
- Electrical conductors and optical fibers in stainless steel microtubes.
- No O-rings (laser welded sondes)
- Stiff bow spring decentralizers on instrument pods
- 3 levels of multi-component sondes
 - GERI DS150 3C 15 Hz seismometer
 - Modified GERI DS150 with 3C Colibrys MEMS accelerometer
 - Pinnacle borehole tiltmeter
- Hydraulic packer to isolate perforated casing in the fault zone
- Pressure sensor to measure pore pressure below packer
- Optical fiber telemetry (4K sps)
- GERI Geores control computer
- Earthworm data distribution and archiving system
- On-site event detection and integration of SAFOD, HRSN and NCSN waveforms using Norsar MIMO system
- Limited real-time telemetry
- Full data stream recorded on LT03 tapes

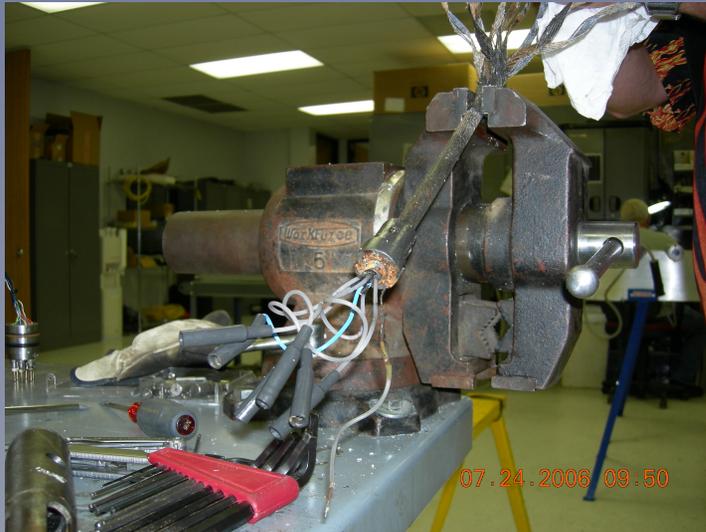
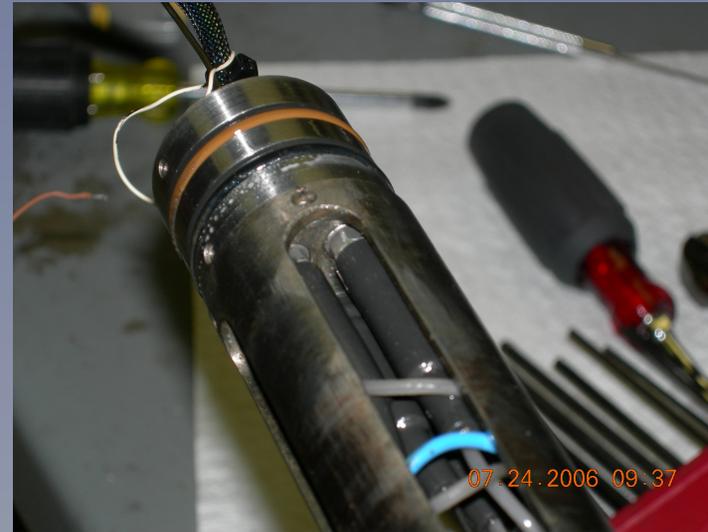
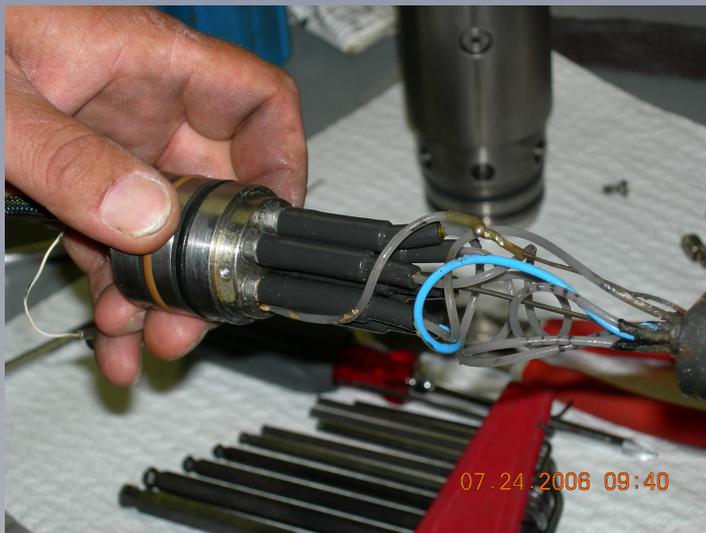
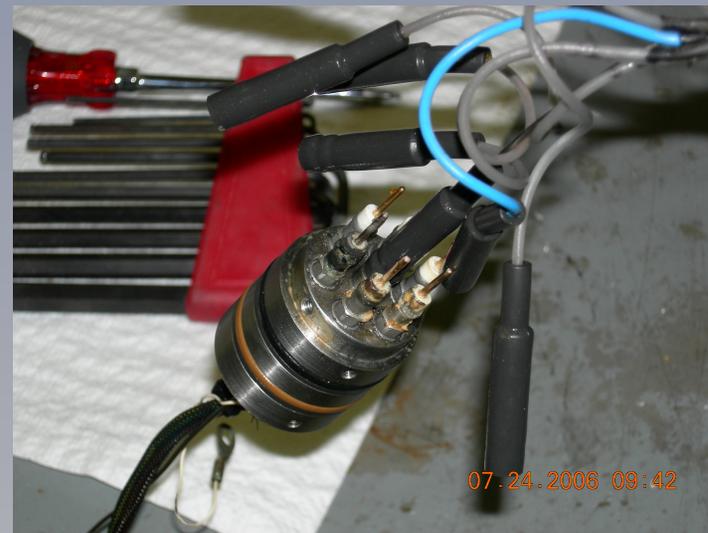
Recent failures have all occurred by shorts on the wet side of the cable head or in the wireline

Gas under high pressure diffusing through O-rings

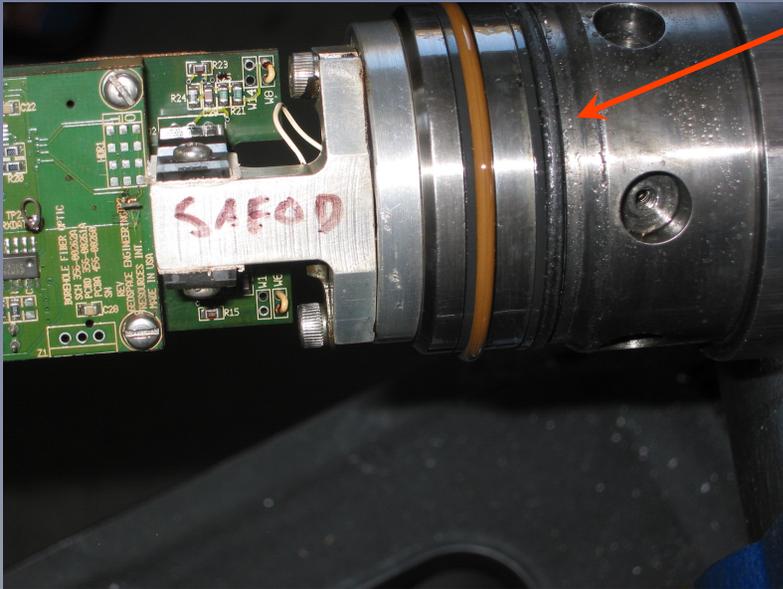
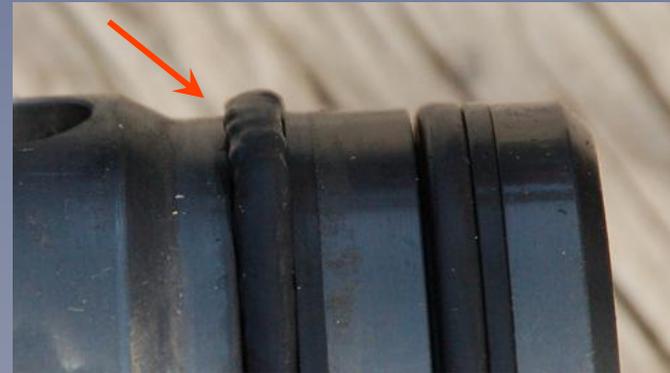
Blistering of Kalrez O-rings

Deformation of Viton O-rings

Replacement of Viton O-rings by Kalrez O-rings (at considerable cost) helped reduce, but not eliminate the gas problem inside the pressure vessels.

90 durometer Viton O-rings proved to provide better gas protection than Kalrez

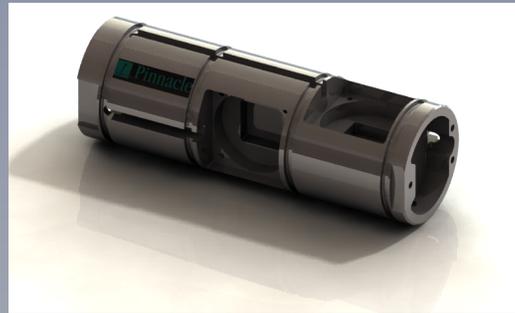
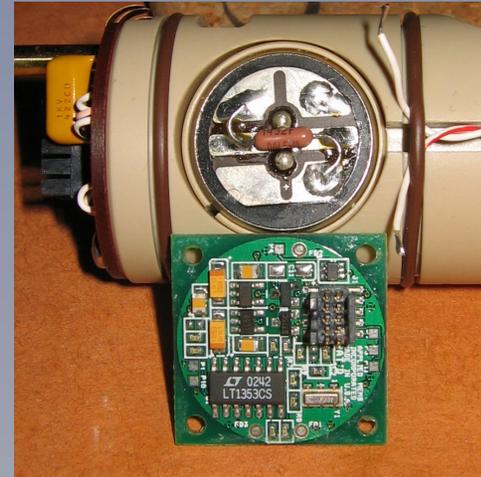
Replace 15 Hz geophone
with MEMS accelerometer

House MEMS in specially-
designed chassis

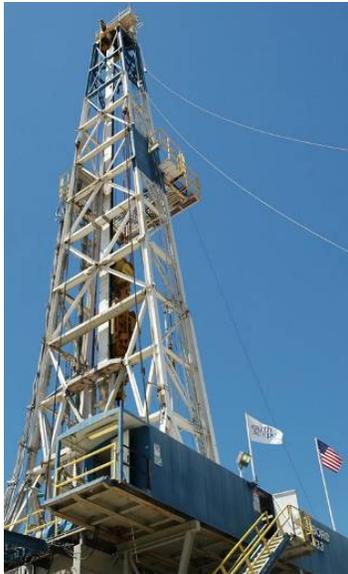
Figure 1: SAFOD drilling rig on location in the summer of 2004.

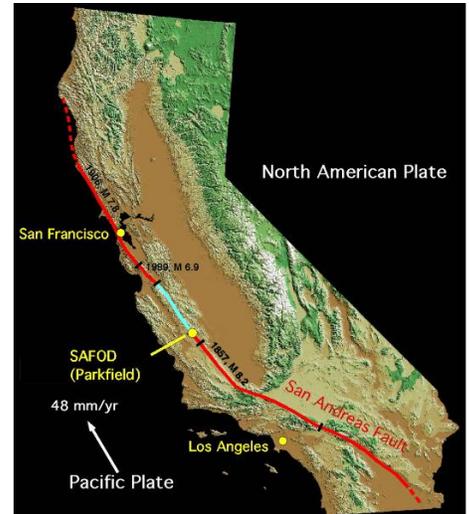
Figure 2: Location of SAFOD relative to the San Andreas Fault, including segments that fail periodically in moderate to large earthquakes (red) and the segment that moves through a combination of fault creep and ongoing microseismicity (blue).

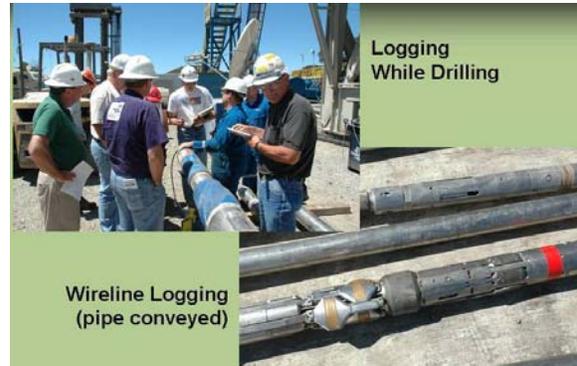
Figure 11: Geophysical logging tools used at SAFOD.

A variety of geophysical logs have been carried out throughout each phase of SAFOD drilling, as illustrated in Figure 11 and shown in Table 4.

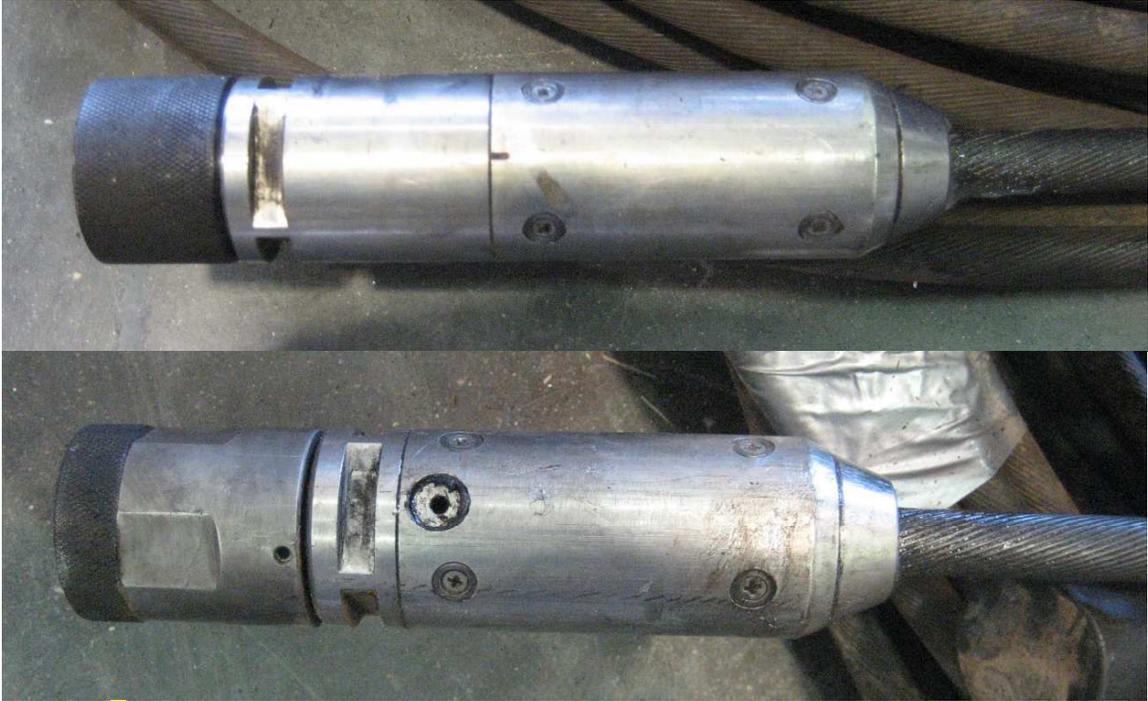
Figure #: Down hole (top) / Up hole (bottom) of Unmodified Wireline Interconnect

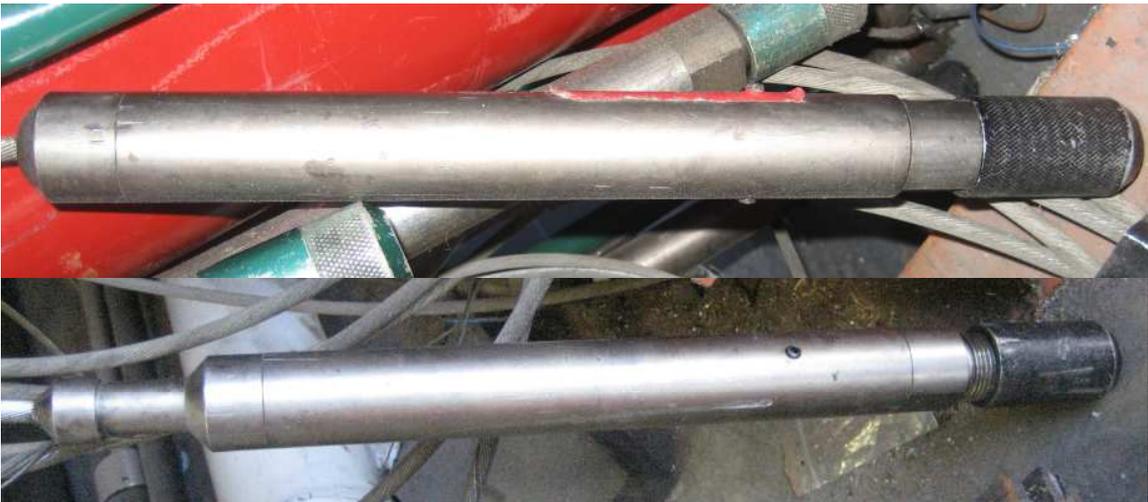
Figure #: Down hole (top) / Up hole (bottom) of Unmodified Gen III Cable Head

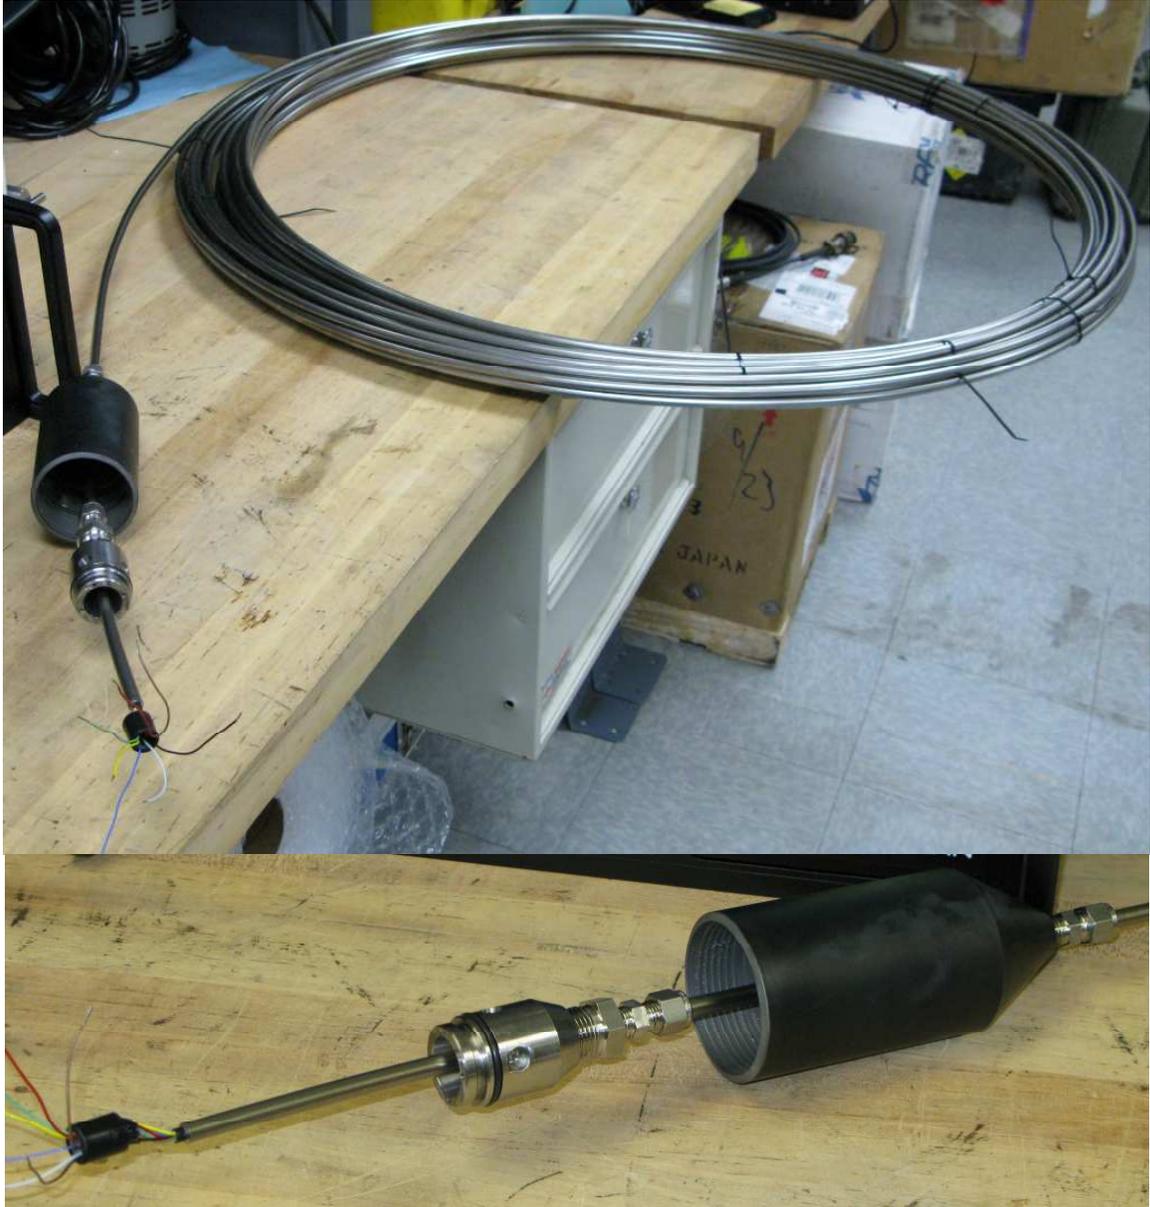
Figure #: Swagelok® fittings and Bull Plug run over the line before Interconnect

Short lengths of standard wireline terminated with DS150 interconnects were purchased, and the ends were cut off. The wireline itself was then removed, and the connector was disassembled. A 1/2" NPT thread was tapped into the end of the connector in which the wireline would normally terminate. Gen III cable heads also had the wireline removed from their ends, and a 1/4" NPT thread was tapped in its place. If the interconnect was to go on the up hole end of the tool string, extra lengths 1/4" or 5/16" tubing would be needed about the interconnect (over 40 feet). For this reason, the fittings with ferrules and the upper bull plugs for the pods would need to be run over the line before assembly of the interconnect itself. An example can be seen in Figure #.

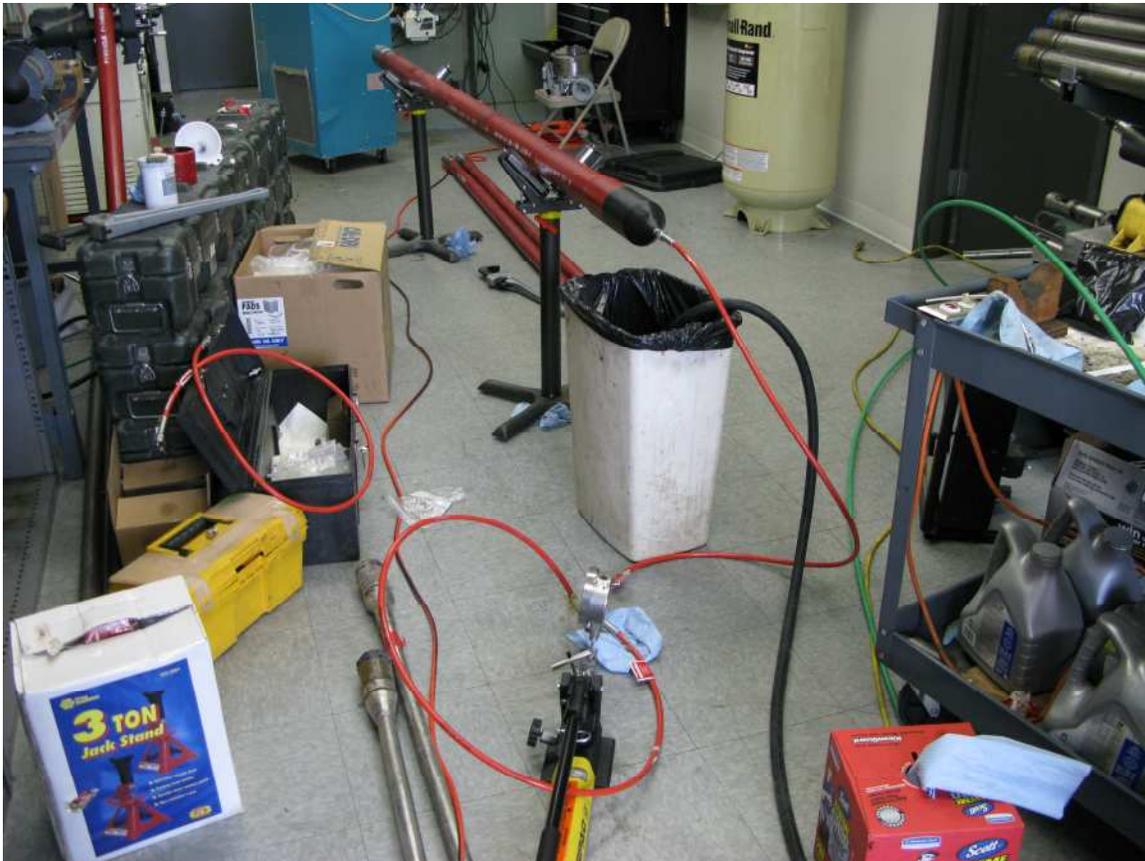
Figure 3: Pod 1 during pressure testing

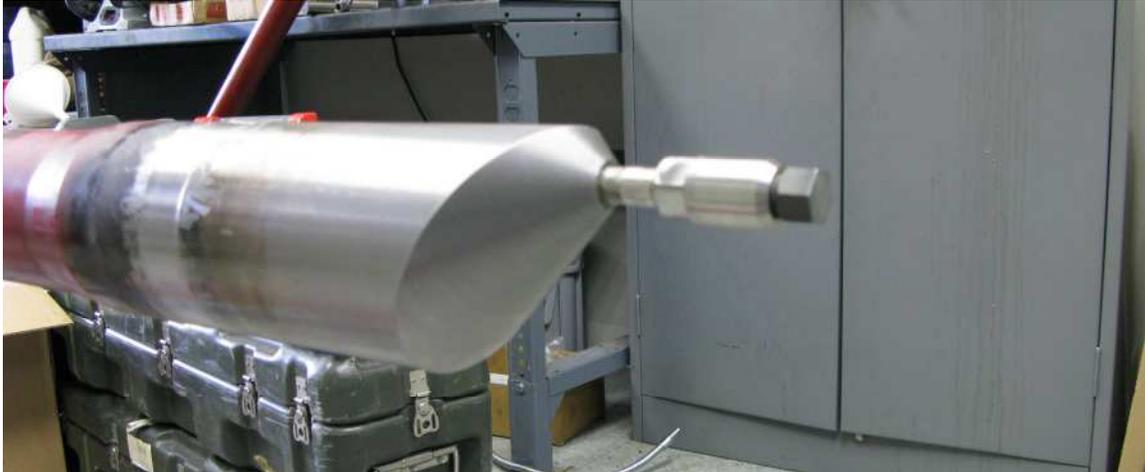
Figure #: Lower Bull Plug of Pod 1 plugged for pressure testing

Each of the pods 1 through 4 was made primarily of a pup joint with bull plugs on each end. Although the size varied from pod to pod, a BTS-8 box by pin pup joint was ordered from Benoit and sent to a machine shop for further work. The data sheet, torque requirements, and blanking dimensions for Benoit BTS-8 thread connections can be found in Appendix 2. These are standard, off the shelf pup joints that are mass produced. The box end of the pup joint had the box thread cut off, and the lower, down hole end, bull plug was welded into place matching the upset OD of the pup joint itself. The outlet at the bottom of the bull plug was sloped toward the 2-3/8" tubing to avoid catching on anything while being run down hole. Each pod was internally pressure tested to 6,000 psi. to make sure the weld of the lower bull plug onto the pup joint could hold pressure. The test was conducted with water using a hand pump to build pressure. The lower bull plug was plugged for testing. Pressure testing setup can be seen in Figures 3 and 4. The test was a pass/fail through visual inspection. Failure of the weld would have been visible through water seepage, and a pressure drop would have been noticed on the pressure gauge. Communication of pressure to and from the pump was locked off by a valve on the pump side of the pressure gauge.

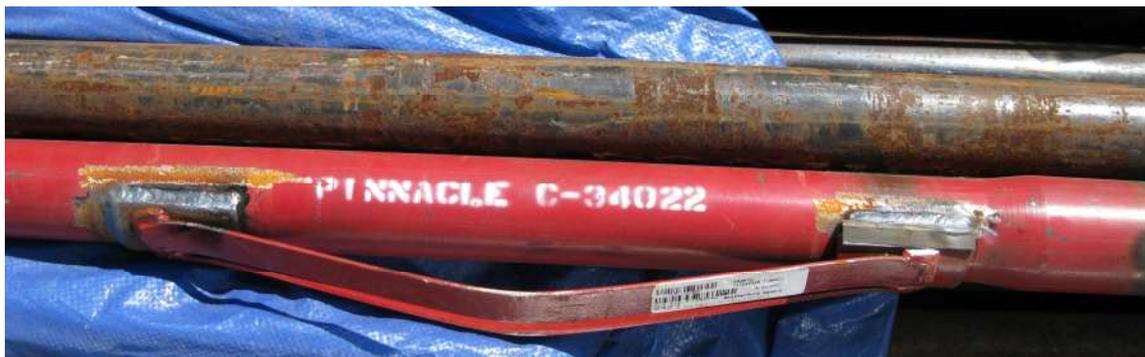
Figure #: De-centralizer on one of the pods

The coupling method that was chosen for better coupling the pods to the casing involves centralizers which were purchased from Weatherford Gemoco. Centralizers are normally used to centralize tubing inside of casing. The design of the bow springs for the centralizer deals with casing size and weight, and the centralizers are generally an 'off the shelf' part. The problem with that, however, is that we want to DE-centralize our pods so that the tubing is actually firmly coupled to the casing. Centralizers are also generally run on one piece of tubing, whereas we essentially have two pieces of tubing welded together side by side. The way they calculate and rate bow spring forces is as an average of all bow spring forces acting on the casing from one centralizer at any given time. This makes it hard to know how much restoring force will be acting on the casing in our case because we take one centralizer with 6 bow springs spaced 60° apart, and we cut the centralizer to only utilize 2 bow springs. Ultimately, we are running the centralizer in a non-standard application, so the restoring force is really more of a theoretical number in the design. Centralizer bow springs were only used on pods 1-4. An example of what the bow springs look like attached to a pod, which is then attached to the 2-3/8" tubing can be seen in Figures # and #.

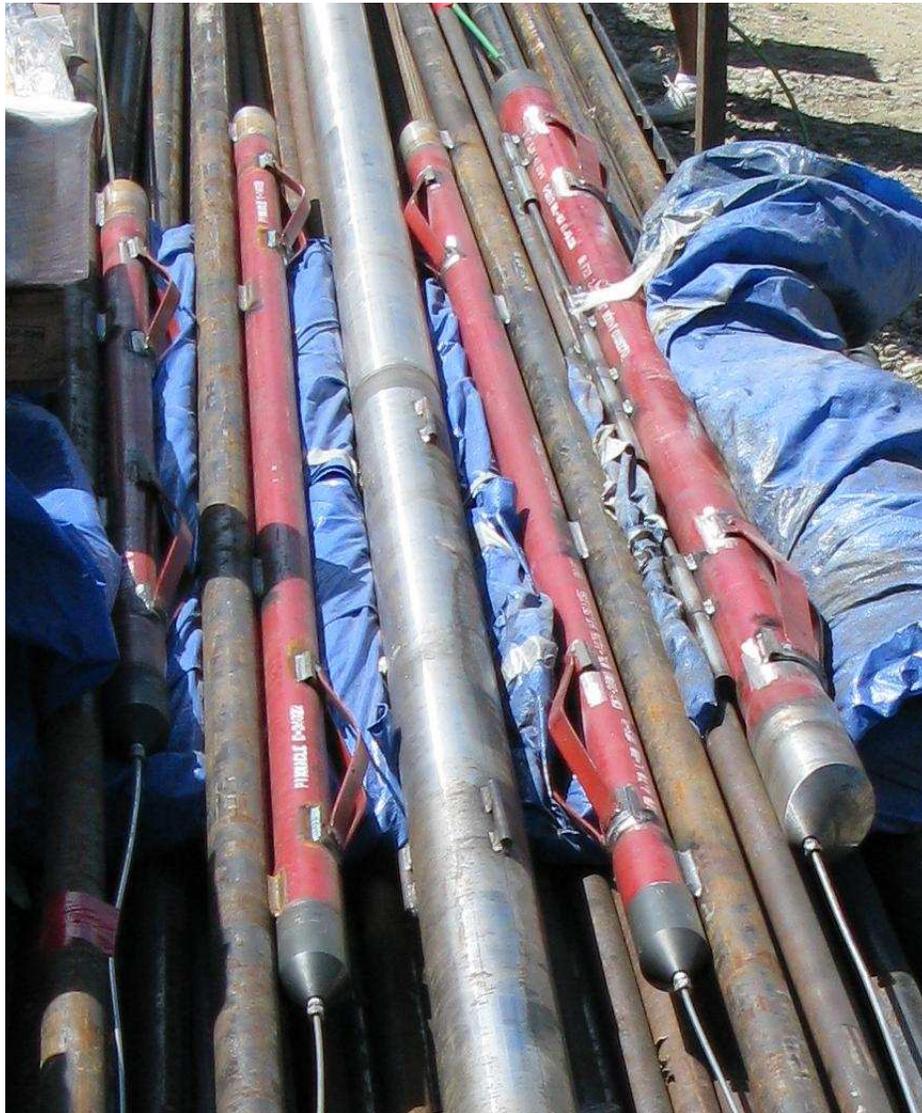
Figure #: All pods had modified Centralizers welded on, except for pod 5

The De-centralizers were all welded on the up hole end and were held close to the pods by guide rails on the down hole end. The up hole end was welded, which can be seen in Figure #, so that tool string could always be pulled up and out of the hole. The guide rails were also welded onto the pods, and all sharp edges were ground off so that no sharp edges might catch when running down hole. The purpose for the guide rails is to relieve added stress on the bow springs by allowing them movement up and down along the pod once the springs make contact with the 7" casing. An example of a guide rail can be seen in Figure #. Drawings from Weather Gemoco of the centralizers used can be found in Appendix ?.

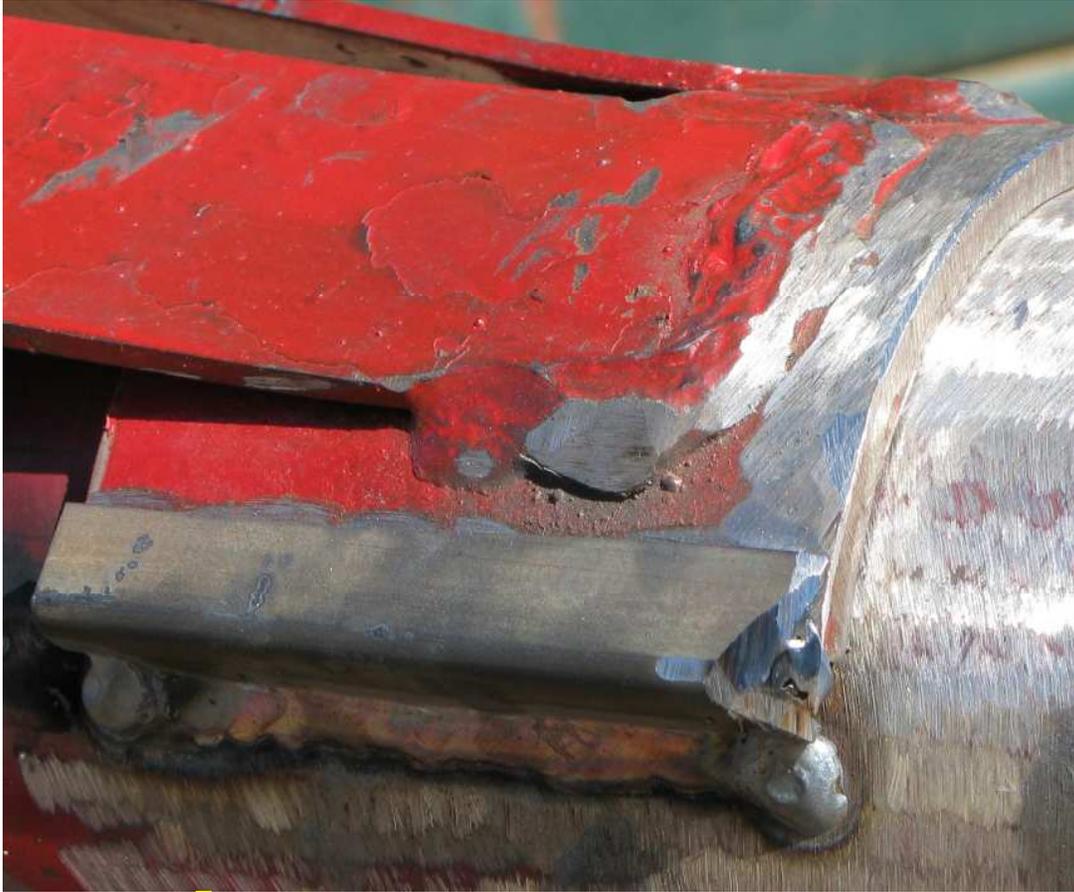
Figure #: Bow Spring Guide Rails with sharp corners ground off

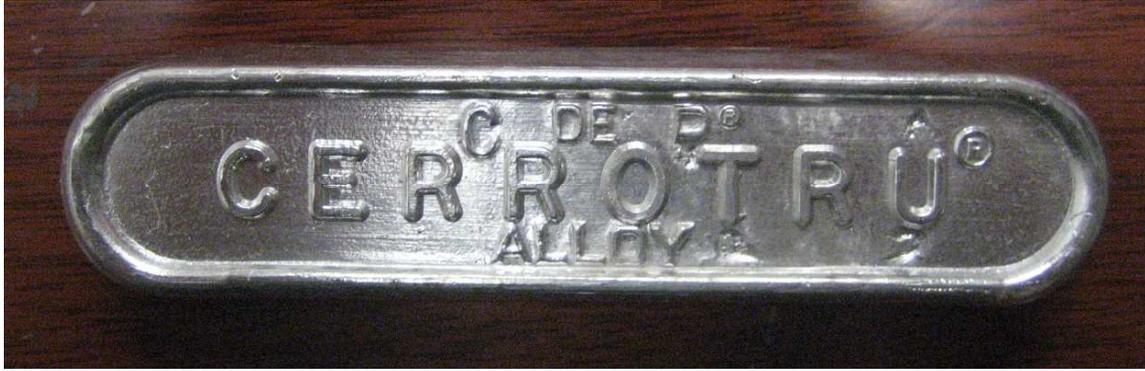
Figure #: Bar of CerroTru® Low Melt Alloy

While the pods and tubing on which the pods were run were coupled to the casing using bow springs, the tool strings inside of the pods needed to be coupled to the ID of the pod using another method. The pup joints chosen for the tools did not allow enough room for bow springs to be added to the tool strings inside of the pods. Instead the decision was made to use a low melt alloy that could provide coupling to the pod wall. The company Bolton Metal Products, also Cerro Metal Products, was contacted to find out information on different properties of the low melt alloys that they could provide. After reviewing data sheets from more than one alloy, an alloy called CerroTru® was decided upon. CerroTru® happened to be one of their most popular low melt alloys, and well as one with the least environment/health effects. The key factor in the decision was the temperature range in which we were working. The metal would need to liquefy at a temperature higher than that of the well conditions so it didn't melt down hole and lower than that of the maximum temperature range of the electronics inside the tools. CerroTru® is sold by weight and comes in bars that can be seen in Figure #.

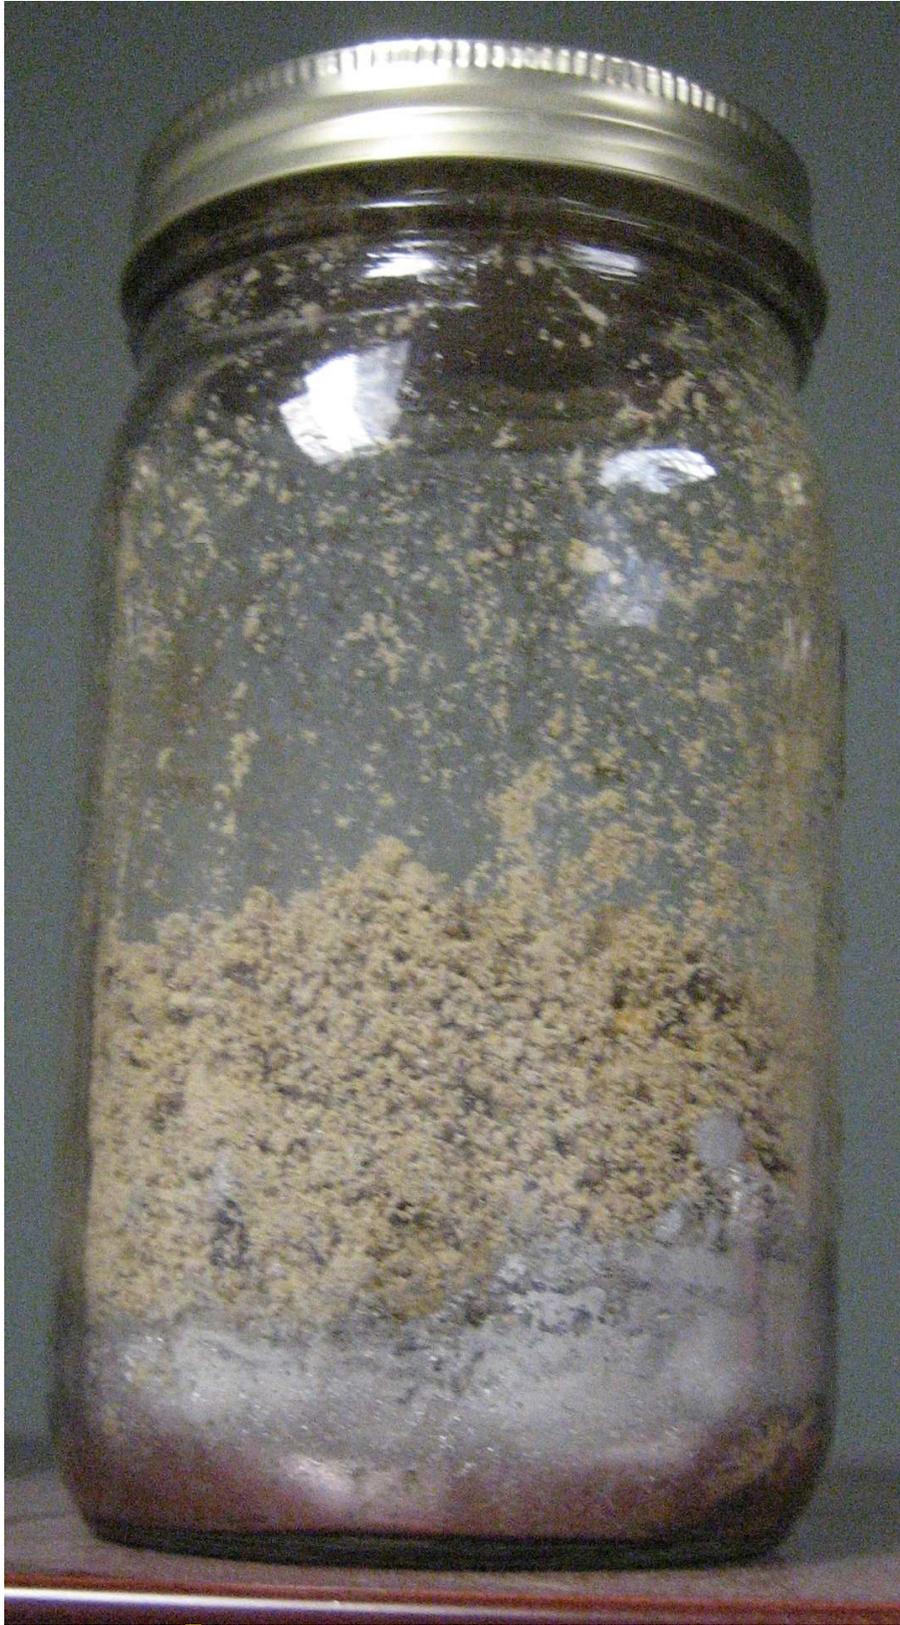
Figure #: CerroTru® Test using dirt as filler medium

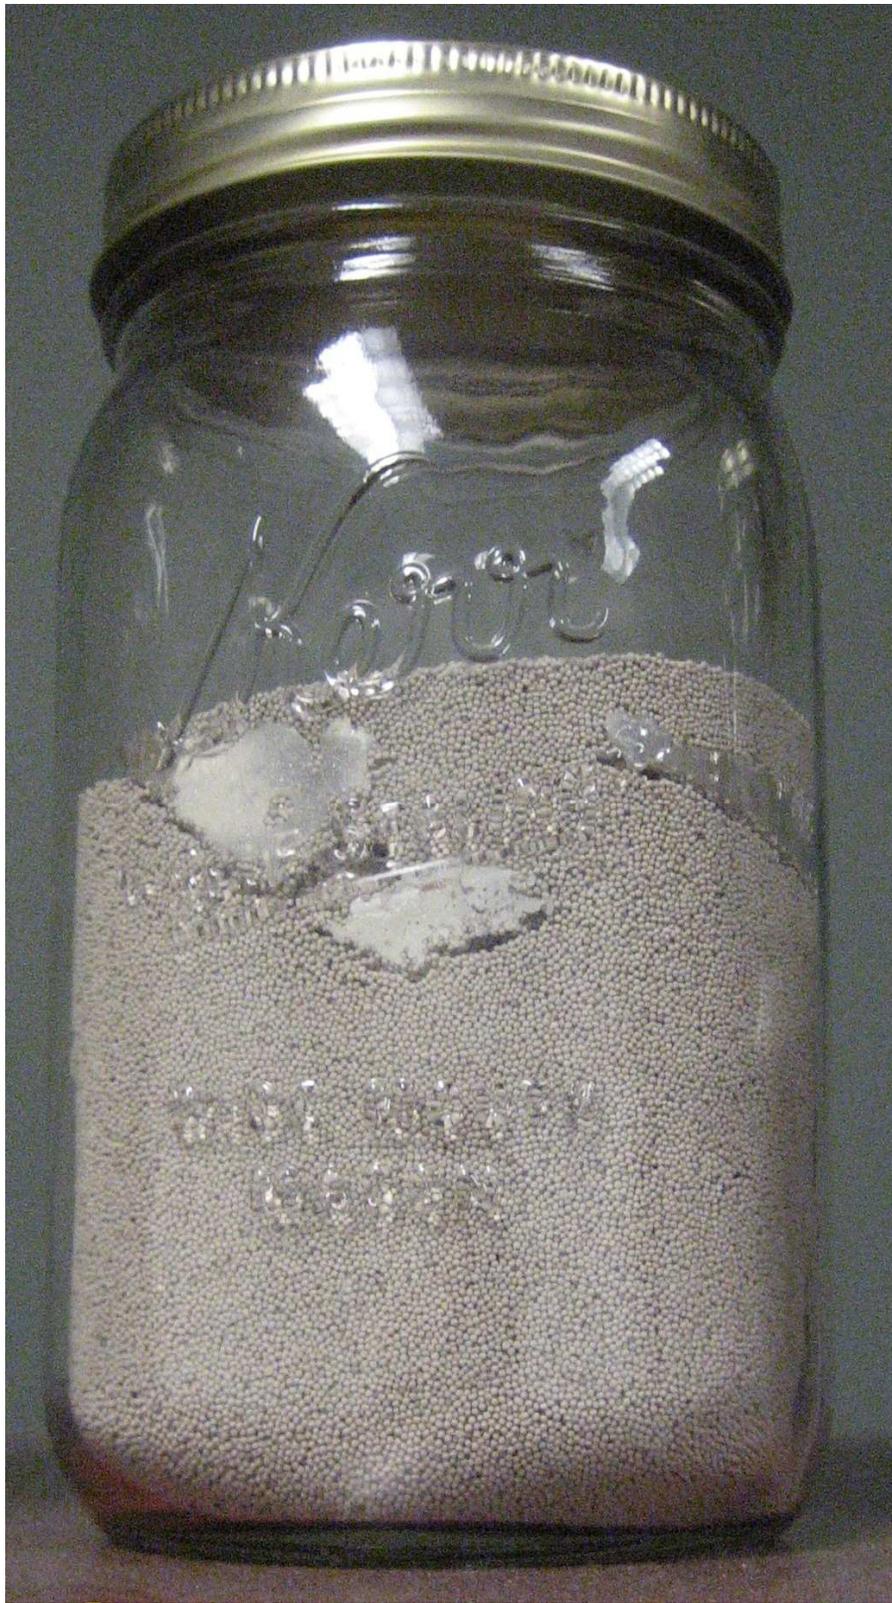
Figure #: CerruTru® Test using CarboLite® 20/40 as filler medium

Unfortunately, as with any project, cost was an issue, and filling every pod up to the top with CerroTru® would have cost too much. This and other reasons drove the search for a filler material that could be used between layers of CerroTru®. A number of tests were done to find the best material to use as a filler. The first test was just run with the nearest plain sand and dirt from the ground outside of the test lab. Those results can be seen in Figure #. The liquid CerroTru® went right through it and was not supported at all. As Pinnacle was owned by Carbo Ceramics at the time, there was extra proppant lying around in the fabrication shop. The second filler test was done with CarboLite® 20/40 as a filler, and it proved to be much more effective in retaining the CerroTru®. The result can be seen in Figure #. While it was more promising than regular dirt and sand, it still did not produce the most optimal results. Before accepting it as the filler material, the decision was made to use a higher density proppant to see if there would be a difference. The last filler test was done with CarboProp® 20/40. This test proved to be the most successful, and the result can be seen in Figure #. The decision was then made to use a standard 10W-30 motor oil as a filler liquid. This made sense because motor oil is non-conductive, and it would prevent water from seeping into the electronics if the metal to metal seals of the pod ever failed and pressure equalized. The data sheet for the CerroTru®, as well as marketing information on CarboProp® 20/40, can be found in Appendix ?.

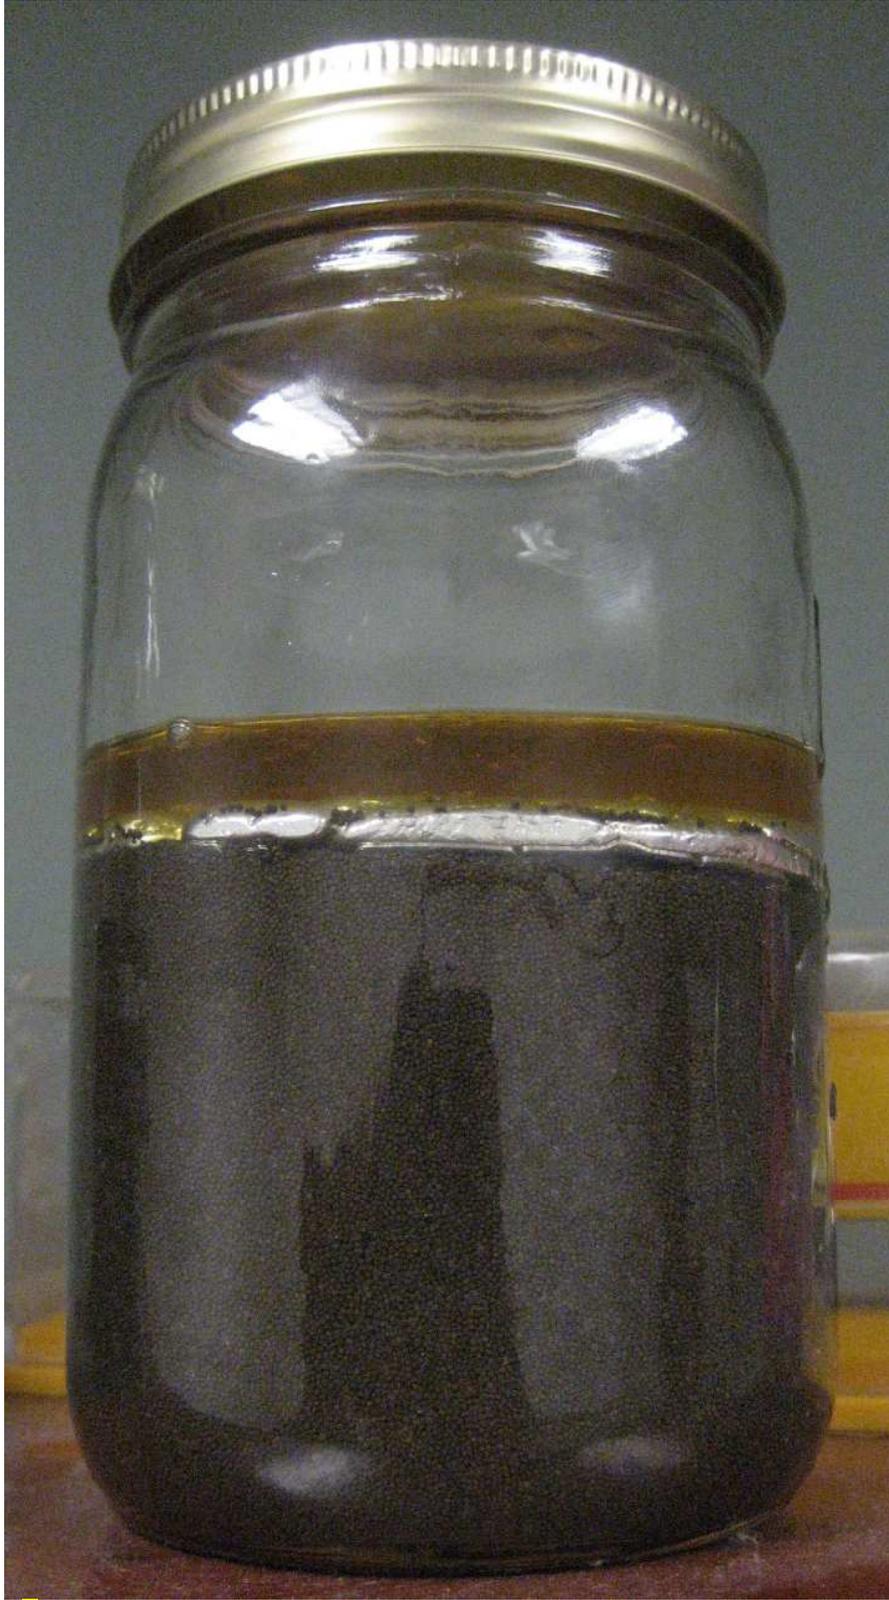
Figure #: CerroTru® Test using CarboProp® 20/40 with oil as filler medium
