**BACKGROUND MATERIALS TO ACCOMPANY THE REPORT
OF THE SAFOD ENGINEERING SUBCOMMITTEE OF THE
ADVISORY COMMITTEE FOR GEOSCIENCES
MARCH 17, 2011**

BACKGROUND

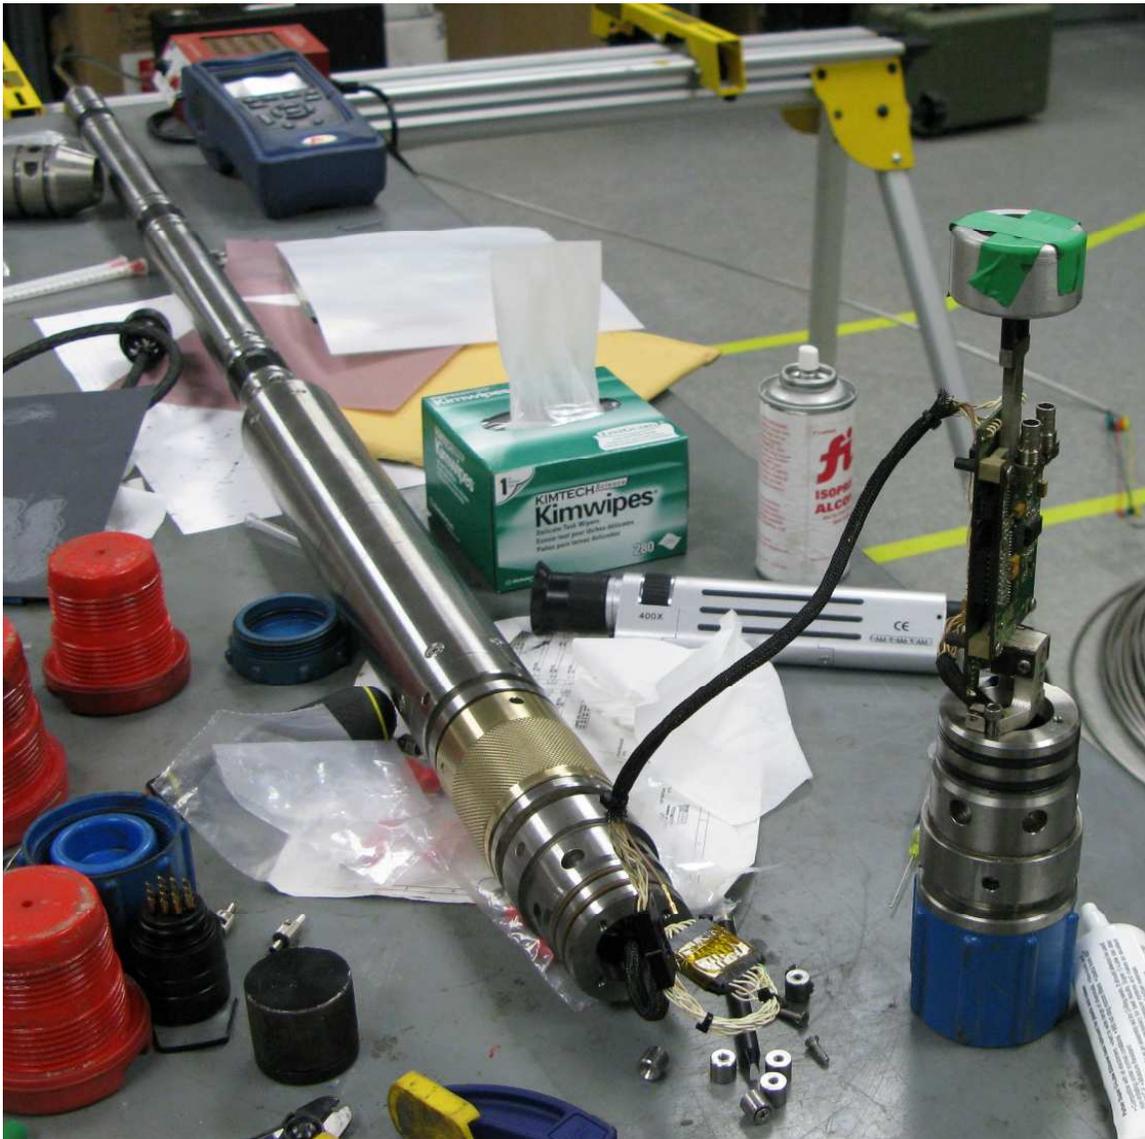
Figure #: 2.5" diameter Crossover to 1-5/8" tool string for Pod 1

Pod 1 was the most challenging pod to design around because it received the fiber optic cable from the surface. A DS250 cable head from Geospace was used as a housing for terminating the fiber optics. While the geophones/MEMS and DS150 interconnect all have a 1-5/8" OD, the DS250 cable head has a diameter of 2.5". You can see the larger diameter of the cable head crossover to 1-5/8" diameter in Figure #.

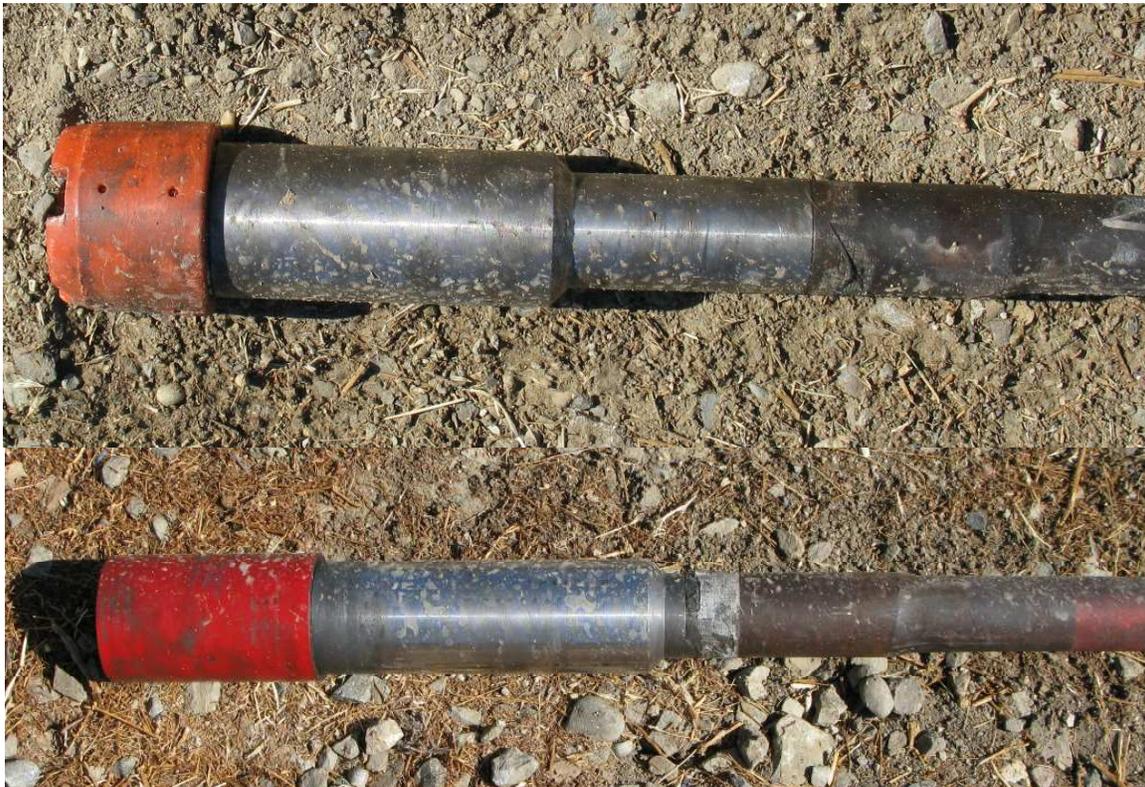
Figure #: Lower Crossover (top) and Upper Crossover with tubing Collar (bottom)
2-3/8" 4.3# EUE 8 Round to 1-1/4" 3.02# CS Hydril® Tubing

The 3.5" 9.3# pup joint has an upset on each end that gives a maximum OD of 3.915" on the ends. We were unable to mount the pup joint for pod 1 on a standard 2-3/8" 4.7# tubing because the tool string would not be able to pass into the 7" casing. Instead, a different type of tubing was selecting for mounting pod 1. We needed something with a smaller OD with close to the same strength as the 2 3/8" tubing. Eventually, it was decided that a 1-1/4" 3.02# CS Hydril® tubing be used. The OD of the body to which it would be mounted was 1.660" and would provide plenty of clearance into the 7" casing. Two crossovers were ordered and used on either end of the 30' long CS tubing to connect back to the 2-3/8" 4.7# tubing joints. A picture of the crossovers can be seen in Figure #. The crossover diameter matched the upset diameter of the 2-3/8" 4.3# tubing, so the cannon centralizers, which can be seen in Figure #, were not placed over the collars themselves. Instead, a centralizer was added below the lower tubing collar and above the upper tubing collar to provide protection for the lines near the collar as the string was run down hole.

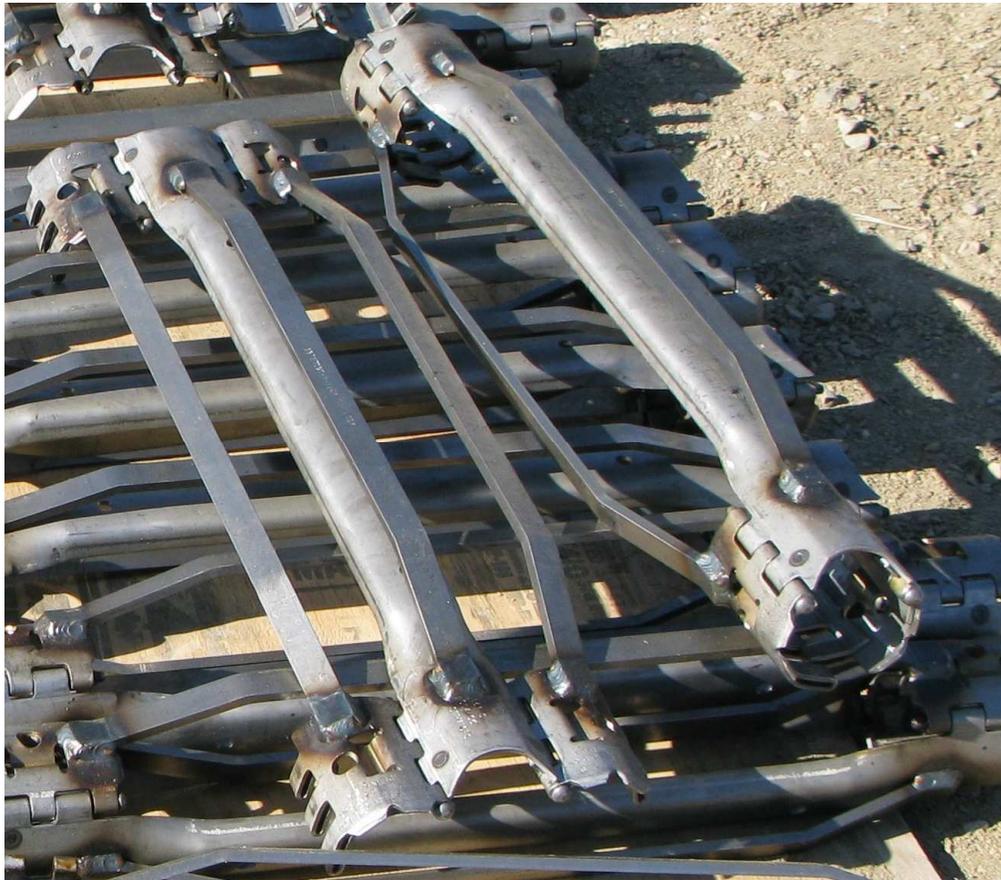
Figure #: Cannon Tubing Centralizers for 2-3/8" Tubing

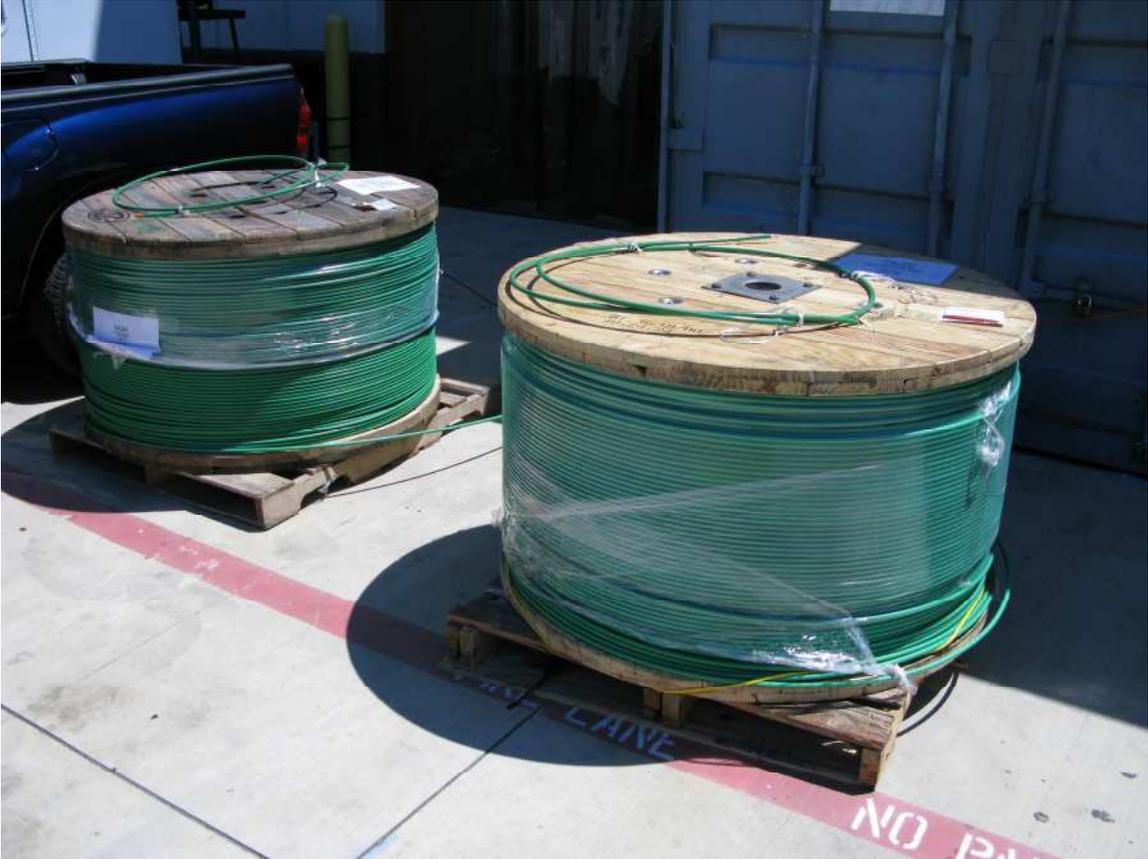
Figure #: 1/4" Tubing with Polypropylene Coating on Spools

Another major issue with pod 1 was the fiber optics. We were able to weld pods 2-4 to the tubing joints on which they were run because a mechanical splice of the 1/4" line was possible above and below the pods themselves. However, with pod 1, the 1/4" line that had to be terminated inside the DS250 cable head. This means that an entire spool of 1/4" line would remain attached to the top of pod 1 during transport and installation. It is impractical to thread the joint on which pod 1 is mounted into the tubing string because the spool of wire would need to rotate with the pod on the rig floor as it is threaded. An example of a spool can be seen in Figure #. Pod 1 was assembled in Houston and shipped to the site connected to the 1/4" tubing. Pod 1 can be seen attached to the spool in Figure #. As that was not a feasible option, a different design was necessary so that the CS tubing could be threaded into place before attaching pod 1 to the tubing string. A concept similar to that of hinges on a door was suggested. The mounting of pod 1 to the CS Tubing using a rod and hinge can be seen in Figure #. It emphasized the alternation between welding a hinge to the pod, then the tubing, then the pod, etc. This shows how the weight of the pod is on the welds of the hinges and not the rods as the assembly is run down hole. There are two rod and hinge placements, one on each side of the tubing. This would be equivalent to having a hinge on two opposite sides of a door. The door would not move.

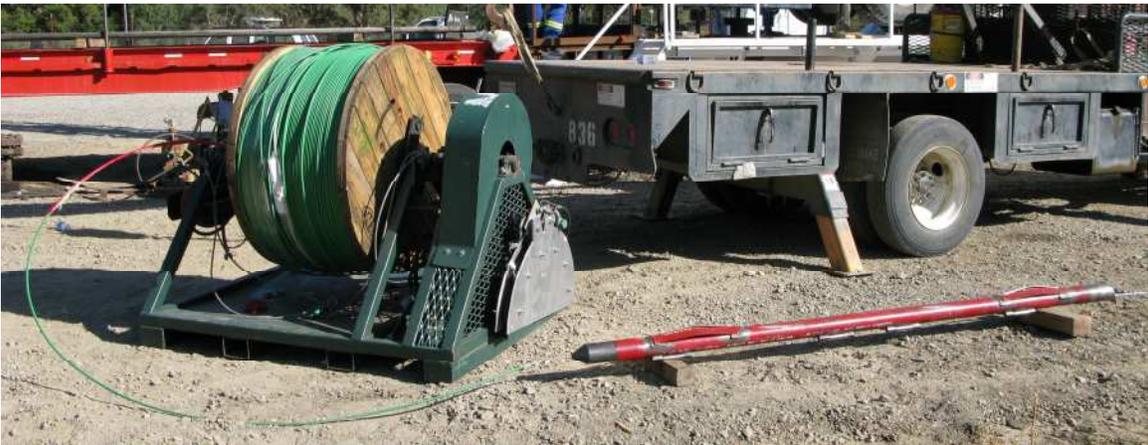
Figure #: Pod 1 was shipped from Houston attached to a Spool

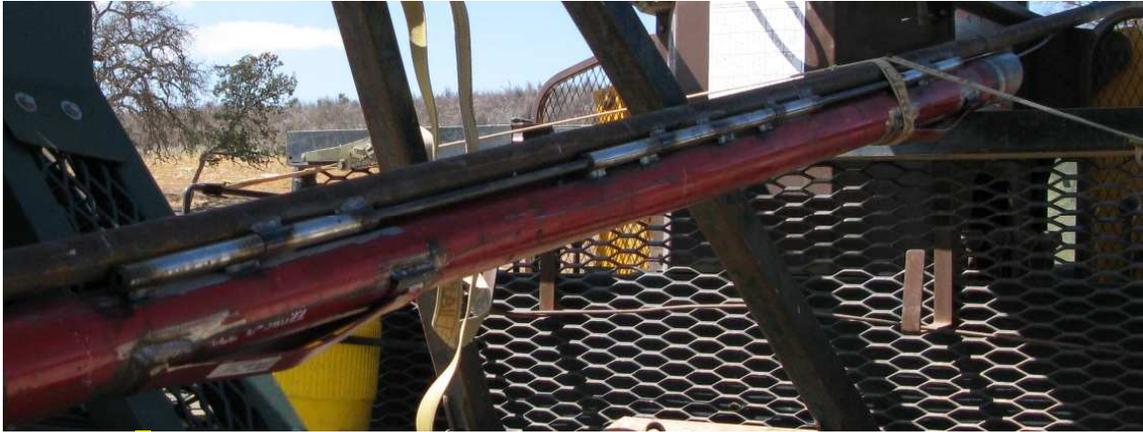
Figure #: Pod 1 also Hinged to CS Tubing for Shipping (down hole to the right)

There were design challenges when dealing with a hinge type connection. The hinges themselves needed to closely match the material of the CS Tubing and 2-3/8" EUE Tubing onto which the hinges would be welded. Similar materials are always desired when welding two pieces of metal together. For this reason, 4142 heat treated and stress free rod was chosen for both the hinges and the rods running between hinges. The rod running through the hinges is a standard 1/2" rod. The hinges themselves started as a 1" rod, and the middle of the rod was drilled out with a 1/2" bit. The ID of the 1" rod was then reamed with a .5156" reamer. The rods were 6' long, while the hinges were just under 8" in length each. Four of the 1" reamed rods were tapped on one end with a 3/4"-10 UNC thread 3/4" deep. This was so the a 3/4"-10 set screw 3/4" long would be used to hold the rod in place as a safety measure on both ends of the 1/2" rod.

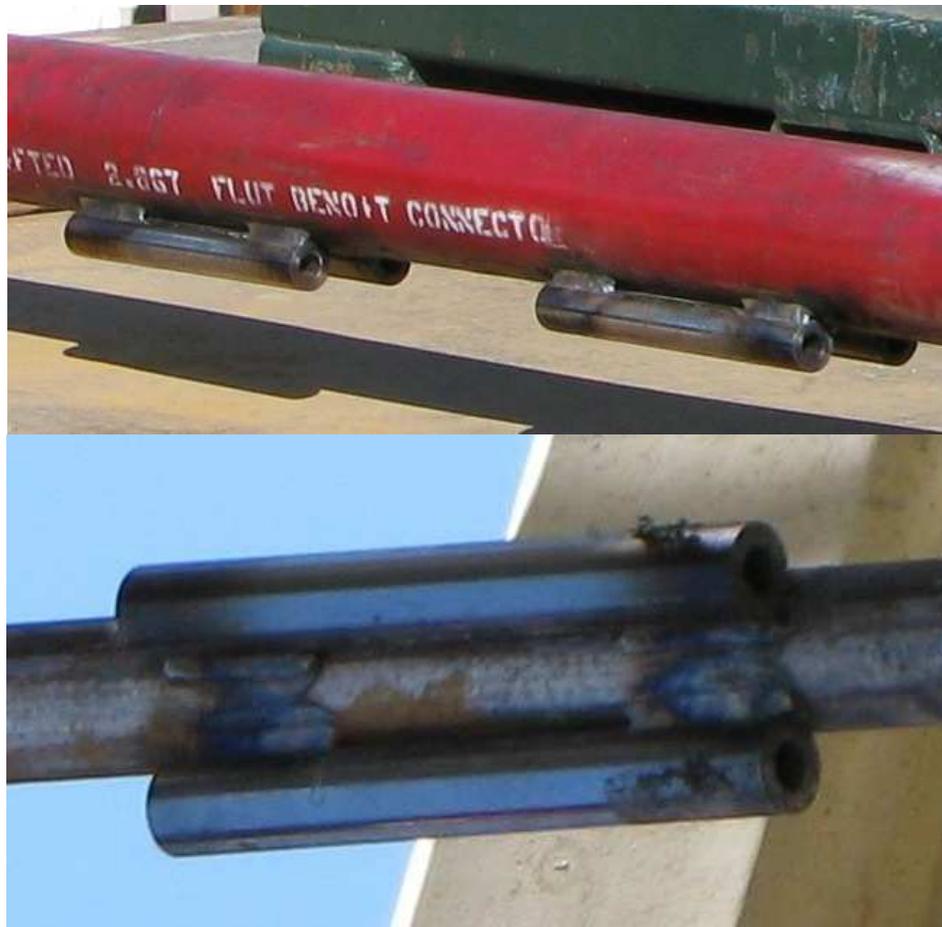
Figure #: Close Up View of Hinges Welded to Pod 1

After reaming the 1" rod, the hinges slid freely over the 1/2" rods without too much off axis movement. Sliding easily along the rod was desirable because the hinges would move and draw during the welding process. The reason for a 1/4" wall thickness on the 1" hinge was also made to avoid too much draw of the hinge onto the tubing from the welding as well as to avoid affecting the concentricity of the reamed ID. The rods were run through the hinges with set screws in place on either end while the hinges were tack welded to the 2-3/8" Tubing and CS Tubing. The rods were then removed to finish the welding process. Hinges were mounted in an alternating pattern so that a hinge welded to pod 1 would rest on a hinge on the CS Tubing as it is run down hole, thus supporting the weight of the pod without creating additional stress on the 1/2" rod. A close up of the welding on pod 1 can be seen in Figure #.

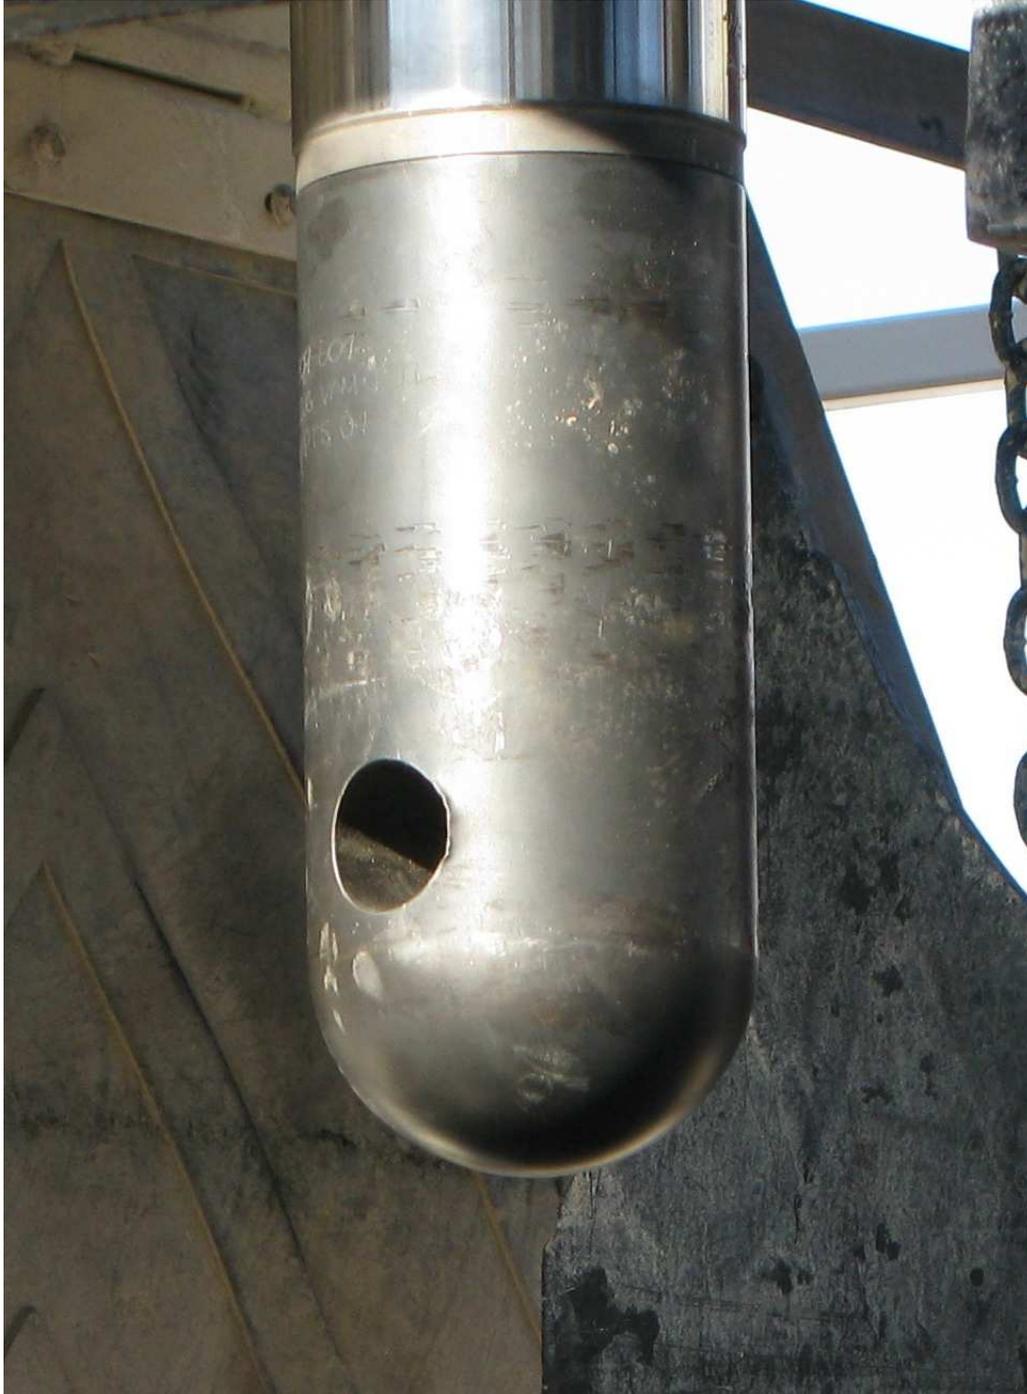
Figure #: Bottom Bull Plug of Pod 5

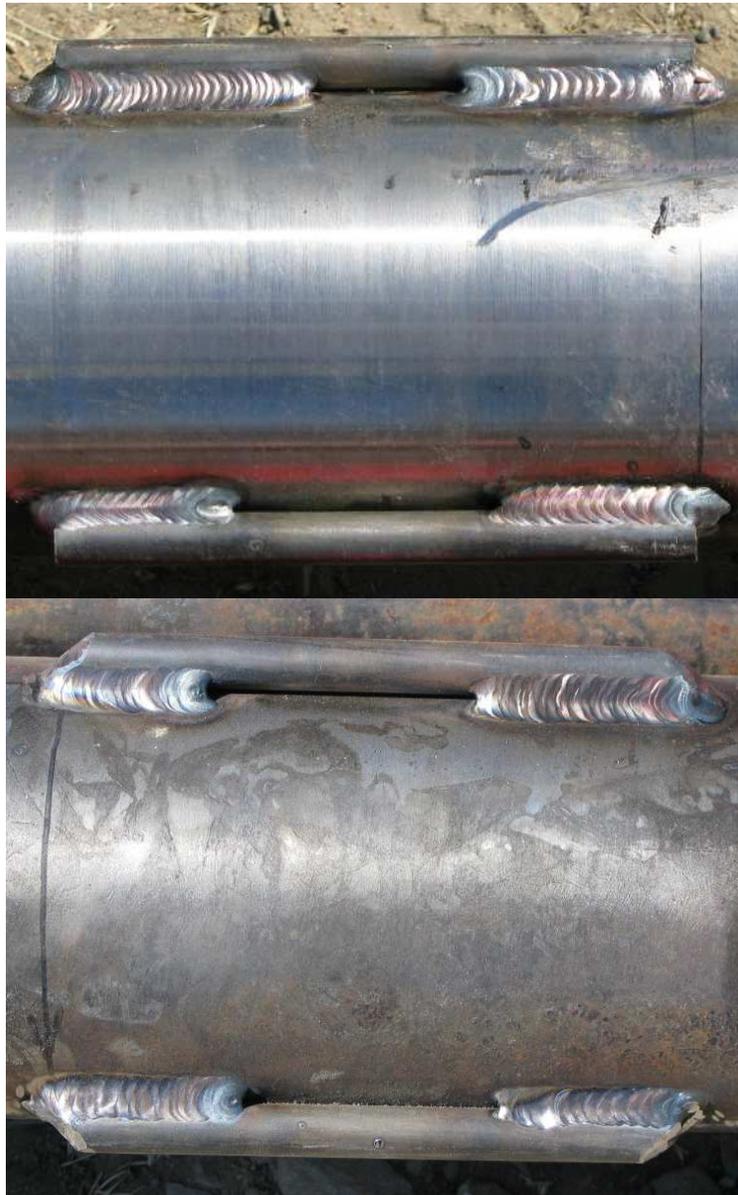
Figure #: Rods Before (top) and After (bottom) grinding of angles

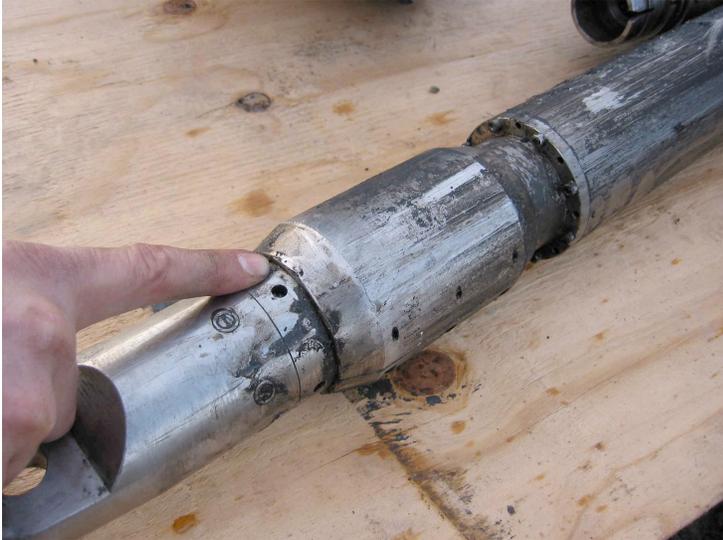
7" SAFOD Phase 2 liner hanger that caught an edge of the DS325 sonde (see photo below). Consequently, the tool was positioned just above liner hanger. All of the tools died soon after installation. We concluded that we needed to switch to the DS250 seismometer, since it and the tiltmeter were of uniform diameter with no external upset. This would give us the best chance of getting past the liner lap.

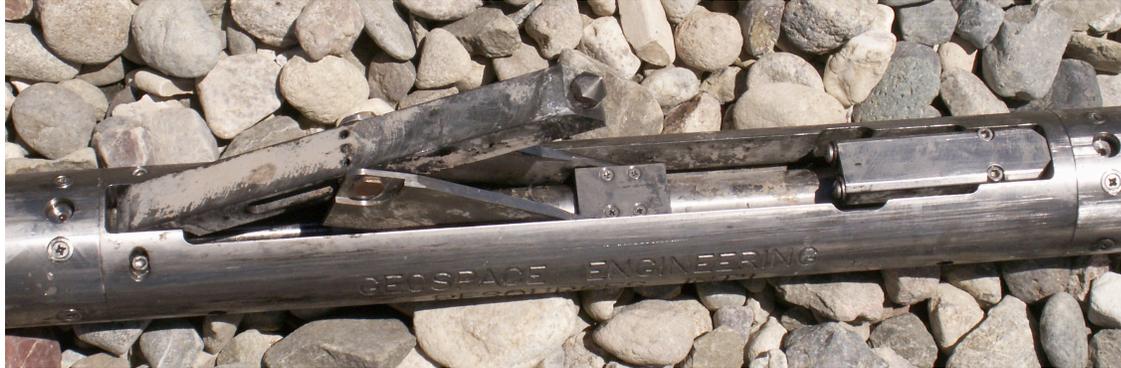
When the instrument string surfaced around 13:00 small gas bubbles were visible coming out of the upper part of the cablehead (seal approx. 2in below the upper end) and the wireline (right on top of the cablehead) through a greasy, clear substance.

The locking arm of the upper DS250s was only half way retracted. The locking arm of the lower DS250 was completely retracted. The connection between the upper DS250 and the tiltmeter had some moisture in it (all other connectors were found dry)

1. complete instrument string (as in the well): Only the arm of the upper DS250 could be moved. Waking up the DS250s was not successful. Tiltmeter showed excessive current draw (120mA compared to 80mA), communication was not possible
2. Cablehead – upper DS250 (S/N 109) – lower DS250 (S/N 108): both arms could be moved in and out – wake up was not successful.
3. Cablehead –lower DS250 (S/N 108): arm could be moved in and out – wake up was not successful.
4. Cablehead – tiltmeter: excessive current draw, communication was not possible
5. Cablehead – upper DS250 (S/N 109): arm could be moved in and out – wake up was not successful.
6. Cablehead alone: Even if no tiltmeter was connected, the tiltmeter power supply showed a current draw of 26mA

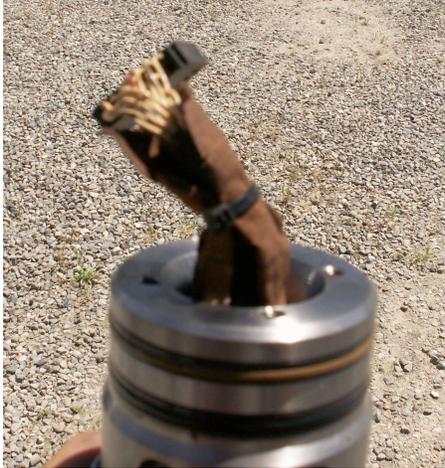
The pressure plug of the cable head (lower part including the fiber optic converter) was opened with the nozzle of the gas monitor held close to the pressure plug. The inside was not pressurized but the gas monitor found extreme high concentration of CO (went off scale) while showing traces of H₂S, and combustibles. Everyone agreed on a strong “burnt” smell when the bottom connector was removed. The wires leading to the bottom connector were found wrapped in a brown paper insulation which looked burnt.

Maybe the paper insulation did not withstand the high temperature and oxidized over time thus releasing CO into the cable head.

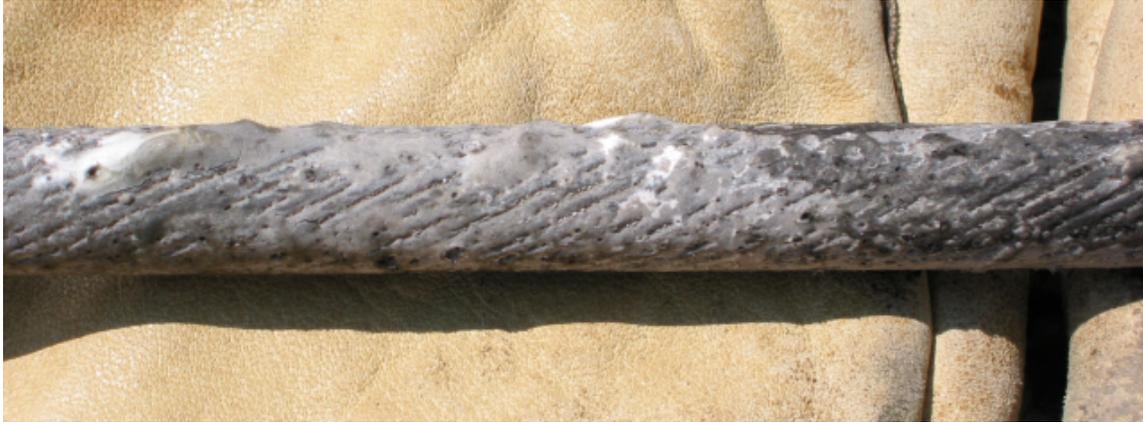
When the tool string arrived at the surface, a substance was hissing out of the wire line for the last couple of meters above the cable head. The picture below was taken one hour later when the substance had dried out.

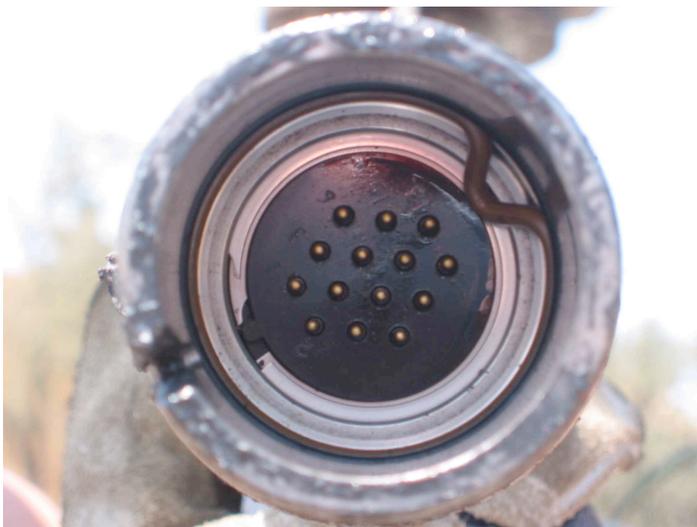
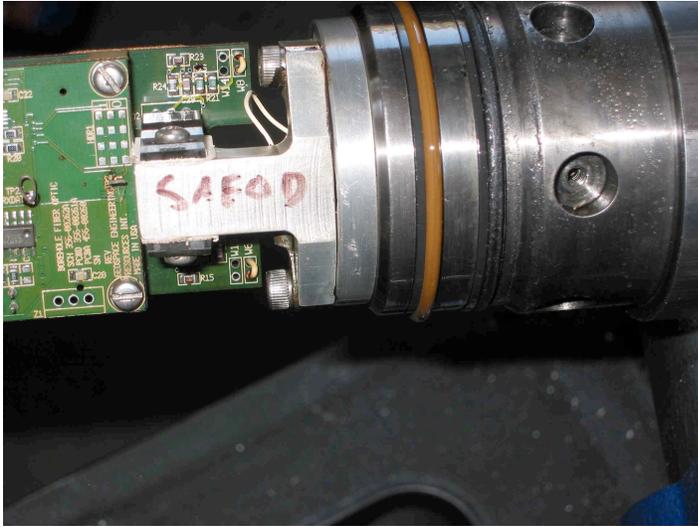
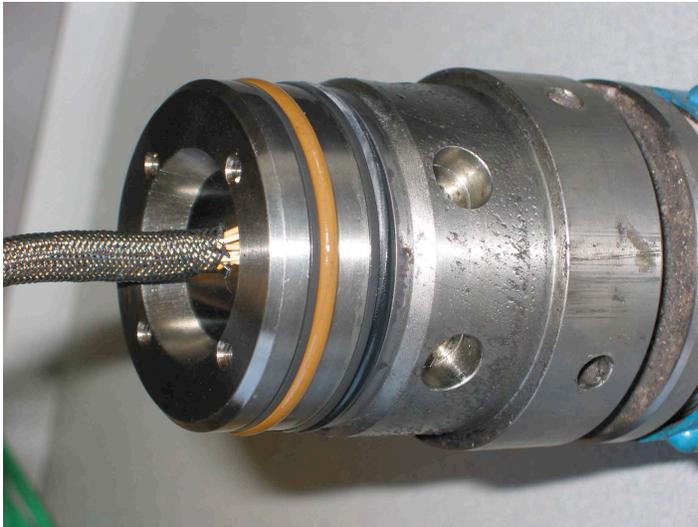
Gas pressure was noted in the cable head when it was taken apart at the wellhead. When opened, a number of O-rings were found to have been damaged. It does not appear, however, that liquid had time to enter the pressure vessels, as all tools tested OK once separated from the cable head. Further testing after severing the cable head from the cable revealed that there was a short in the cable head – clearly the failure point. Although there were doubts about how much Krytox oil was in the cable head when the tools were recovered, draining of the cable head overnight recovered about 100 ml of Krytox oil, which showed no signs of degradation or discoloration. The remaining Krytox might have leaked out or been replaced by the gas-charged wellbore fluid. Corrosion in rope socket supports this view. The Viton O-ring in the cable head interconnect was observed to be swollen (see photo below), but the Kalrez O-ring showed no sign of damage. Similar swelling was seen in the Viton O-ring in the in the cable head bottom bulkhead, but not in the Kalrez O-ring. No O-ring swelling was observed in the interconnects between the DS250s and the tiltmeters.

Cable head shipped to Houston for repair. Evidence found of burning on pins 1 & 2, possibly due to burning of boot due to high current. Considerable discussion of options for potting the wet side of the cable head. Decision made to try grease recommended by Oil Center Research, as the DC111 grease that we have been using has proven inadequate to the task. Will also research high-temperature epoxy as another alternative.

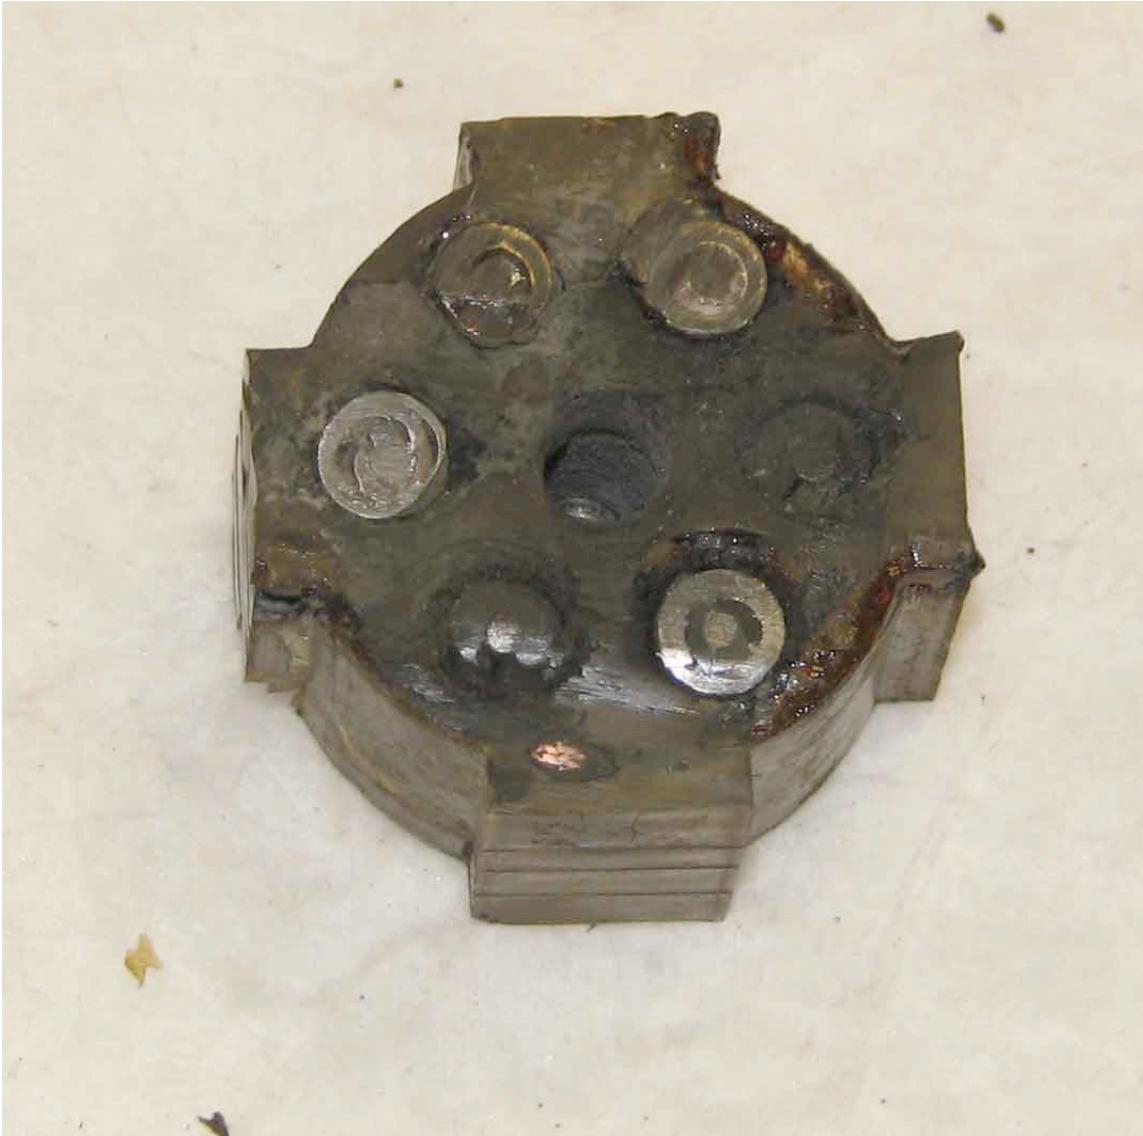
In "Picture 1", if you zoom in on the feed thru, you'll notice bubbles or a path on the feed thru where it looks like the epoxy was delaminated from the feed thru. It looks like water could've come from the bottom side of the epoxy and made its way back up along the feed thru. If that happened, it would explain the short between conductors and ground. It looks like the epoxy bonded well with the copper tubes (Picture 2).

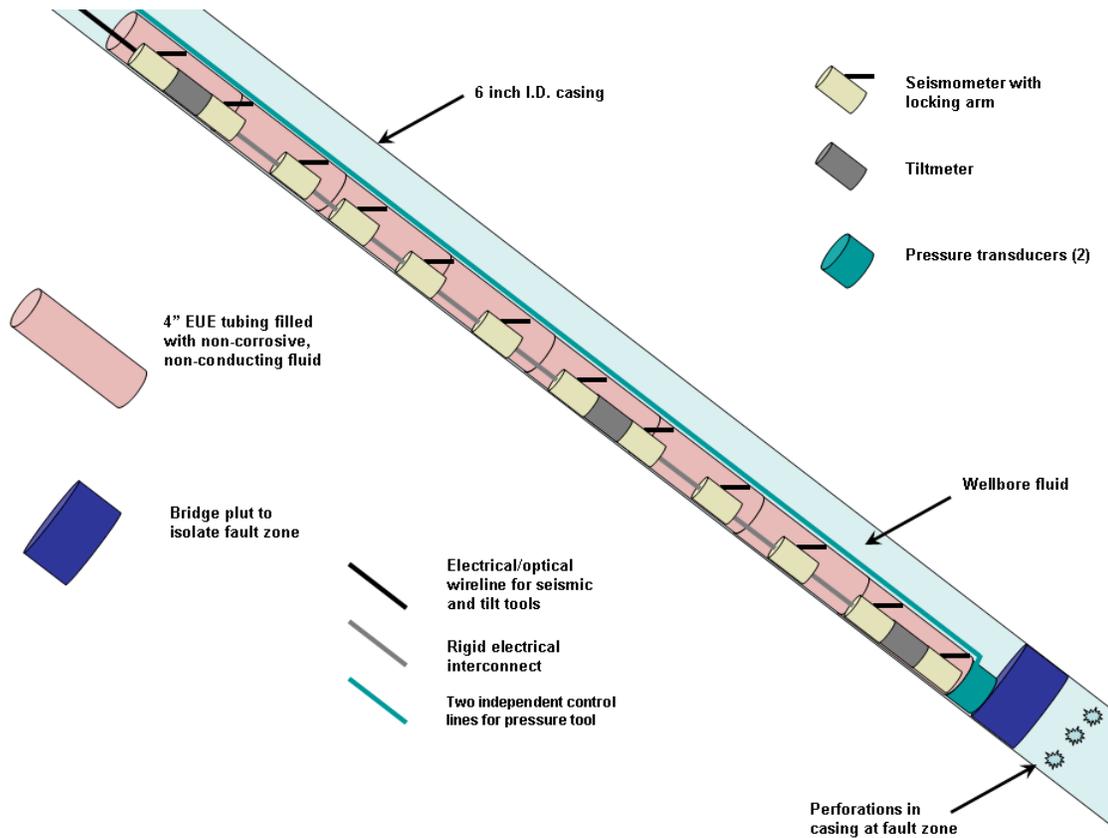
Figure 3. Layout of new SAFOD observatory (see text for details).

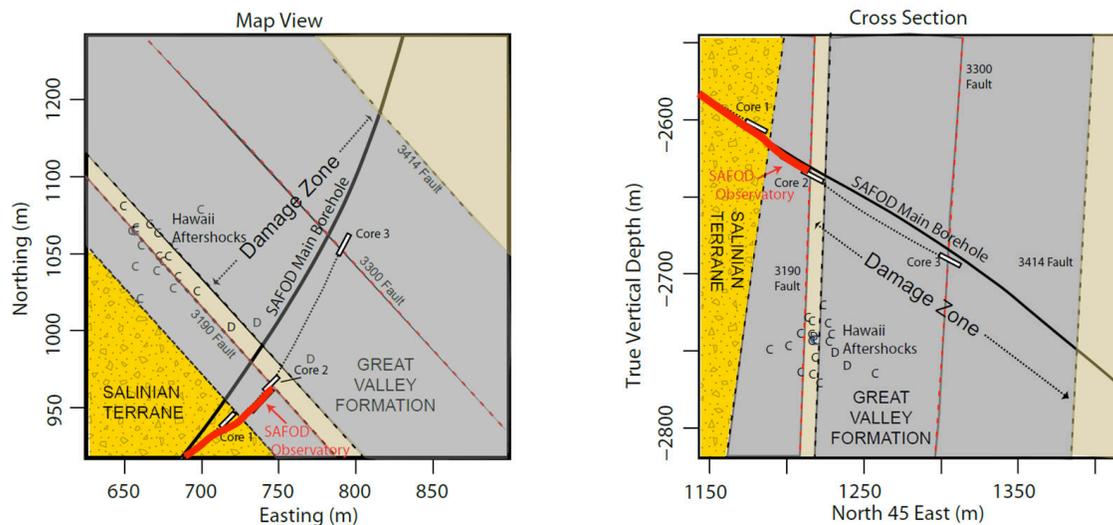
Figure 5. Map view (left) and cross-section (right) of the trajectory of the SAFOD main borehole, the generalized geology, the locations of the major faults (and damage zone) and the locations of the cores obtained in multi-lateral sidetracks. Note that the location of aftershocks of one of the Hawaii target earthquakes (shown by symbols C and D) correlates with the 3190 m shear zone. The position at which the SAFOD observatory is deployed is adjacent to the 3190 m shear zone, about 100m above Hawaii events.

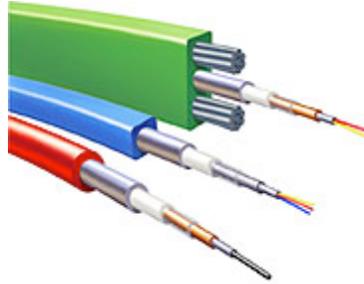
Fig. 1: Tube encapsulated conductors and fiber for permanent installation

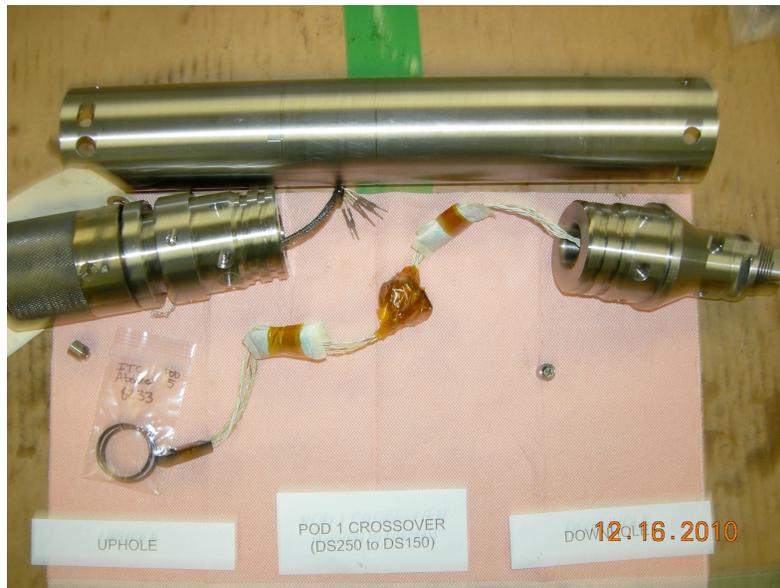
Pod 1

- DS250 Cablehead- Documentation taken by SAFOD.
- DS250 to DS150 Crossover-
 - Would wake up tools.
 - Crossover had pressure built up inside, had same smell.
 - No water intrusion, small amount of oil film on inside where o’rings seat.
 - Corrosion on all connector pins inside case.
 - O-rings had typical seating impression.
- DS150 SN: 6122-MEMS Tool
 - Woke with errors, fails test calibrations.
 - Tool had pressure built up inside, had same smell.
 - No water intrusion, small amount of oil film on inside of tool where o-rings seat.
 - Corrosion on all connector pins inside tool.
 - O-rings had typical seating impression.

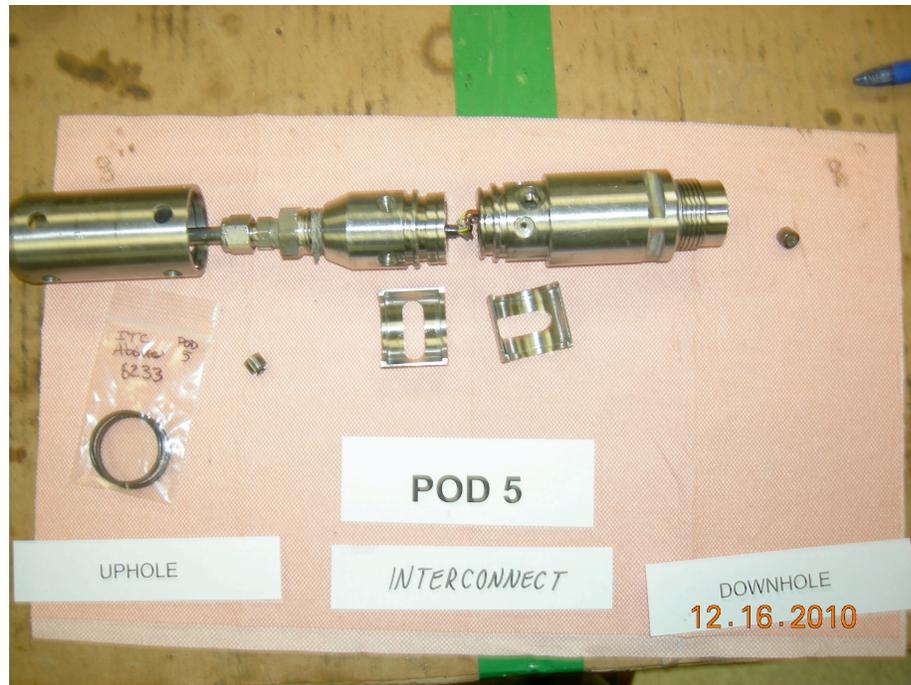
Pod 5

- Interconnect
 - Same smell inside.
 - No DC111 found.
 - O-rings have seated.

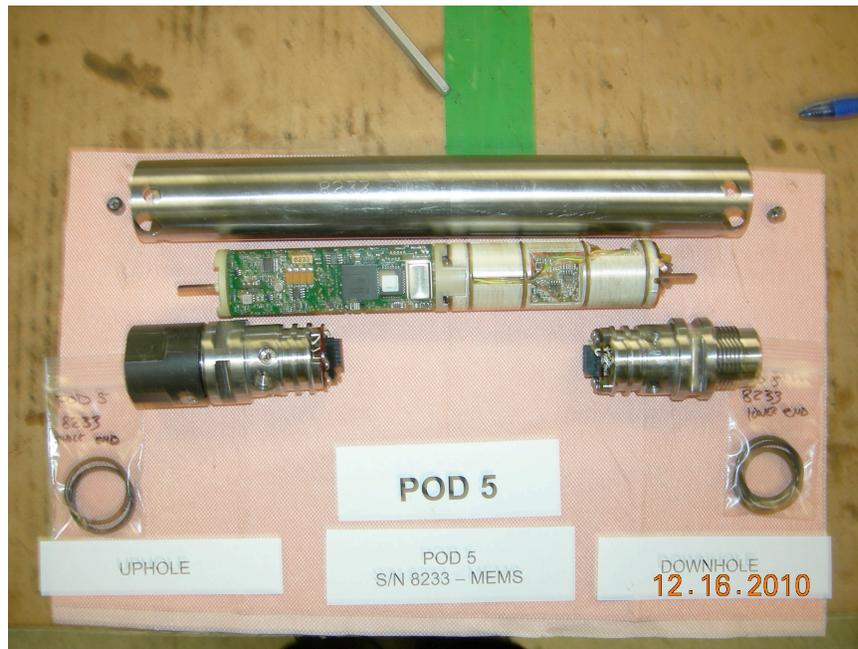
- Tool woke with errors.
- Failed calibration tests.
- Tool had pressure built up inside, had same smell.
- No water intrusion, small amount of oil film on inside of tool where o-rings seat.
- O-rings had typical seating impression.
- Corrosion on all connector pins inside tool.
- C6, 16 cracked on power supply board.
- C55 on analog to digital board cracked.

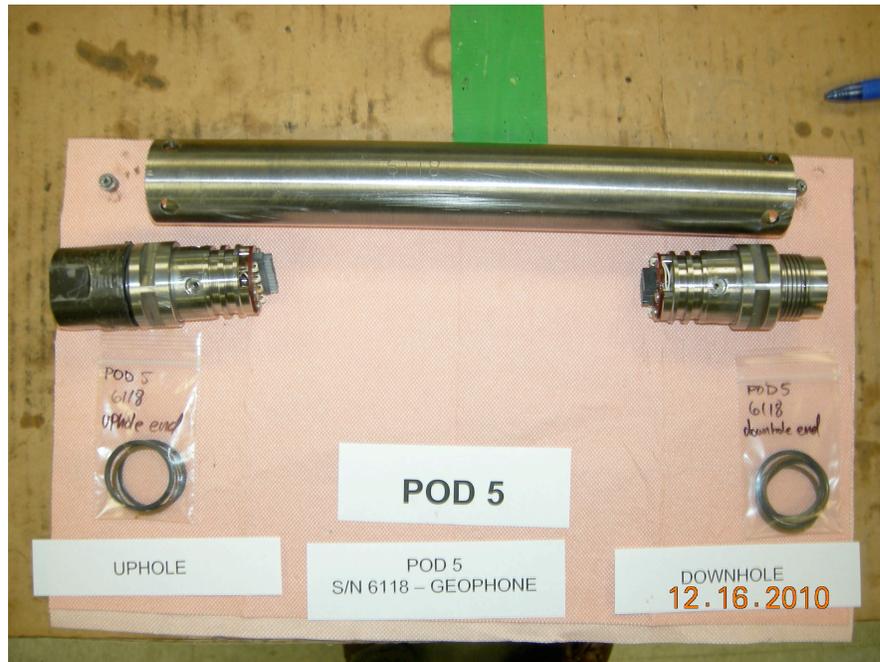
- No wakeup.
- Tool had pressure built up inside, had same smell.
- No water intrusion, small amount of oil film on inside of tool where o-rings seat.
- O-rings had typical seating impression.
- Corrosion on all connector pins inside tool.
- T2 shorted primary to secondary.
- T4 6.2ohm primary to secondary.
- C6, 16 cracked on power supply board.
- C55, 56, 57 cracked on analog to digital board.
- C71 cracked on logic board.

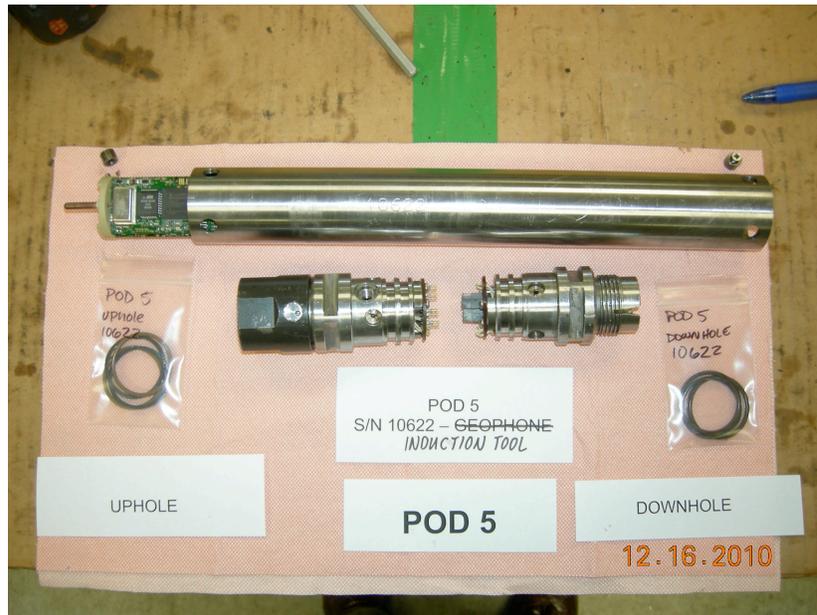
- No wakeup.
- Tool had pressure built up inside, had same smell.
- No water intrusion, small amount of oil film on inside of tool where o-rings seat.
- O-rings had typical seating impression.
- Corrosion on all connector pins inside tool.
- Connectors stuck together inside tool, breaking P1.
- T1 shorted primary to secondary.
- C6, 16, 30, 33 cracked on power supply board.
- C55, 56, 57 cracked on analog to digital.
- C47, 48, 71 cracked on logic board.

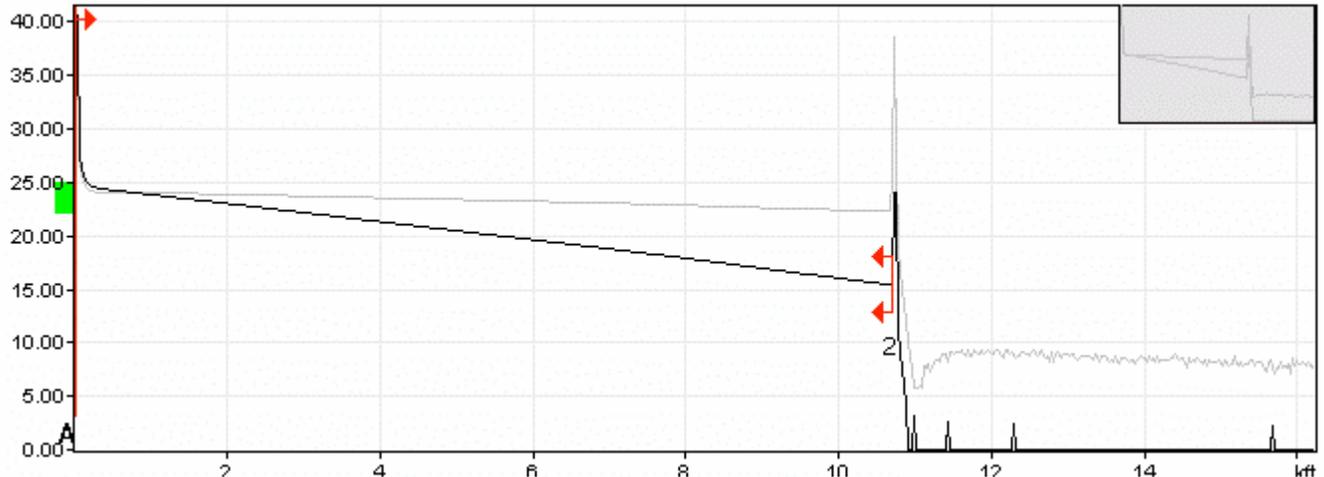
The graph shows signal strength (in dB) vs. depth (in kft) for the DATA fiber at 850nm (dark line) and 1300nm (light line). After a very sharp drop over the first couple of 100ft (which corresponds to the part of the cable which was above ground) the attenuation is linear with depth. The reflection at ~10700ft is the result of the end of the fiber (or the F/O converter on top of the top seismometer)

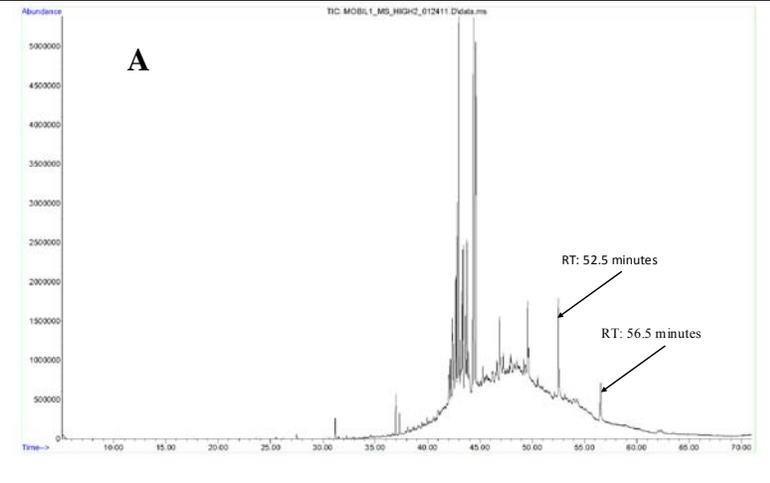
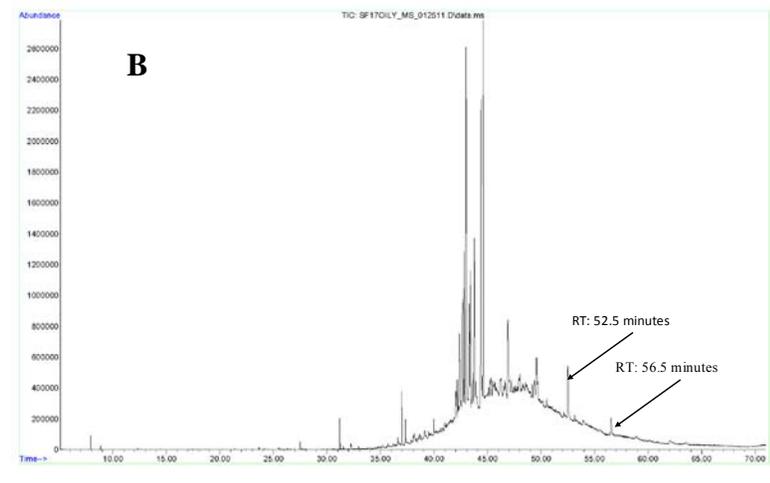
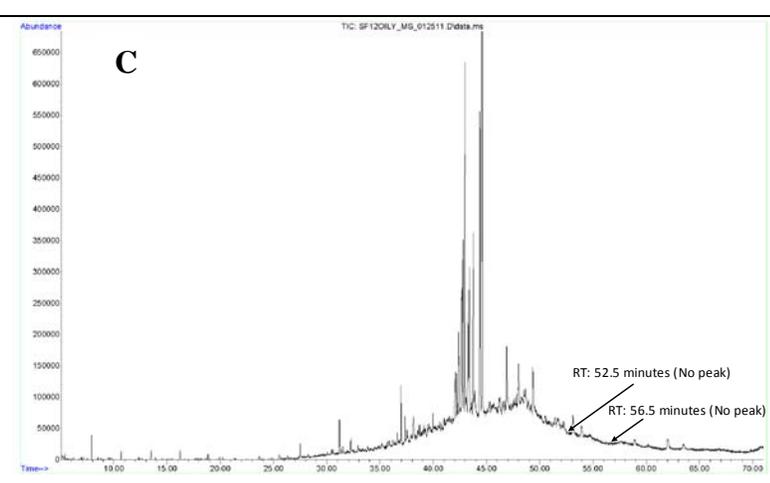
Figure 8. Spectra of oil components with a peak retention time of 52.5 minutes. (A) Mobile-1 synthetic 10W-40 motor oil. (B) Sample SF-17, POD 1 Sample 3 drained from the bottom of POD while tilted at 20 degrees. Mass spectra are consistent with nitrogen containing organic compounds, but were not identified using a library search.

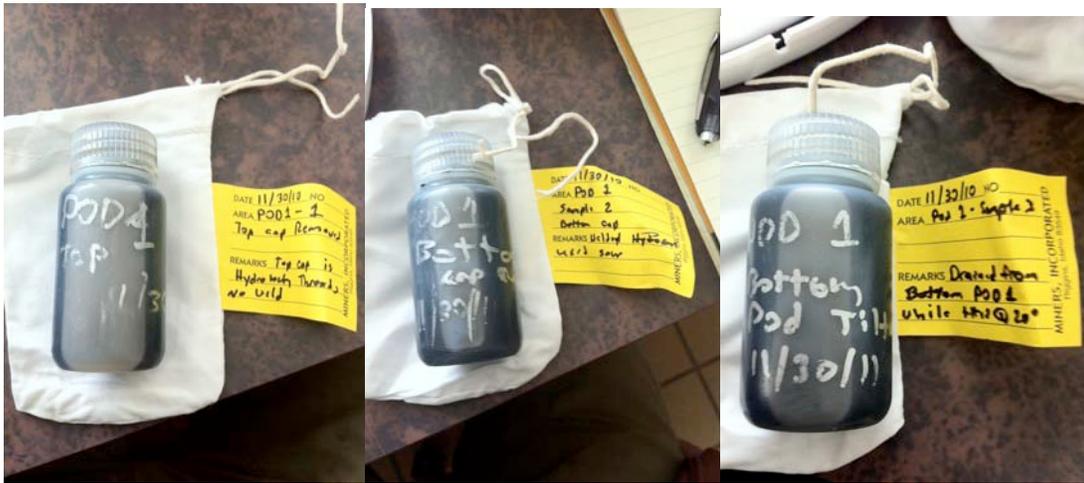
Sample 3: Fluids and some propant. Collected from bottom of Pod1 while it was at ~20degree angle.
