**BACKGROUND MATERIALS TO ACCOMPANY THE REPORT
OF THE SAFOD ENGINEERING SUBCOMMITTEE OF THE
ADVISORY COMMITTEE FOR GEOSCIENCES
MARCH 17, 2011**

BACKGROUND

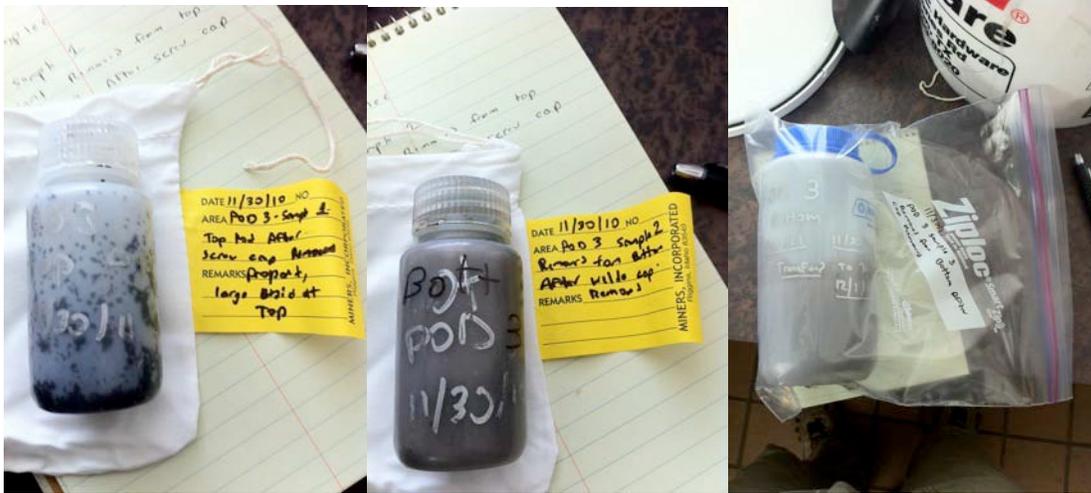
Sample 1: Propent and some fluid. Large voids at top. Had to dig out propent with rod.

Sample 2 and 3: Fluid collected when bottom cap was cut off. Milky grey fluid with gel like material.

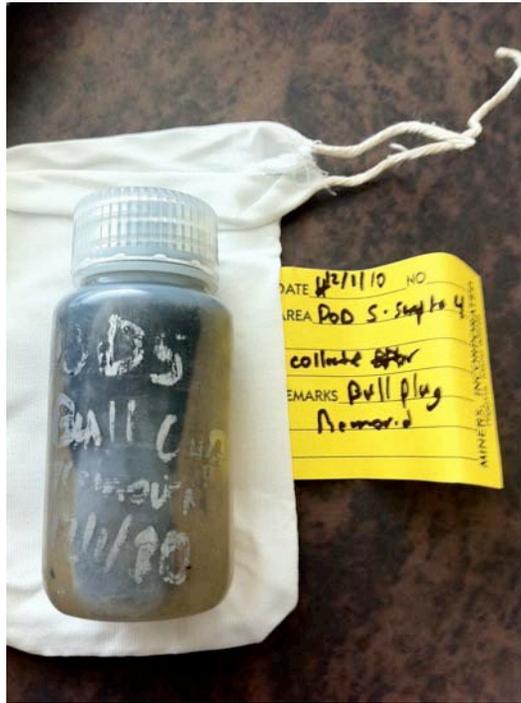
Sample 4: Captured when bull plug was removed. (bottom cap under Nitronic 50 section)

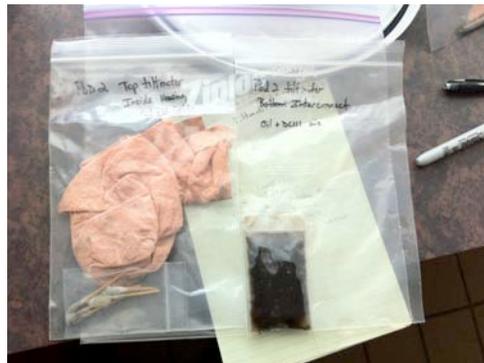
Sample 2: Fluid from Bottom interconnect.
