Appendix F: Pioneer MAB Seabed Survey and ROV Inspections

Pioneer MAB Seabed Survey & ROV Inspections

Control Number: 3210-00004

**Coastal and Global Scale Nodes
Ocean Observatories Initiative
Woods Hole Oceanographic Institution**

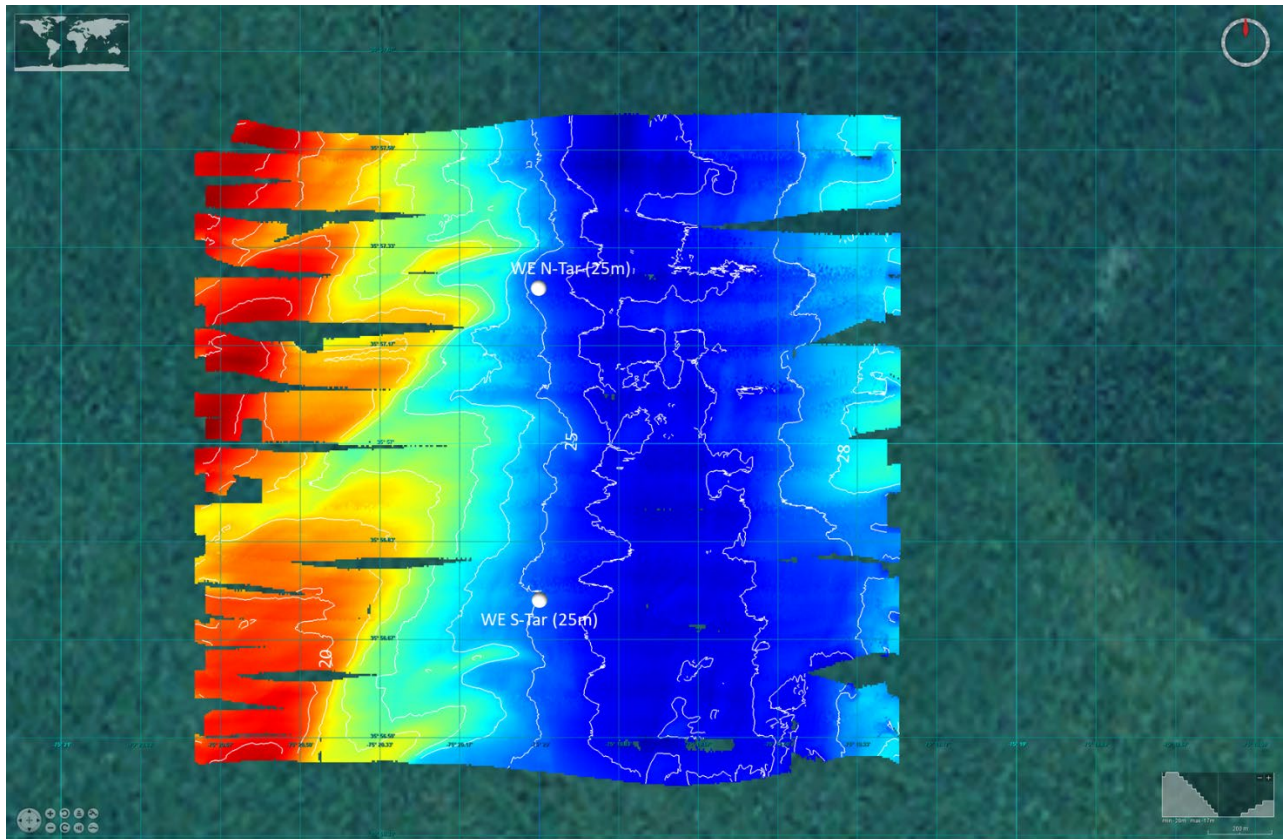
Figure 8: West Site Digital Terrain Model (2m contours)

Moving west to east across the site (Figure 8), the water depth is at the shallowest ~17m, then deepens to ~28m in a somewhat flat north/south running channel, then rises slightly to 24m in the east. The data indicates several shallow banks to the west. As discussed in the Pioneer MAB desktop study, these shallow banks may consist of mobile sand and gravel sediments. The North and South anchor targets are at depths of ~25 m. Data collected over 2km x 2km area using 90m line spacing.

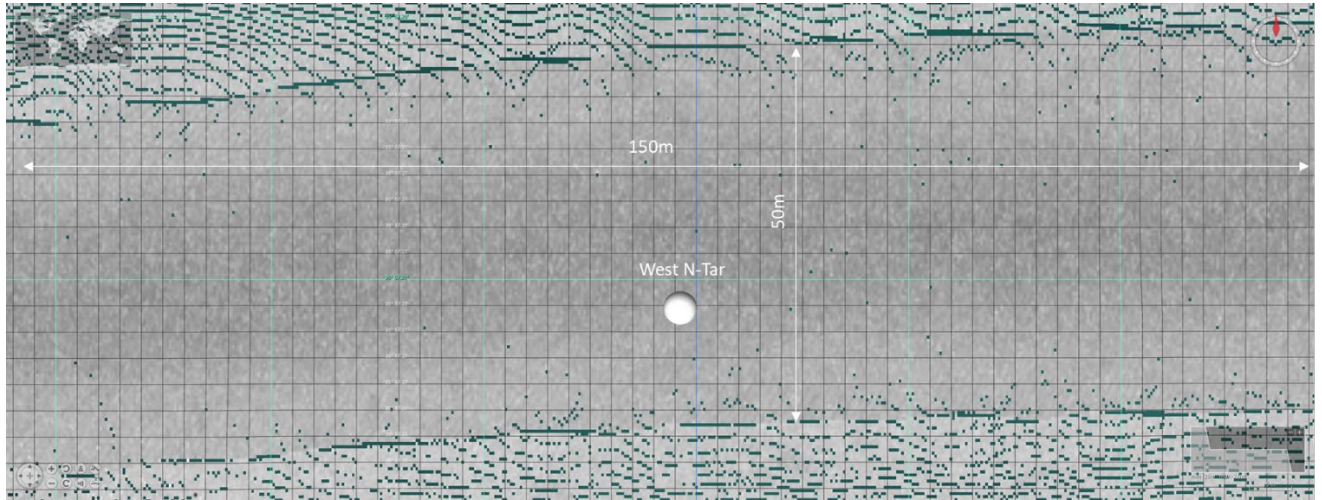
Figure 9: West Site North Anchor Target (N-Tar) Backscatter

Backscatter imagery at both the north and south anchor target sites indicate a homogeneous seabed, no visible hazards such as hard bottom, cables, pipelines, wrecks, or debris (Figures 9 & 10).

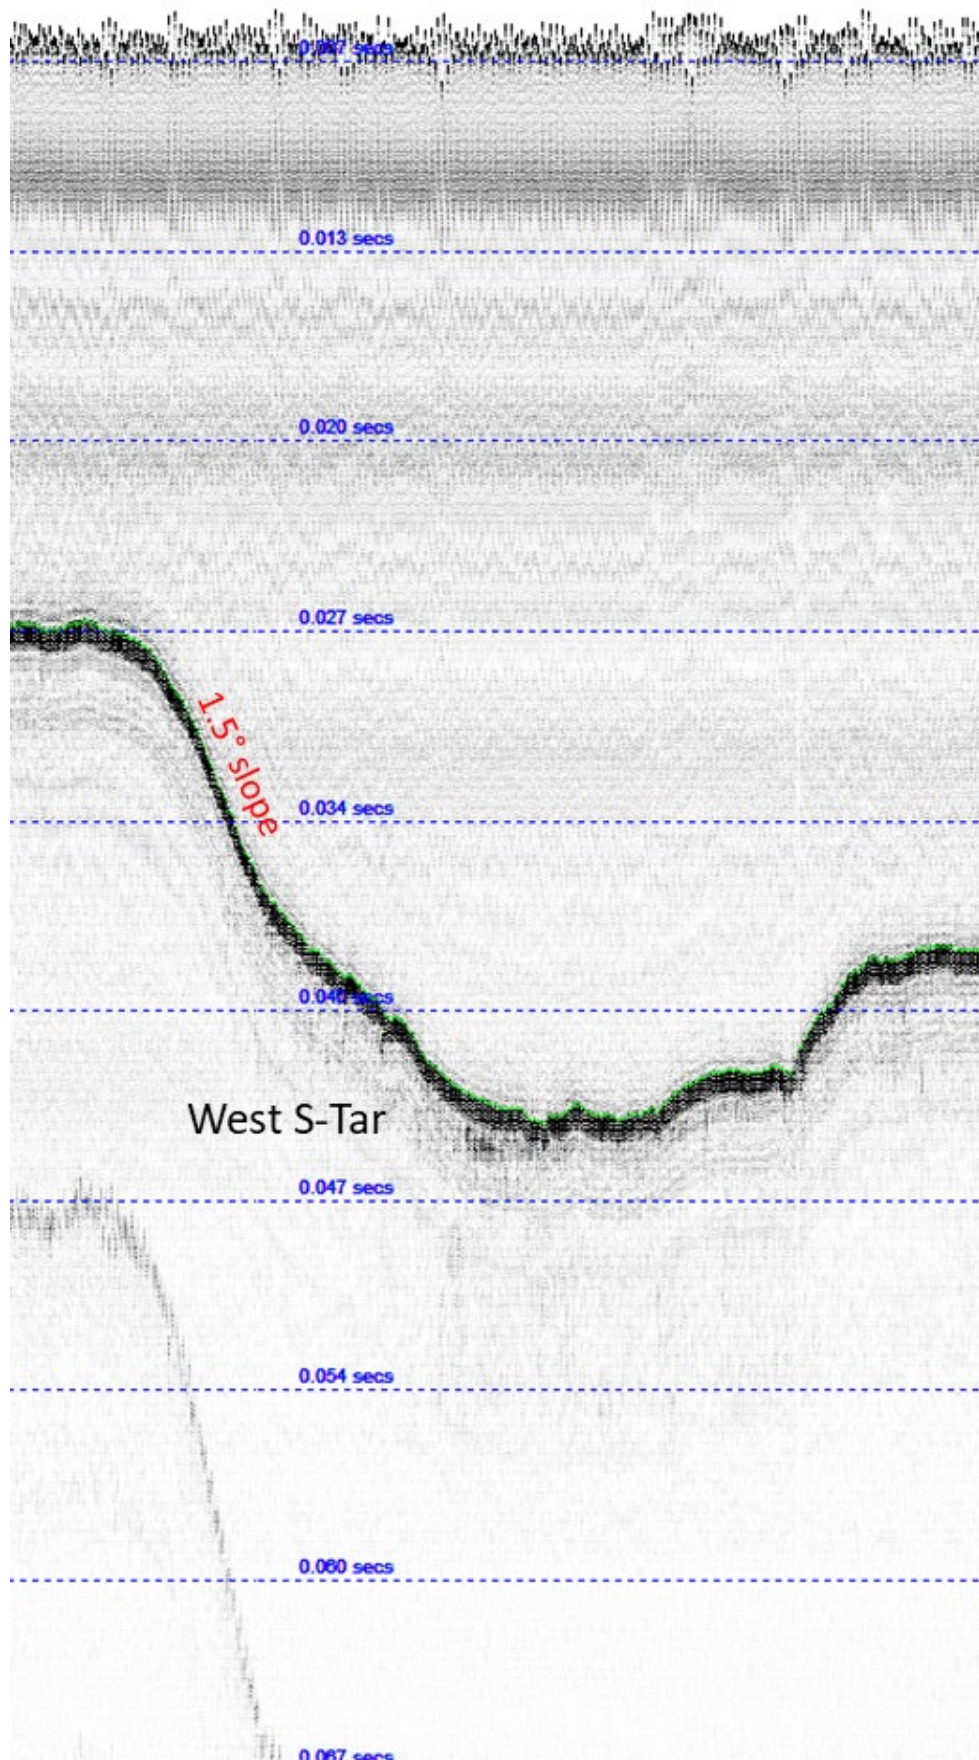
Subbottom profiles at both the north and south anchor target sites indicate a soft and homogeneous seabed with good penetration, no indication of hard bottom or hazards such as cables, pipelines, debris, or wrecks (Figures 11 & 12). Slopes are ~ 1.5 - 2° .

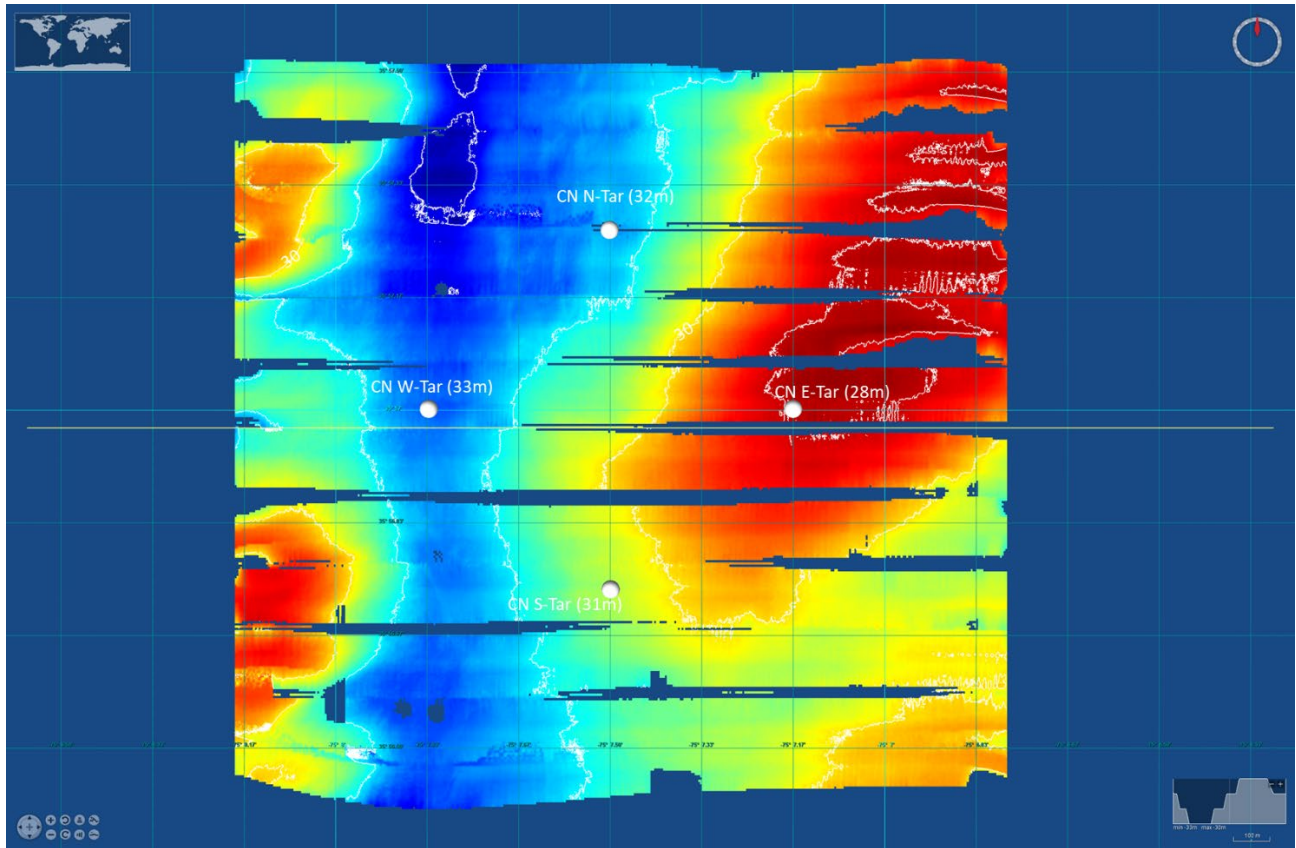
Figure 18: Central Site Digital Terrain Model (2m contours)

Moving west to east across Figure 18, the water depth is at the shallowest ~30m in the north and southwest corners, then deepens to ~33m in a somewhat flat north/south running channel, then rises to ~28m in the eastnortheast. The data indicates several shallow banks to the east and west. As discussed in the desktop study, these shallow banks may consist of mobile sand and gravel sediments. The North, South, East and West anchor targets are at depths of 32 m, 31 m, 28 m and 33 m, respectively. Data collected over 2km x 2km area using 90m line spacing.

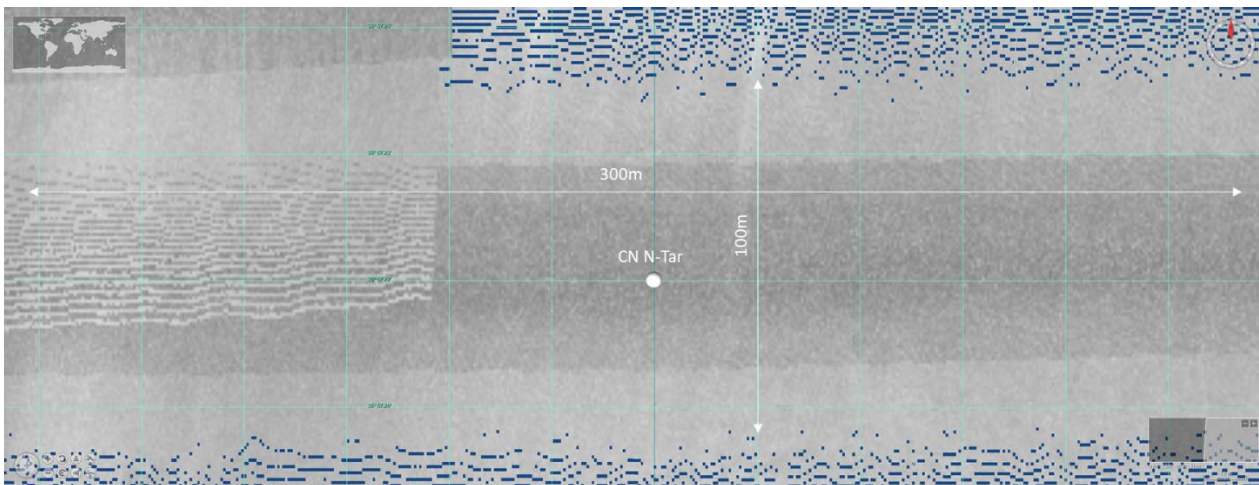
Figure 19: Central Site North Anchor Target (N-Tar) Backscatter

Backscatter imagery at all anchor target sites indicates a homogeneous seabed, no visible hazards such as hard bottom, cables, pipelines, wrecks, or debris (Figures 19 thru 22).

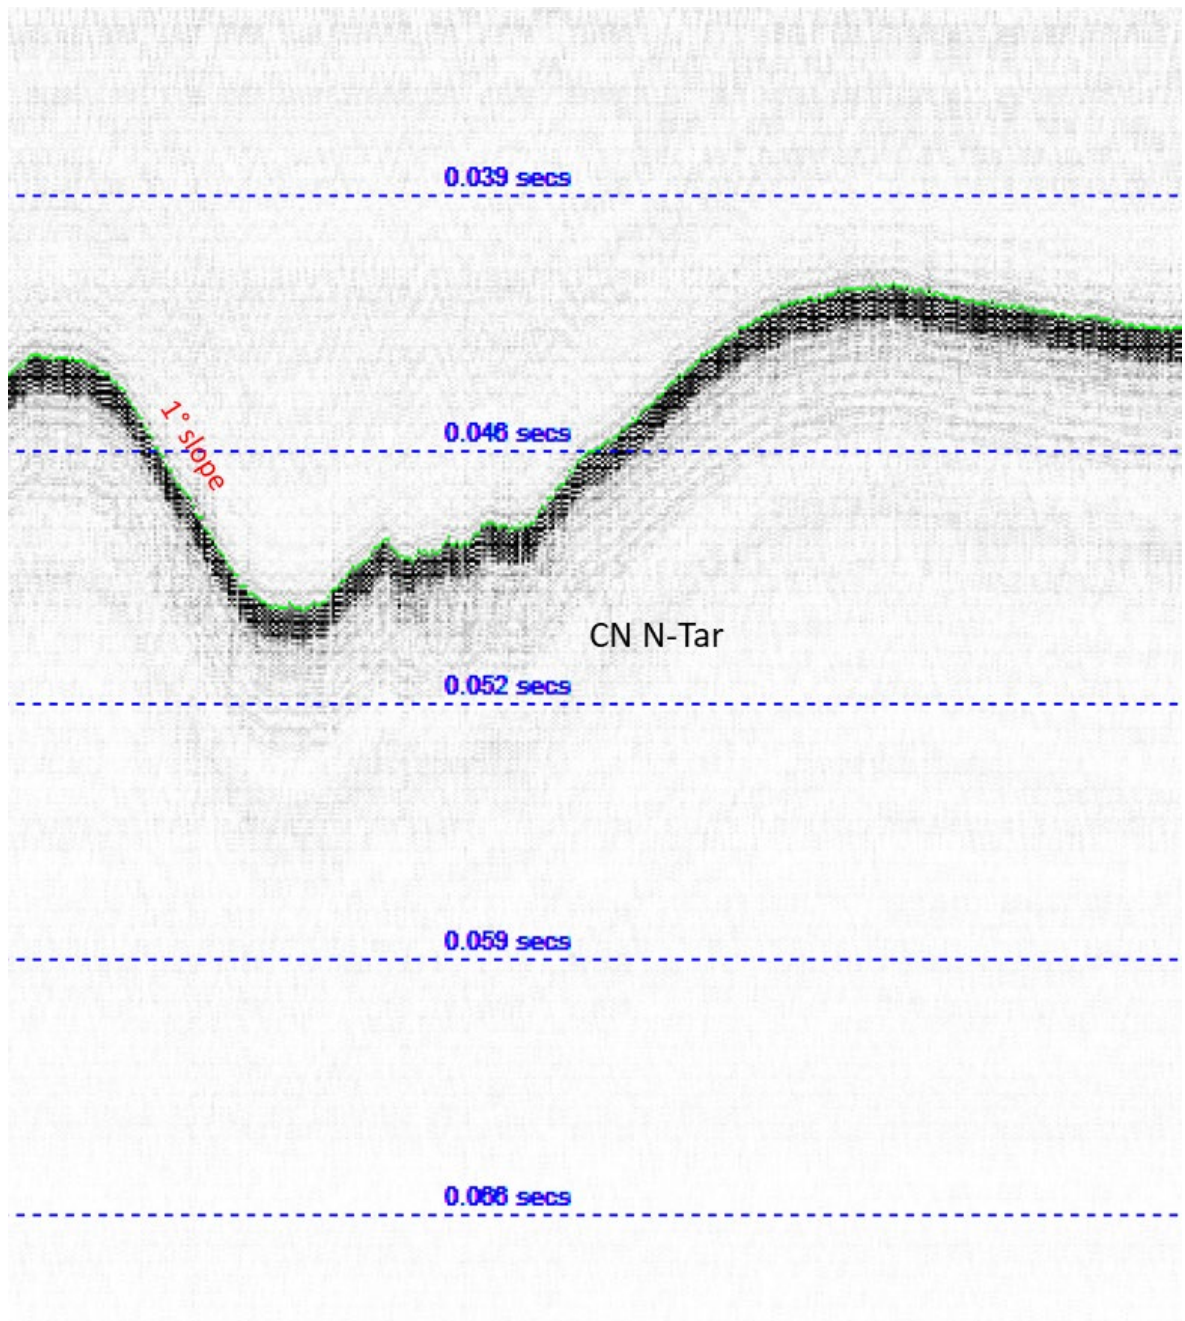
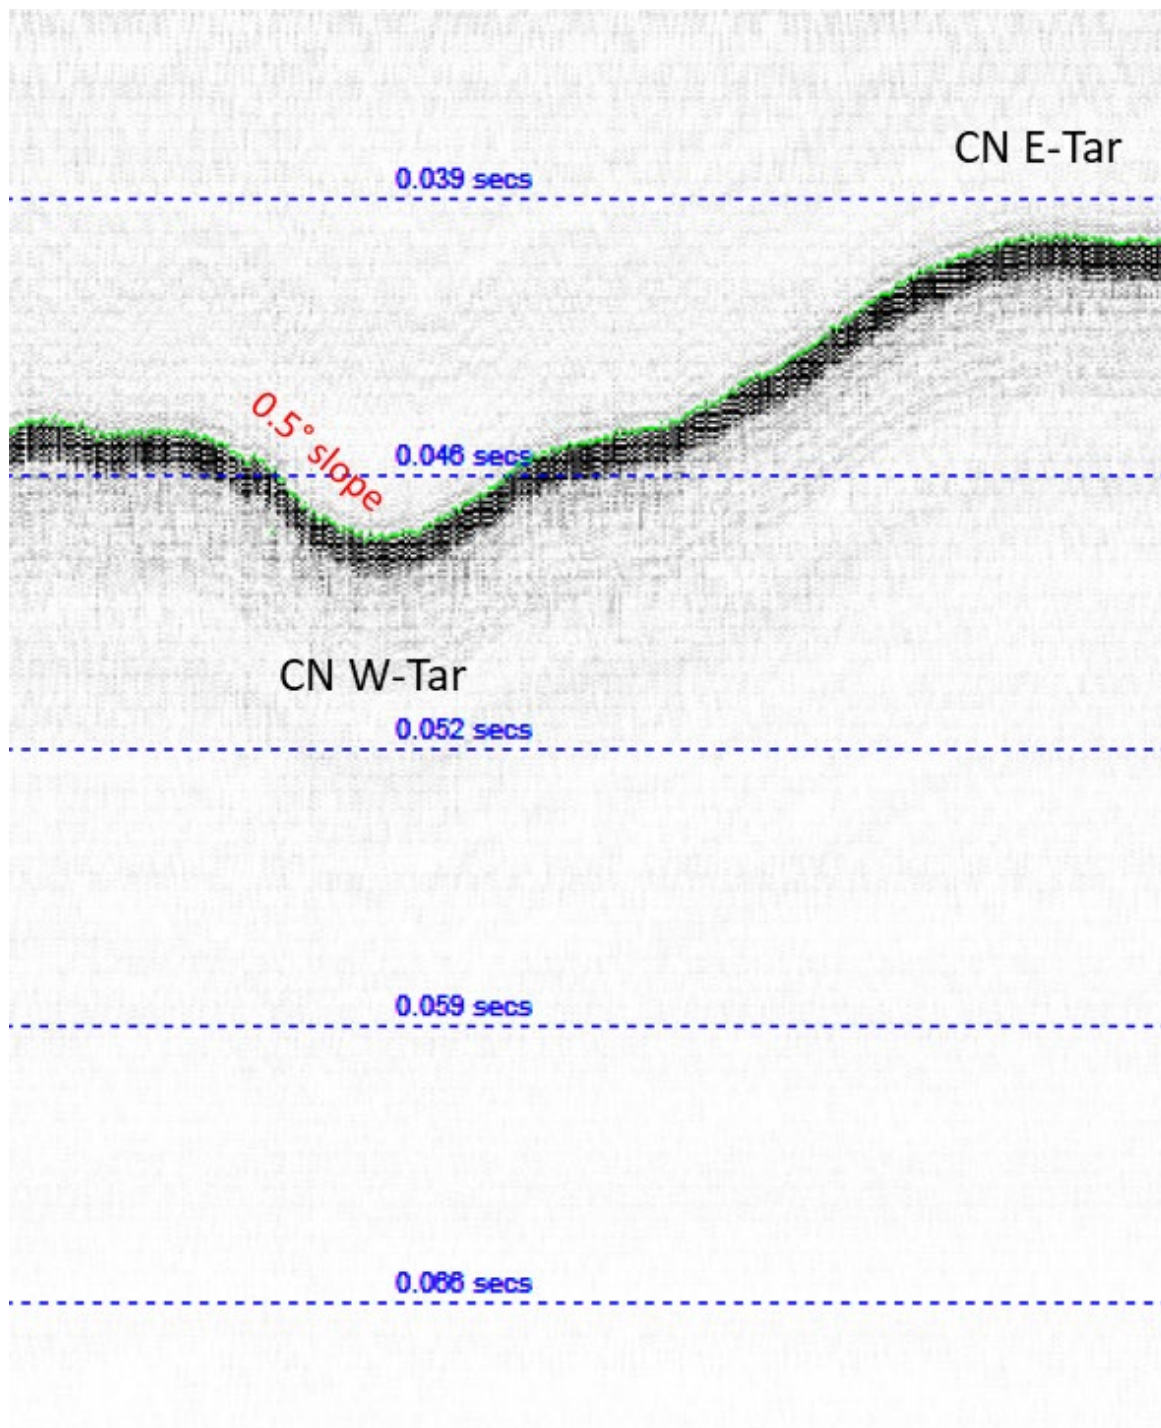
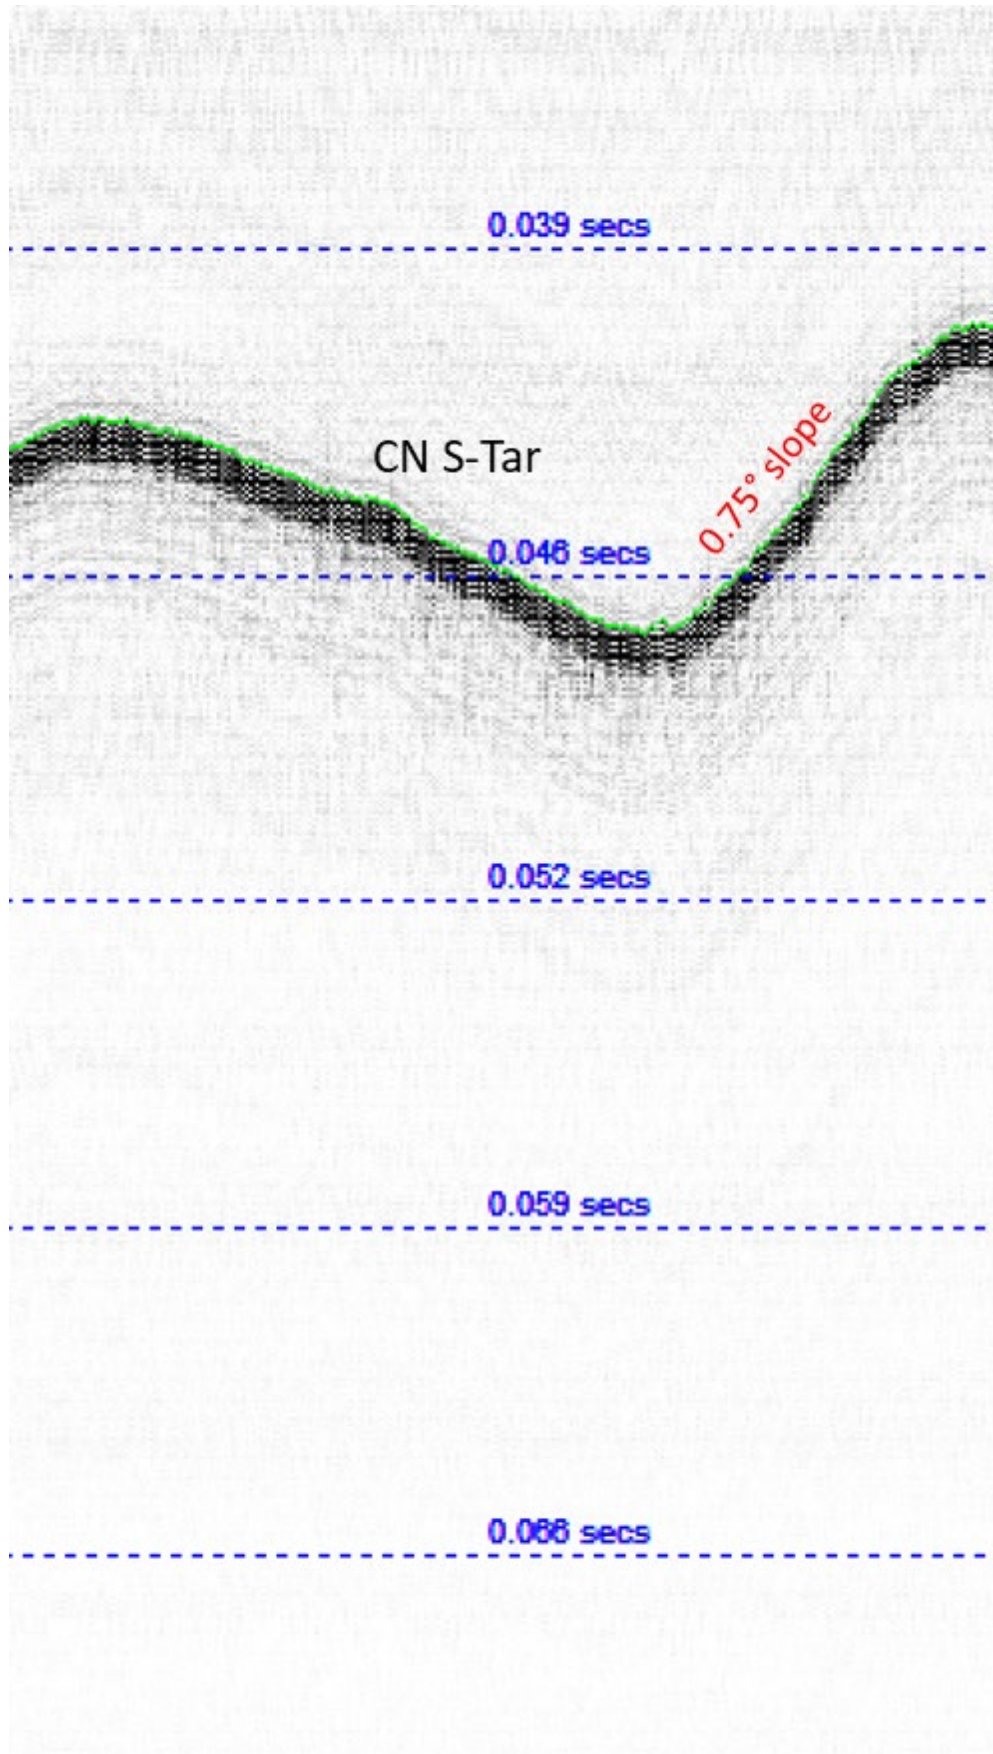
Subbottom profiles at all anchor target sites indicate a soft and homogeneous seabed with good penetration, no indication of hard bottom or hazards such as cables, pipelines, debris, or wrecks (Figures 23 thru 25). Slopes are $\sim 0.5\text{-}1^\circ$.

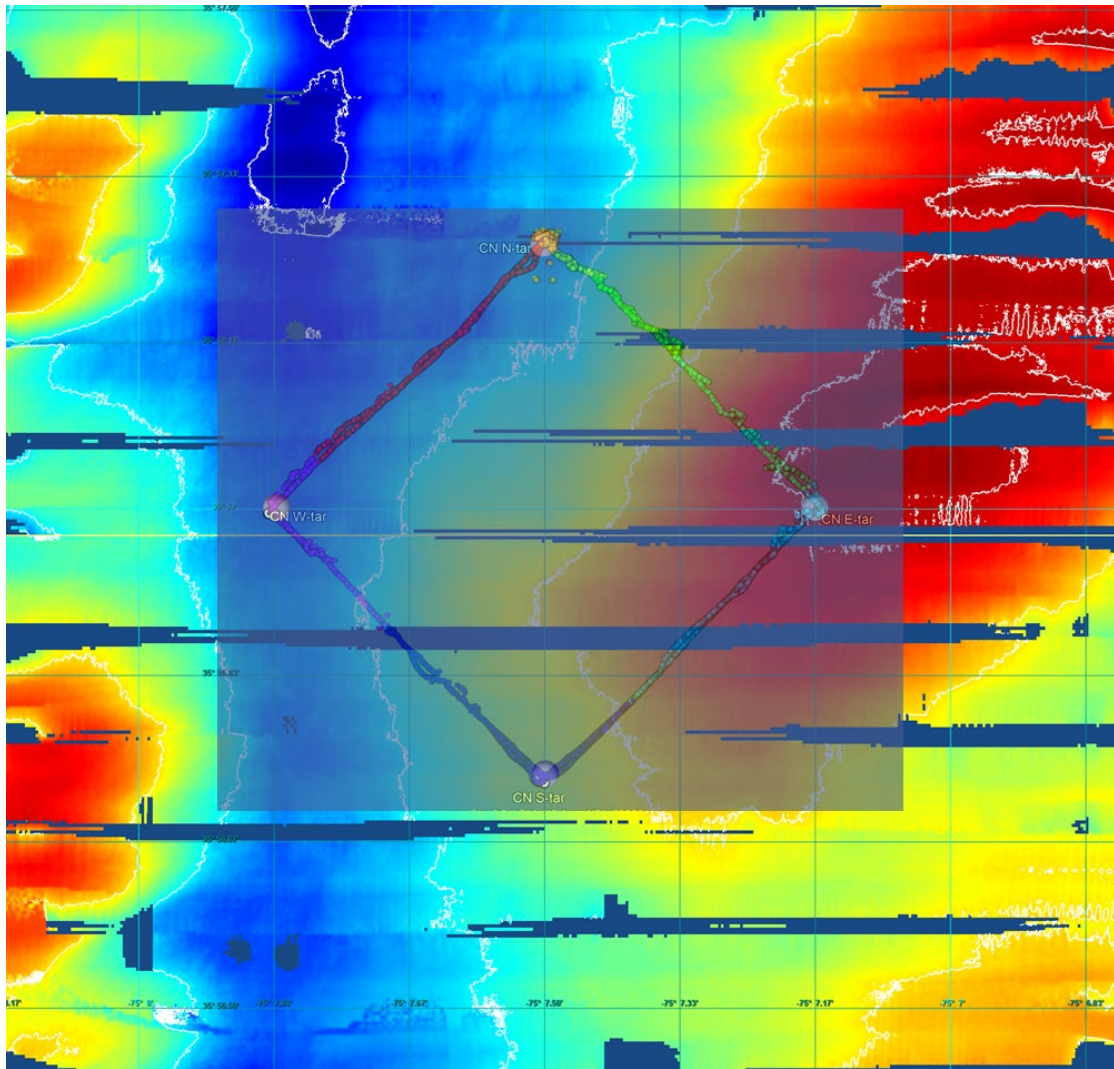
Figure 26: ROV Track at Central Site

ROV inspection was completed at all anchor target sites, Figure 26 shows the ROV and depressor positions overlaid on the DTM. The camera data indicates a flat seabed at all sites consisting of sands, gravels, and shells (Figures 27-30). Wavy seabed also indicates some potential sediment movement. No areas or features of concern (hard bottom, debris, cables, pipelines, wrecks, artifacts, marine habitat) in ROV sonar or imagery in vicinity of anchor targets.

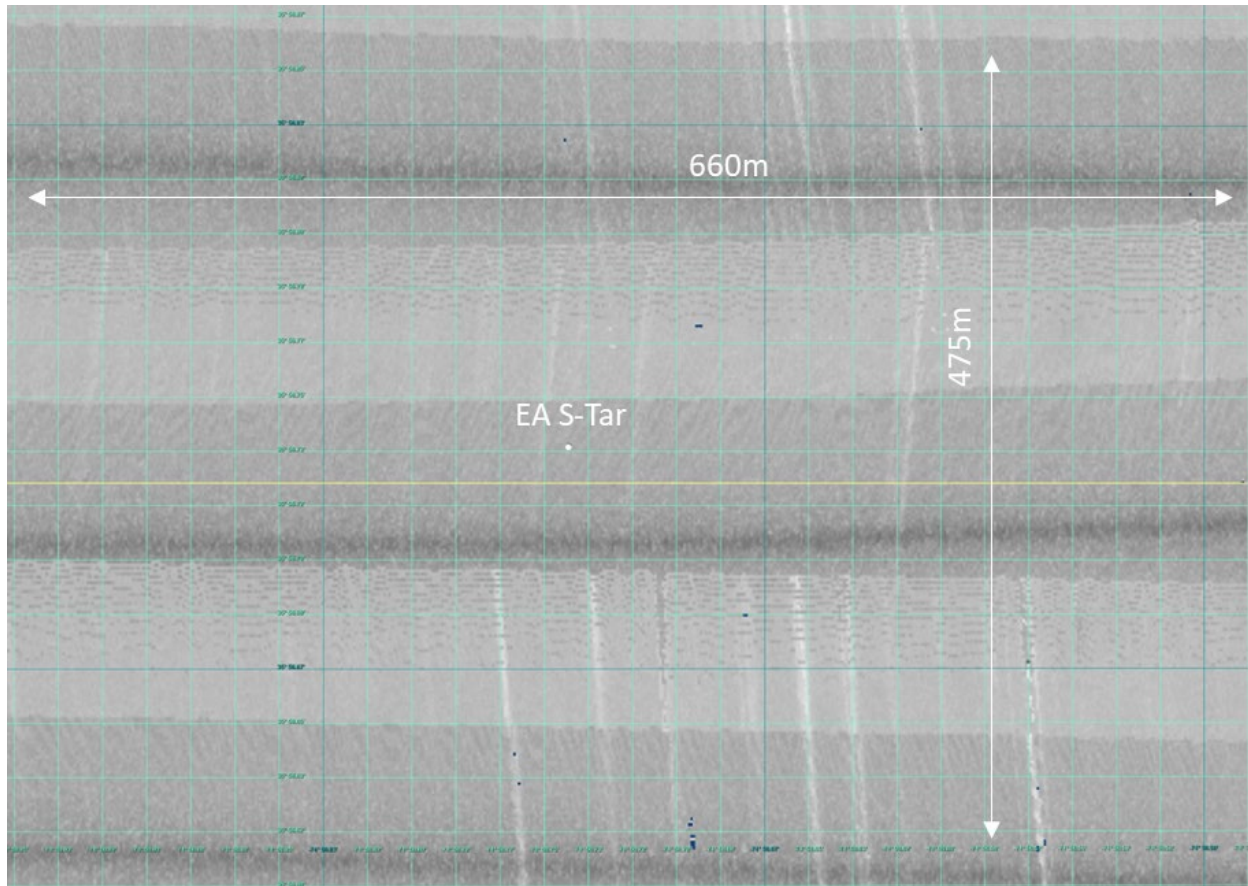
Backscatter imagery at both the north and south anchor target sites indicate a homogeneous seabed, no visible hazards such as hard bottom, cables, pipelines, wrecks, or debris (Figures 32 & 33).

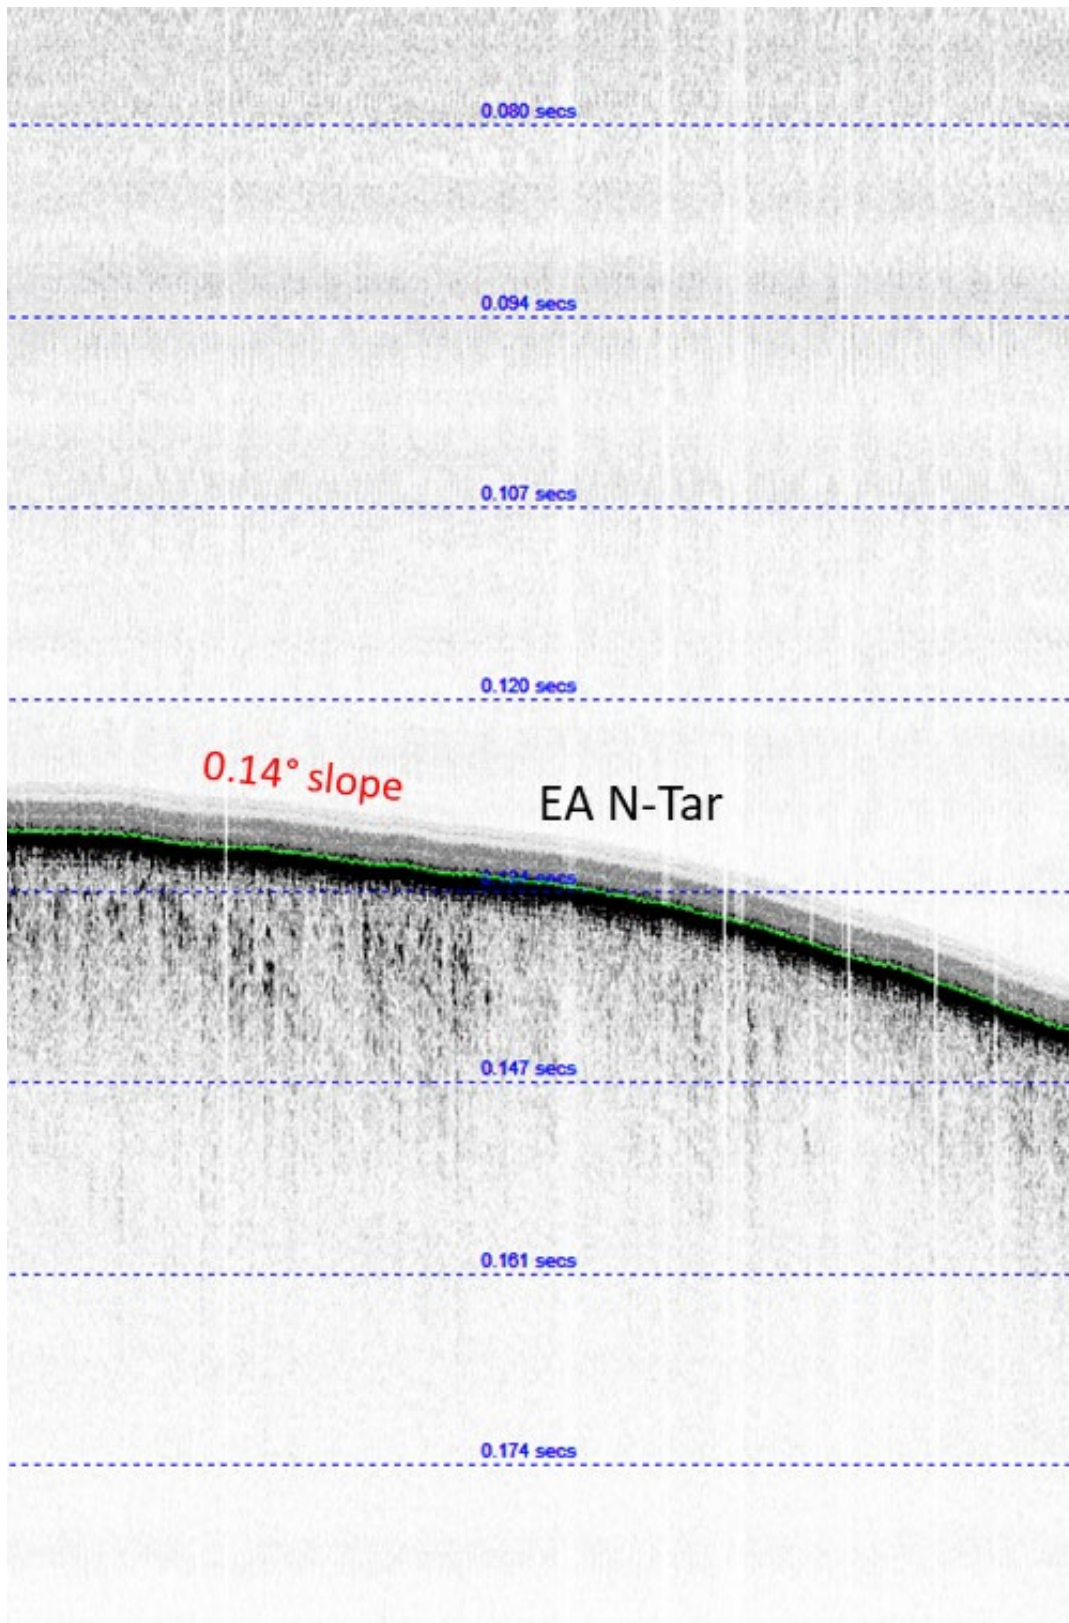
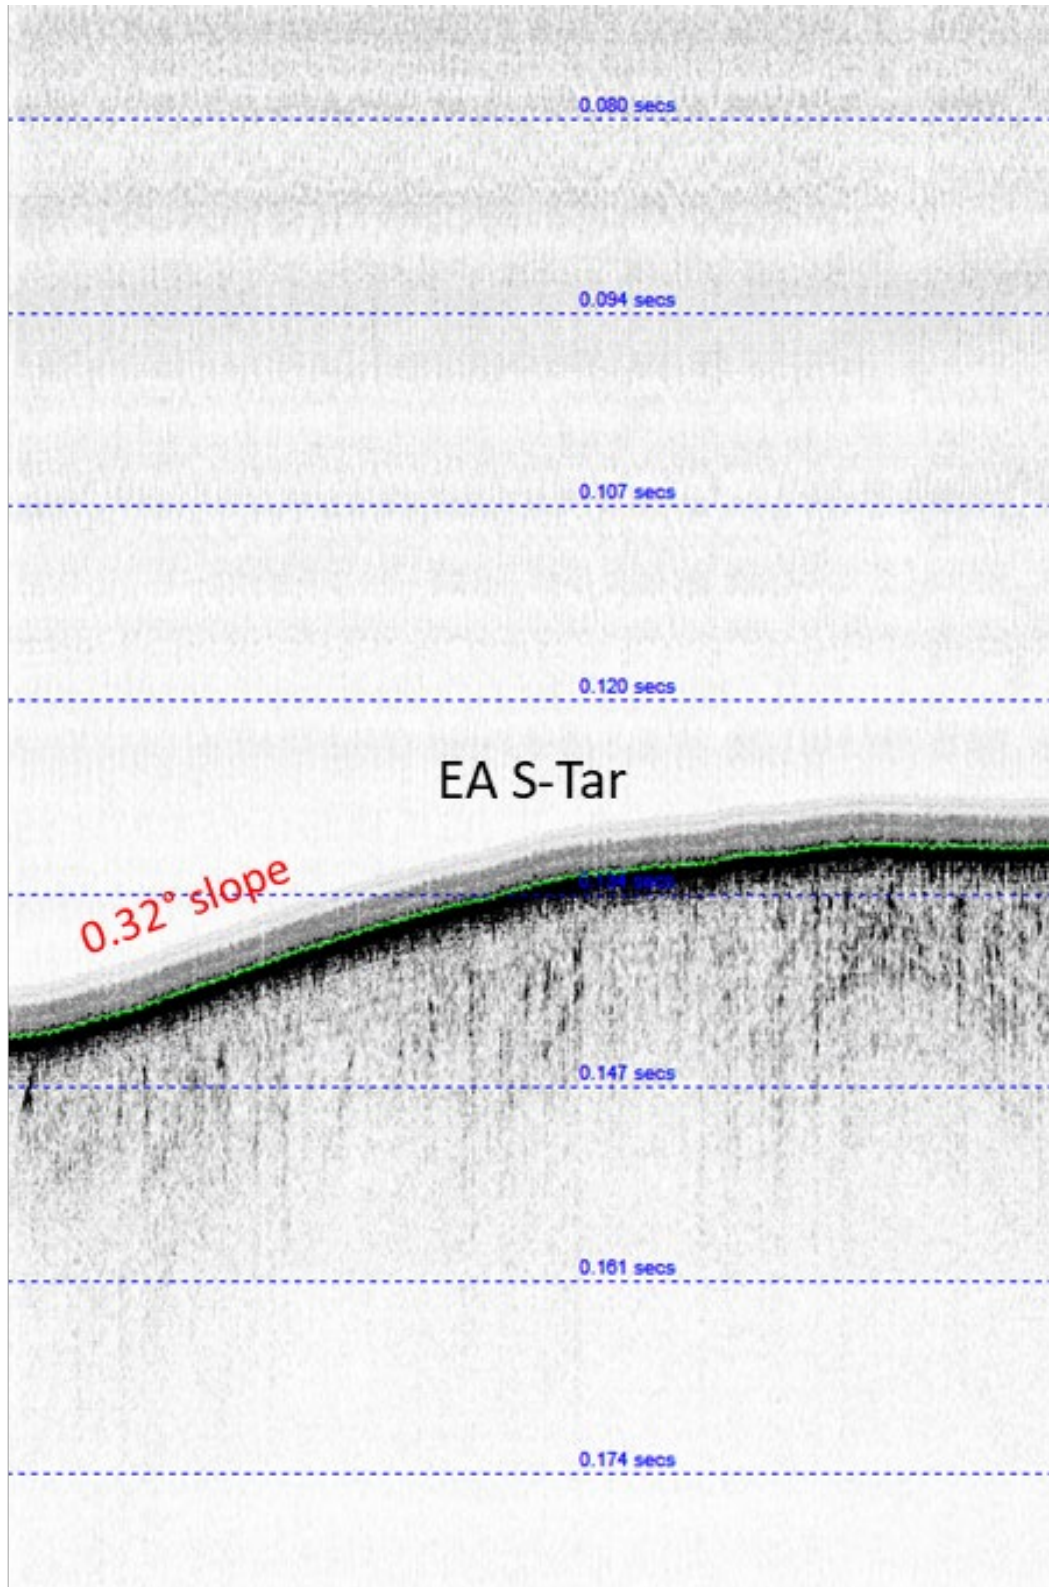
Subbottom profiles at both the north and south anchor target sites indicate a soft and homogeneous seabed with good penetration, no indication of hard bottom or hazards such as cables, pipelines, debris, or wrecks (Figures 34 & 35). Slopes are less than 0.5° .

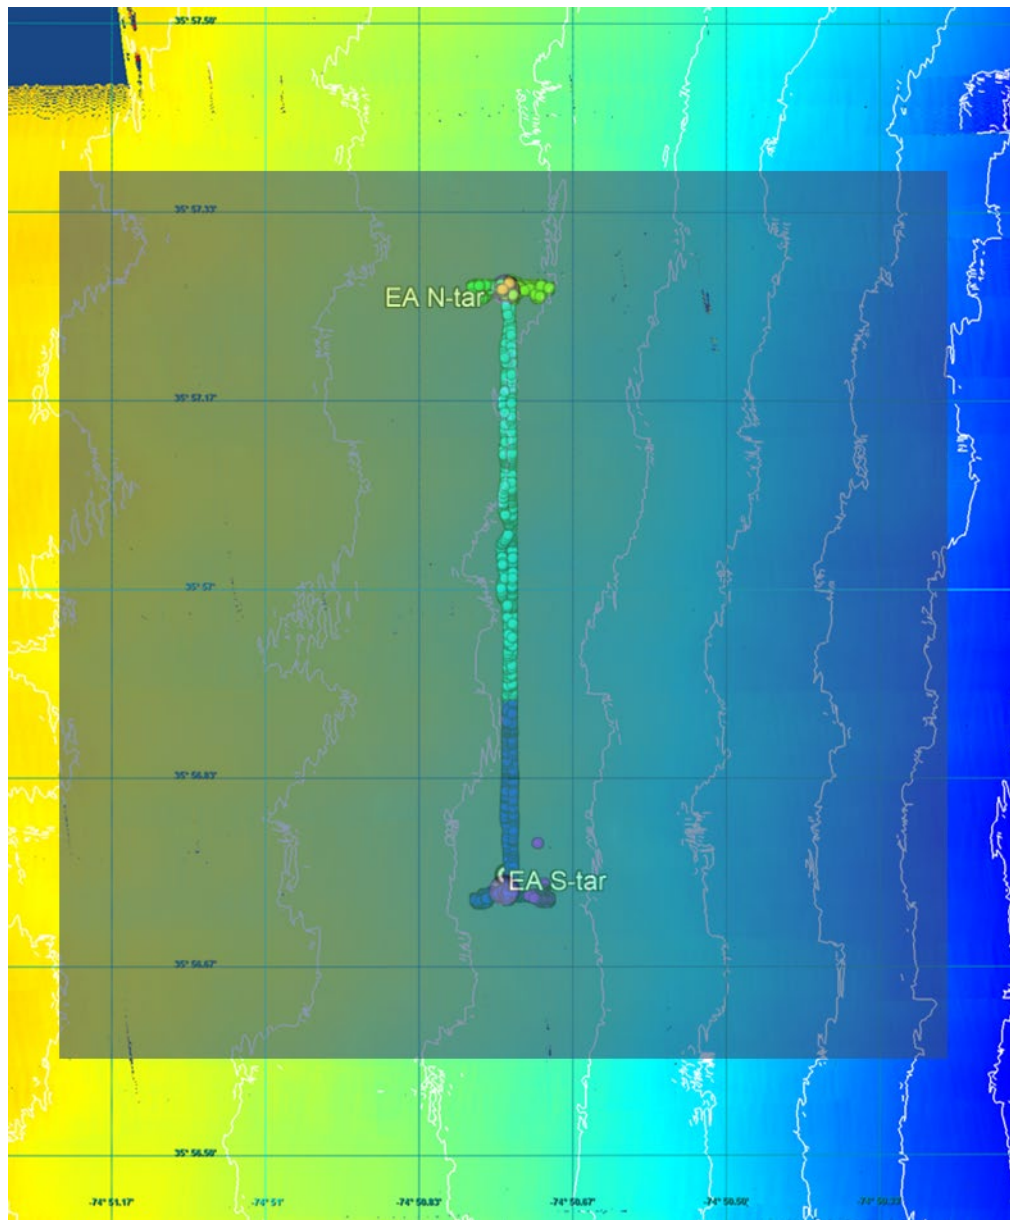
Figure 36: ROV Track at East Site

ROV inspection was completed at both anchor target sites, Figure 36 shows the ROV and depressor positions overlaid on the DTM. The camera data indicates a flat seabed at both sites consisting of sands, gravels, and shells (Figures 37 – 39). No areas or features of concern (hard bottom, debris, cables, pipelines, wrecks, artifacts, marine habitat) in ROV sonar or imagery in vicinity of anchor targets.

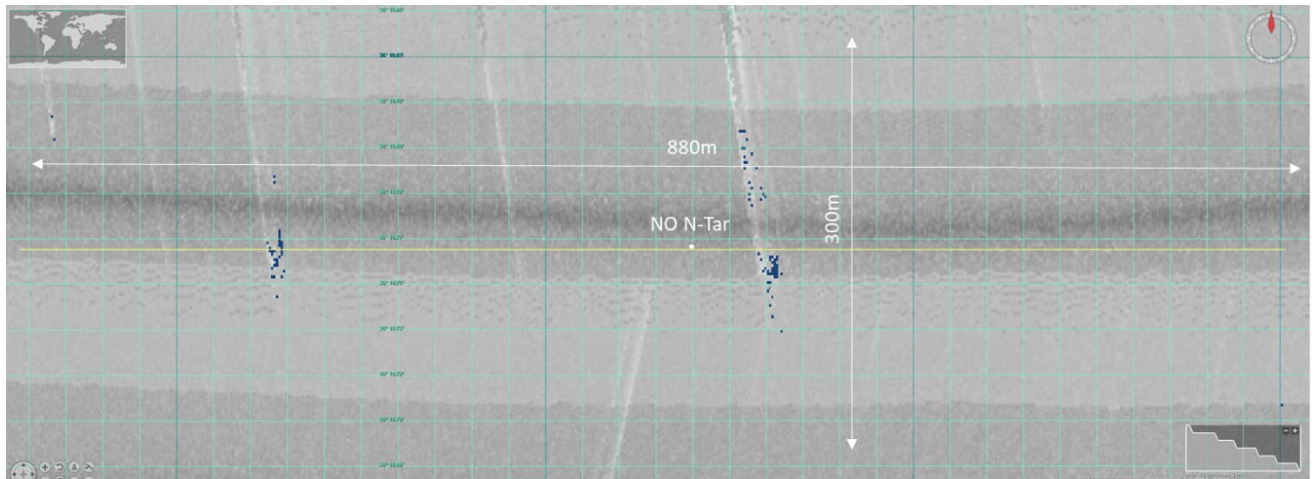
Figure 41: North Site North Anchor Target (N-Tar) Backscatter

Backscatter imagery at both the north and south anchor target sites indicate a homogeneous seabed, no visible hazards such as hard bottom, cables, pipelines, wrecks, or debris (Figures 41 thru 44).
