Appendix F: Pioneer MAB Seabed Survey and ROV Inspections

Pioneer MAB Seabed Survey & ROV Inspections

Control Number: 3210-00004

**Coastal and Global Scale Nodes
Ocean Observatories Initiative
Woods Hole Oceanographic Institution**

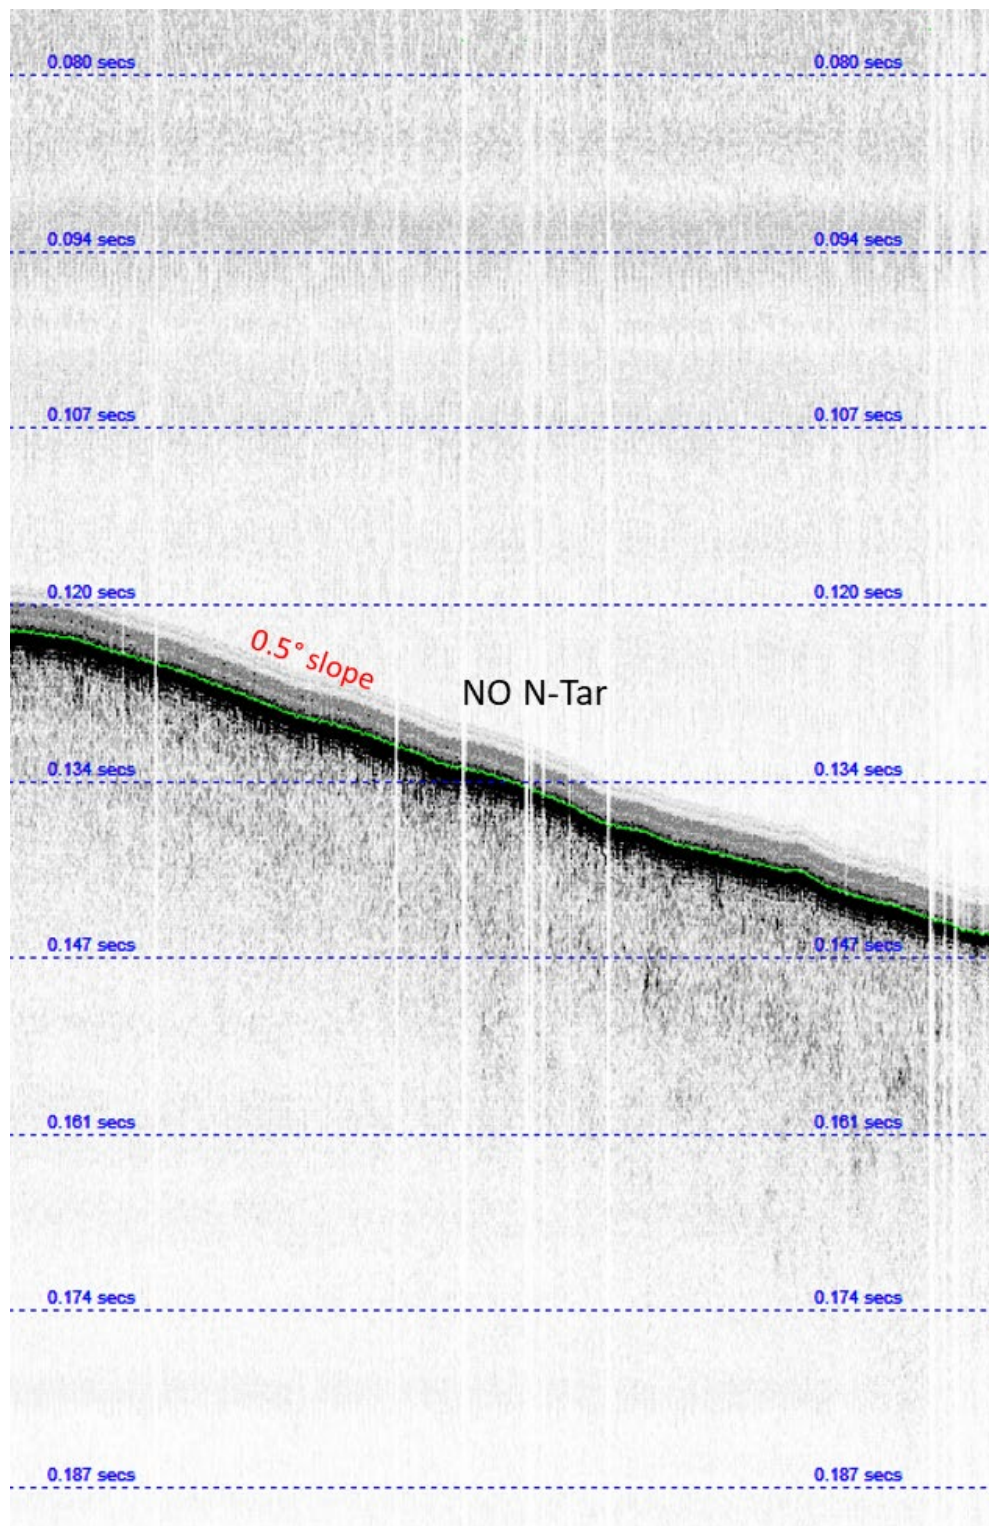
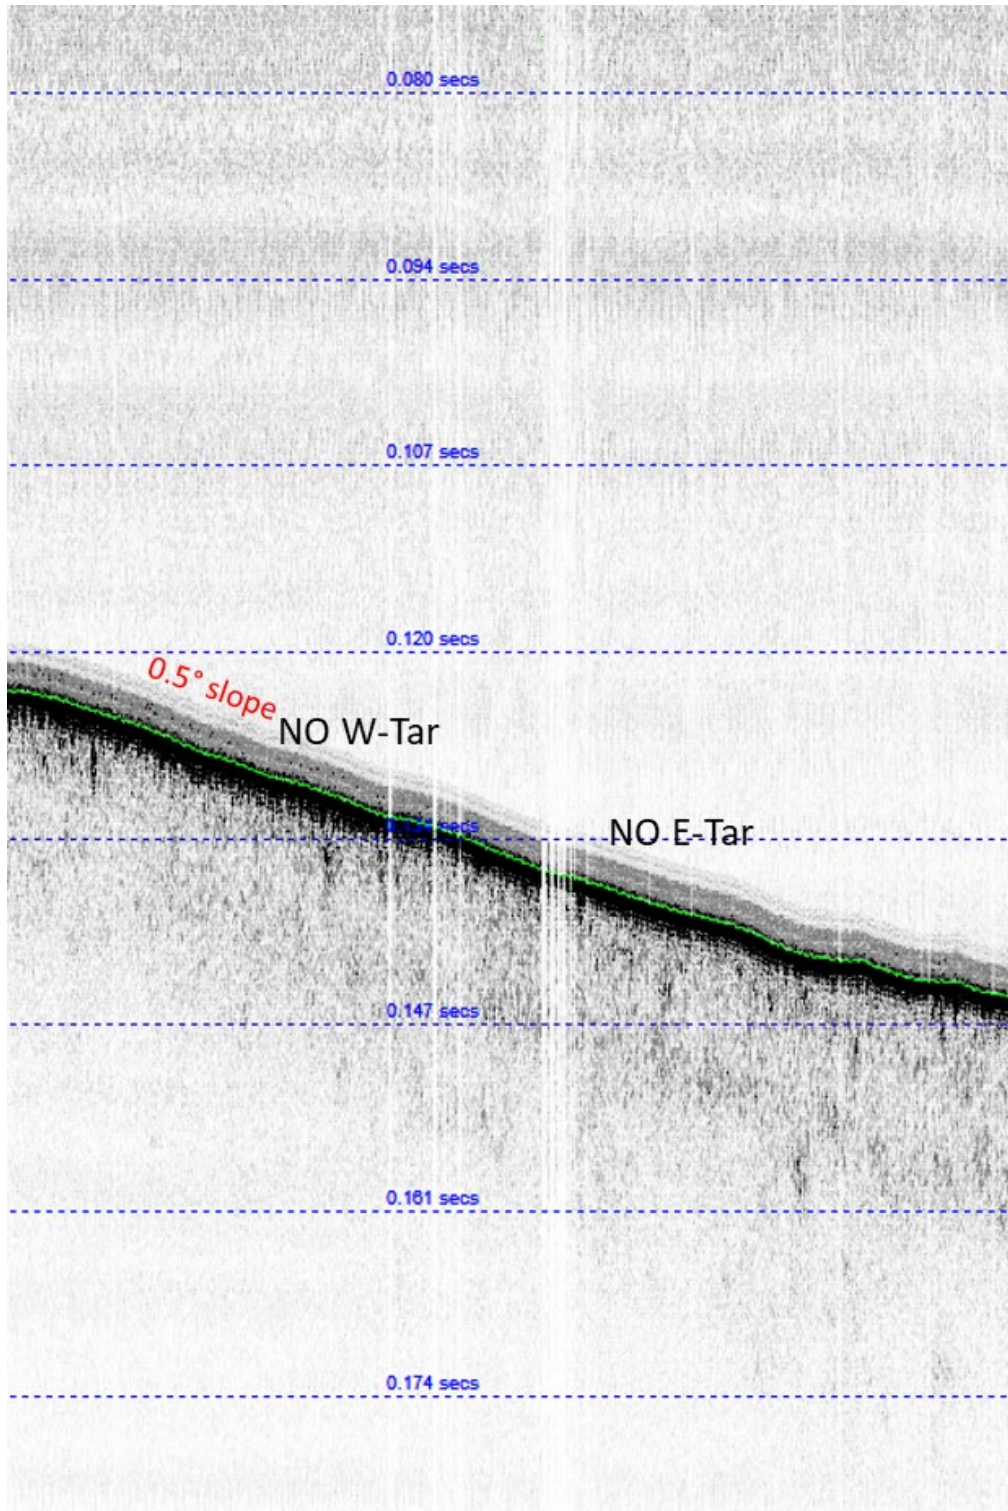
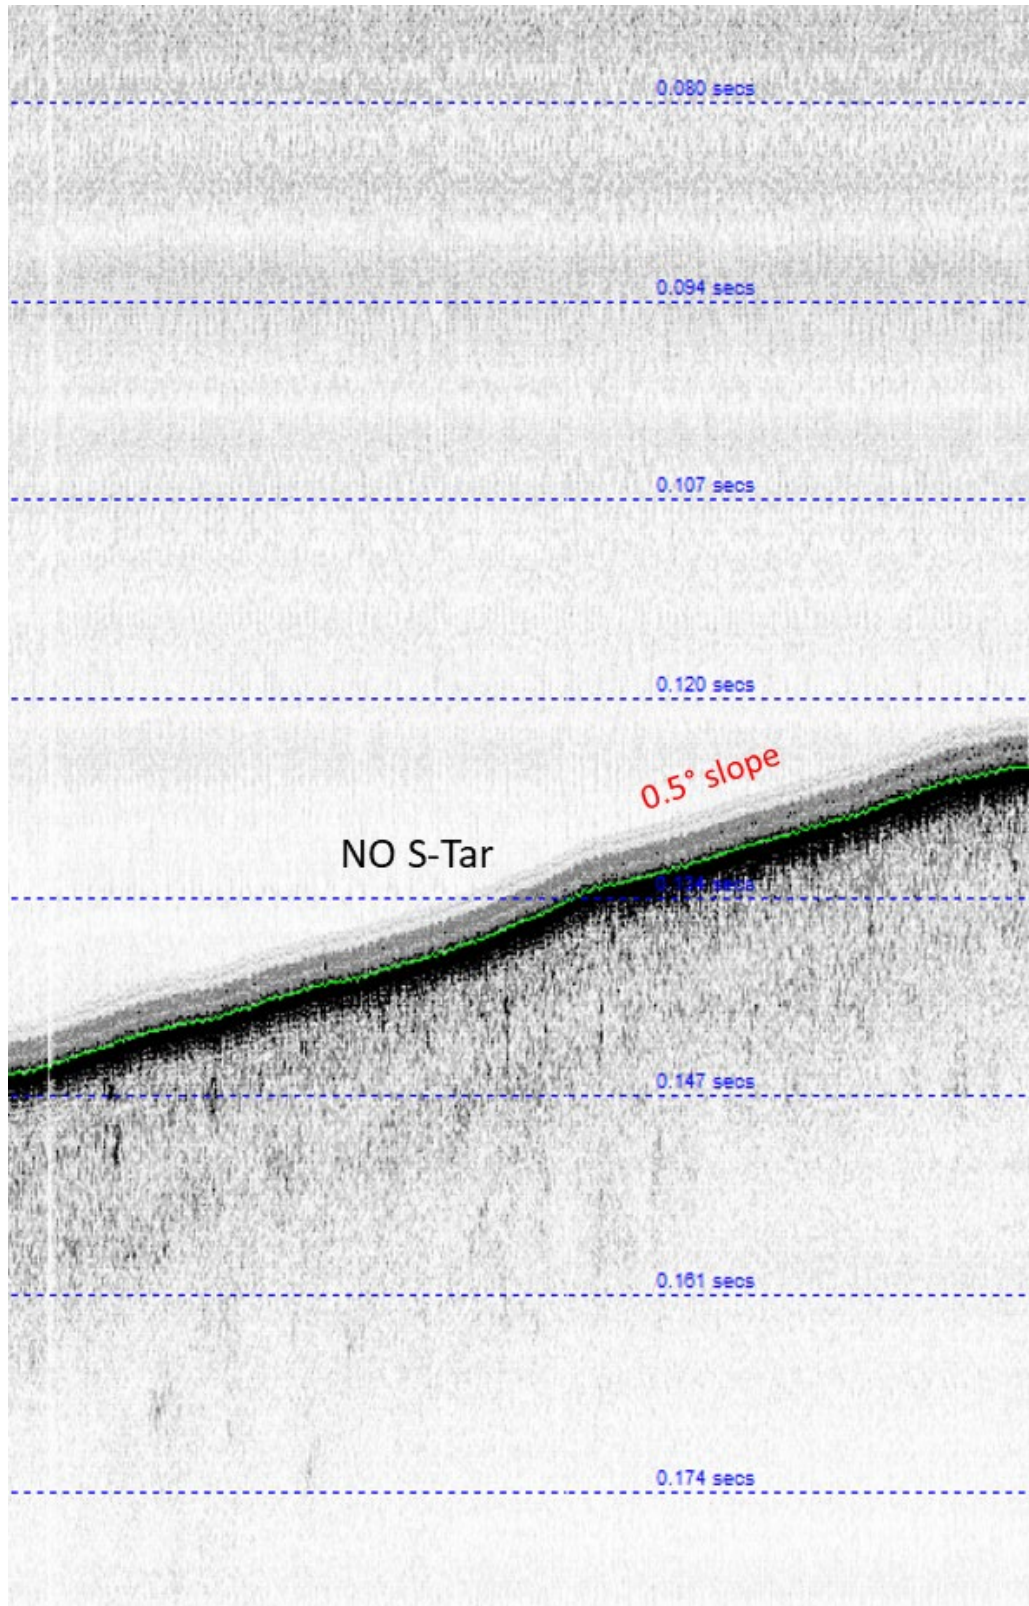
Subbottom profiles at all anchor target sites indicate a soft and homogeneous seabed with good penetration, no indication of hard bottom or hazards such as cables, pipelines, debris, or wrecks (Figures 45 thru 47). Slopes are $\sim 0.5^\circ$.

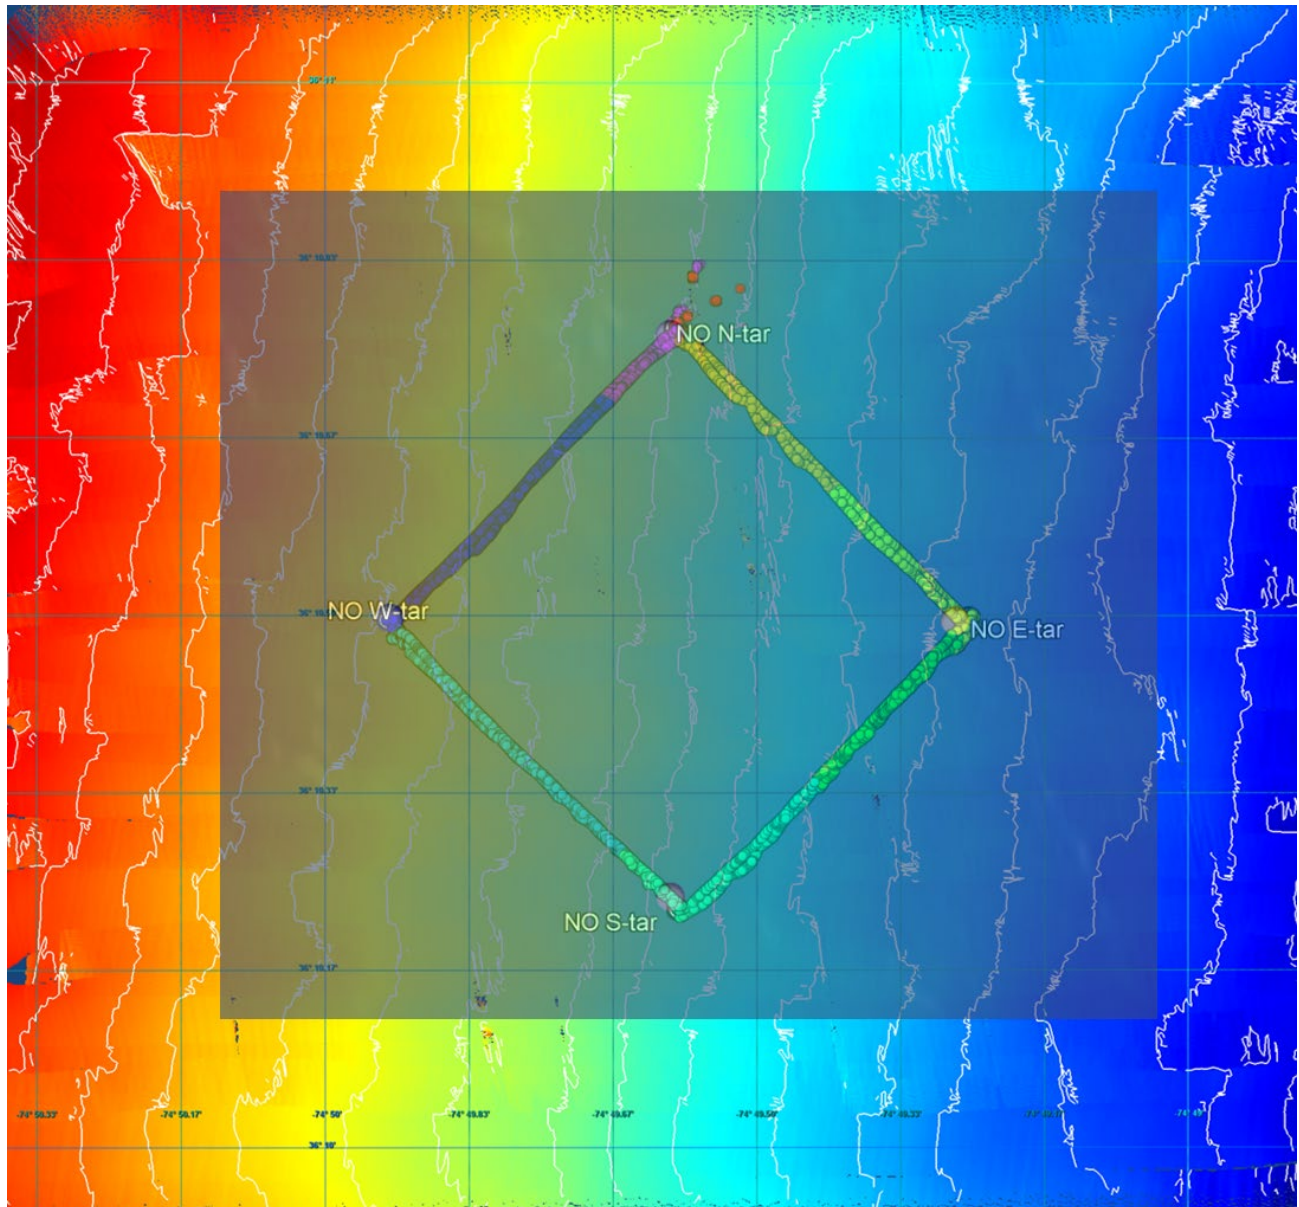
Figure 48: ROV Track at North Site

ROV inspection was completed at all anchor target sites, Figure 48 shows the ROV and depressor positions overlaid on the DTM. The camera data indicates a flat seabed at all sites consisting of sands, gravels, shells (Figures 49 thru 54). No areas or features of concern (hard bottom, debris, cables, pipelines, wrecks, artifacts, marine habitat) in ROV sonar or imagery in vicinity of anchor targets.

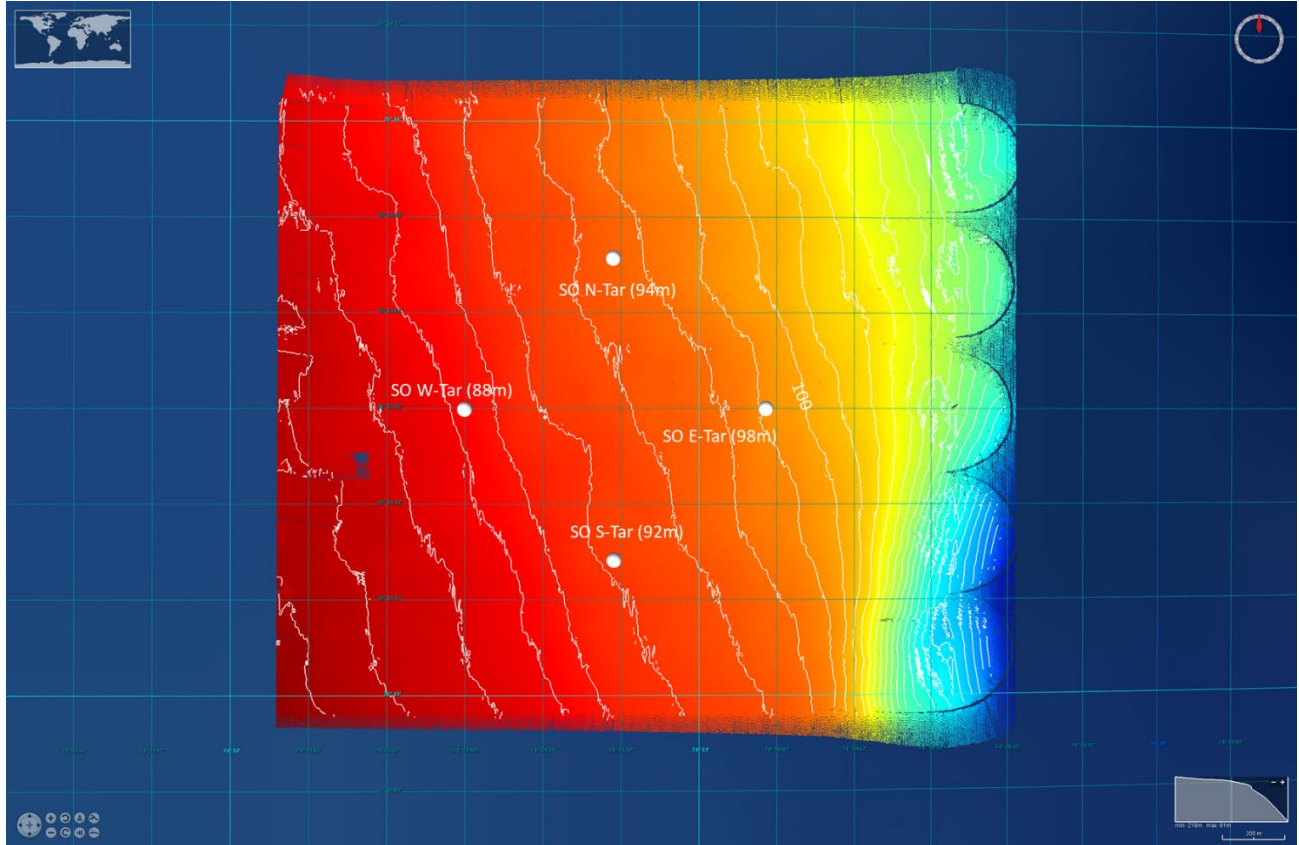
Figure 55: South Site Digital Terrain Model (2m contours)

Moving west to east across Figure 55, the water depth is at the shallowest ~85m in the southwest corner, then deepens to the west with a steeper dropoff starting at the ~118m contour deepening again to ~140m to the west, with a steeper dropoff to ~144m in the southeast corner. The North, South, East and West anchor targets are at depths of 94 m, 92 m, 98 m and 88 m, respectively. Data collected over 2km x 2km area using 200m line spacing.

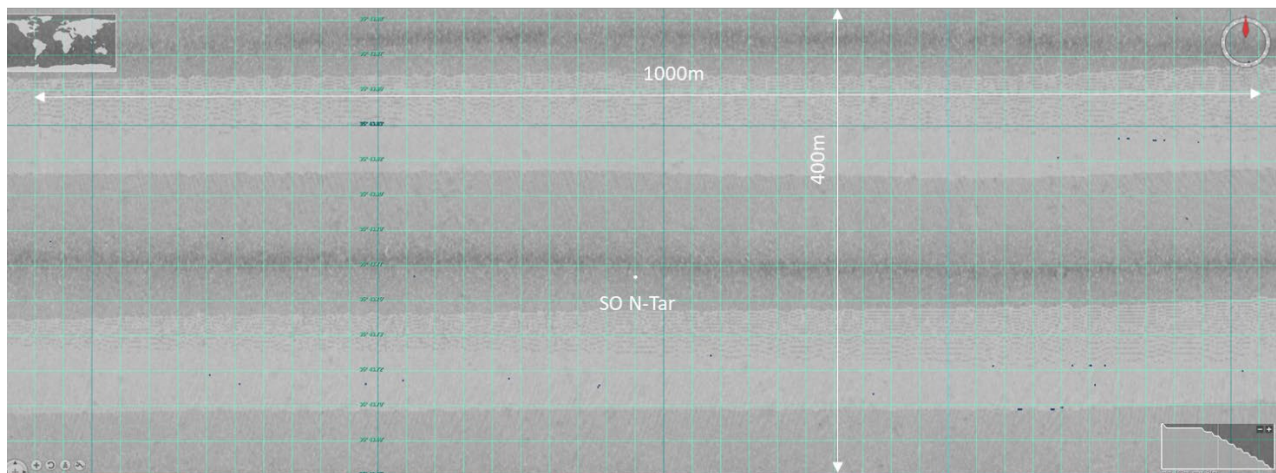
Figure 56: South Site North Anchor Target (N-Tar) Backscatter

Backscatter imagery at both the north and south anchor target sites indicate a homogeneous seabed, no visible hazards such as hard bottom, cables, pipelines, wrecks, or debris (Figures 56 thru 59).

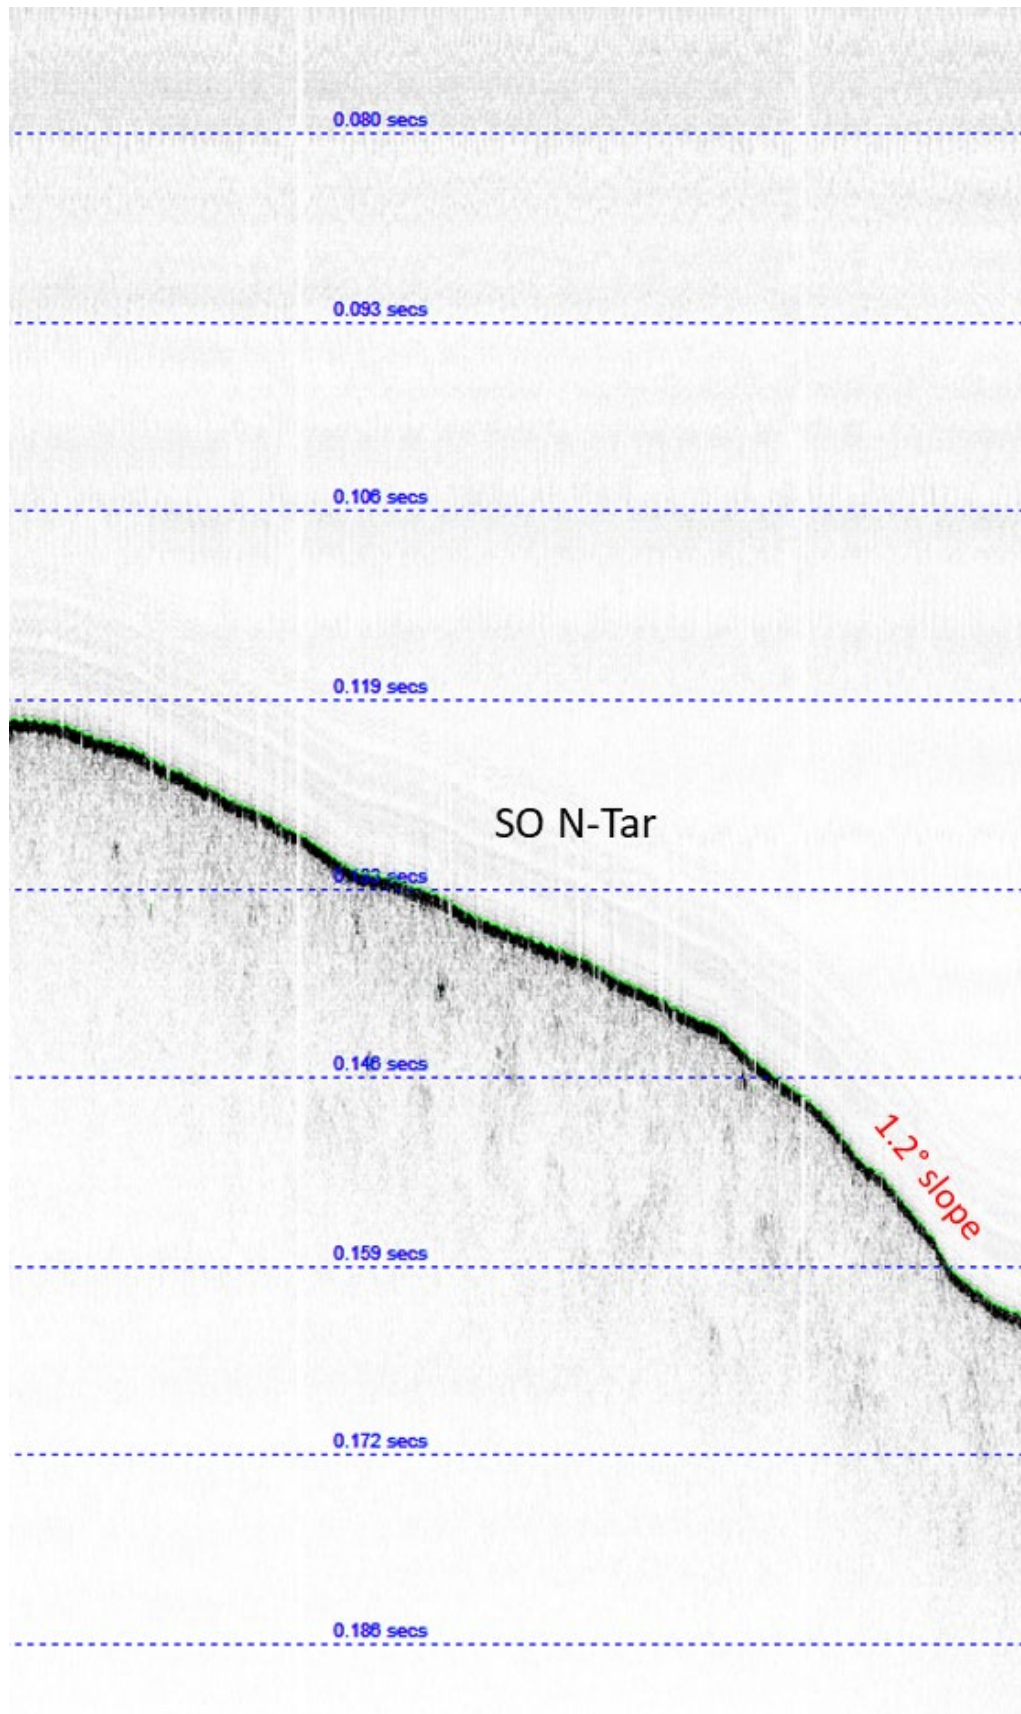
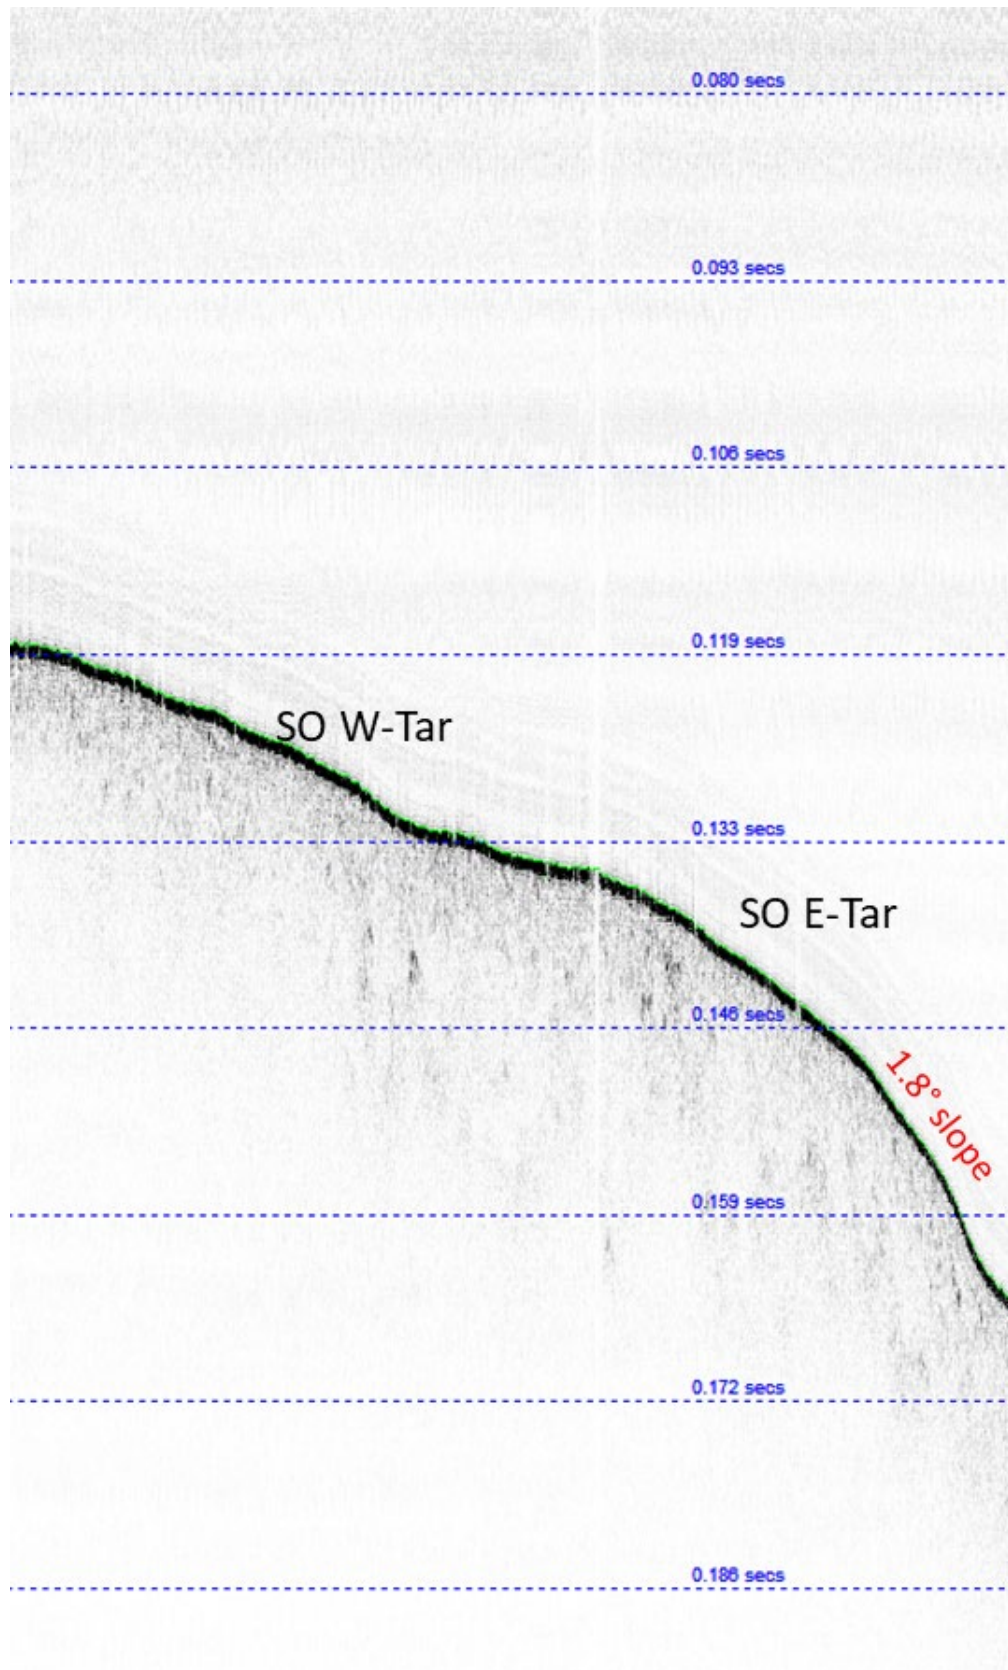
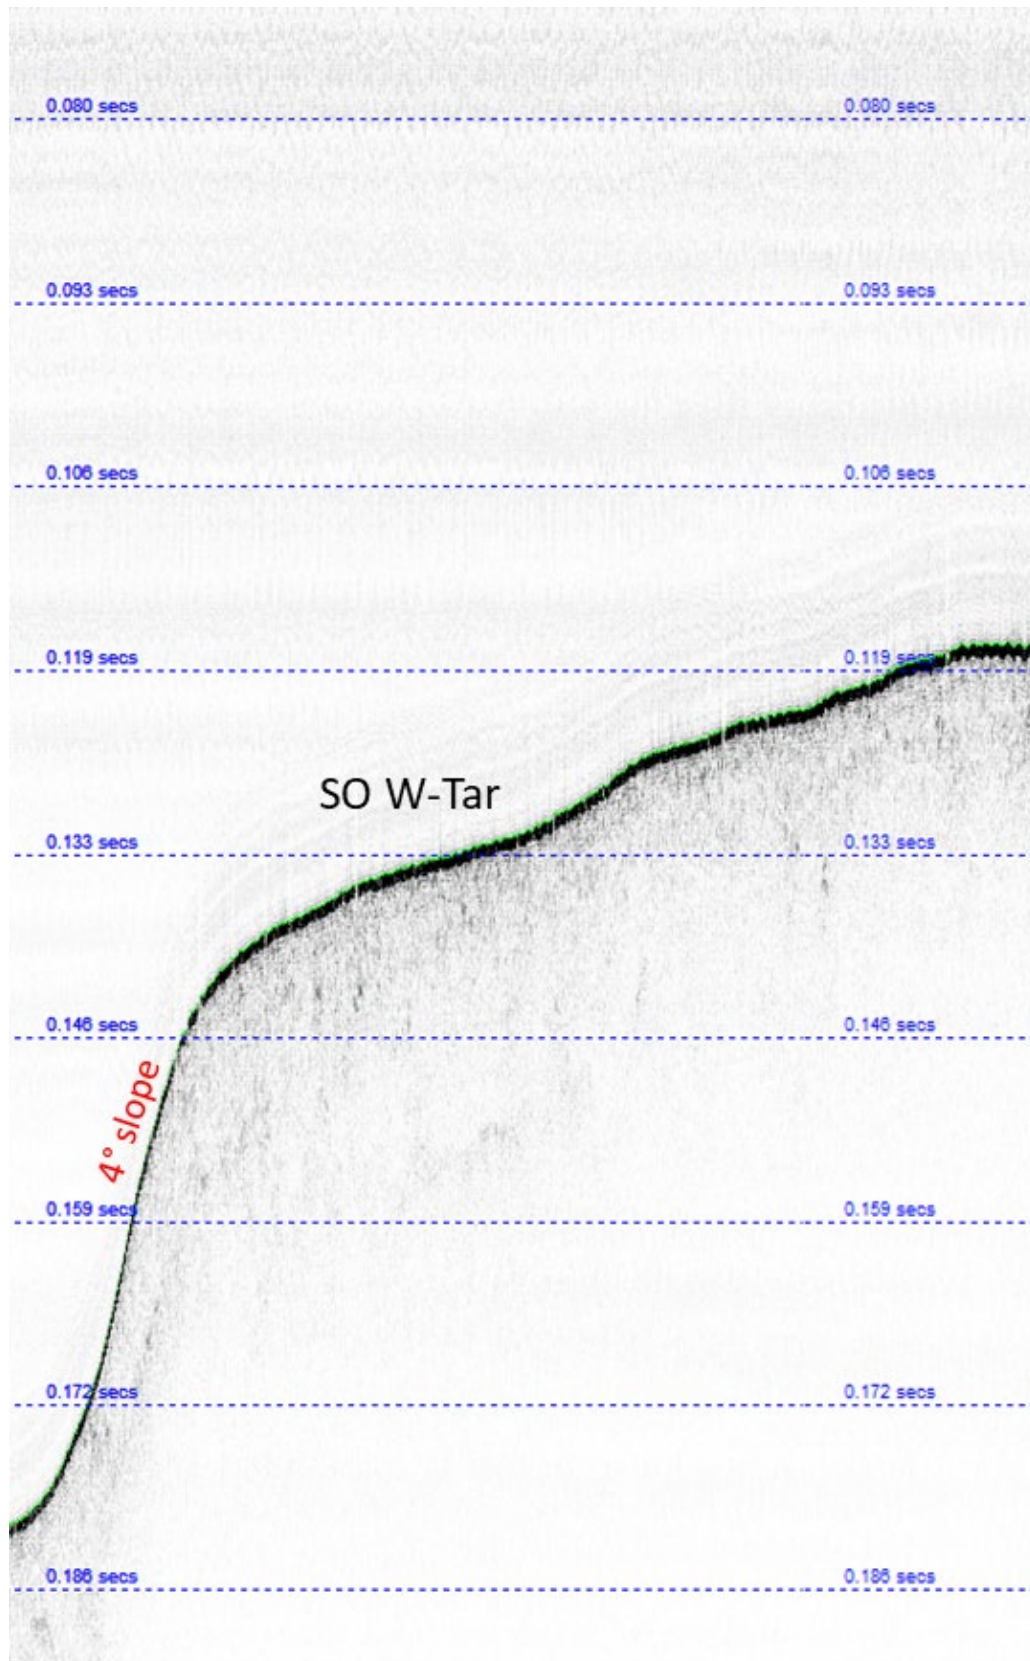
Subbottom profiles at both the north and south anchor target sites indicate a soft and homogeneous seabed with good penetration, no indication of hard bottom or hazards such as cables, pipelines, debris, or wrecks (Figures 60 thru 62). Slopes range from 1-4°.

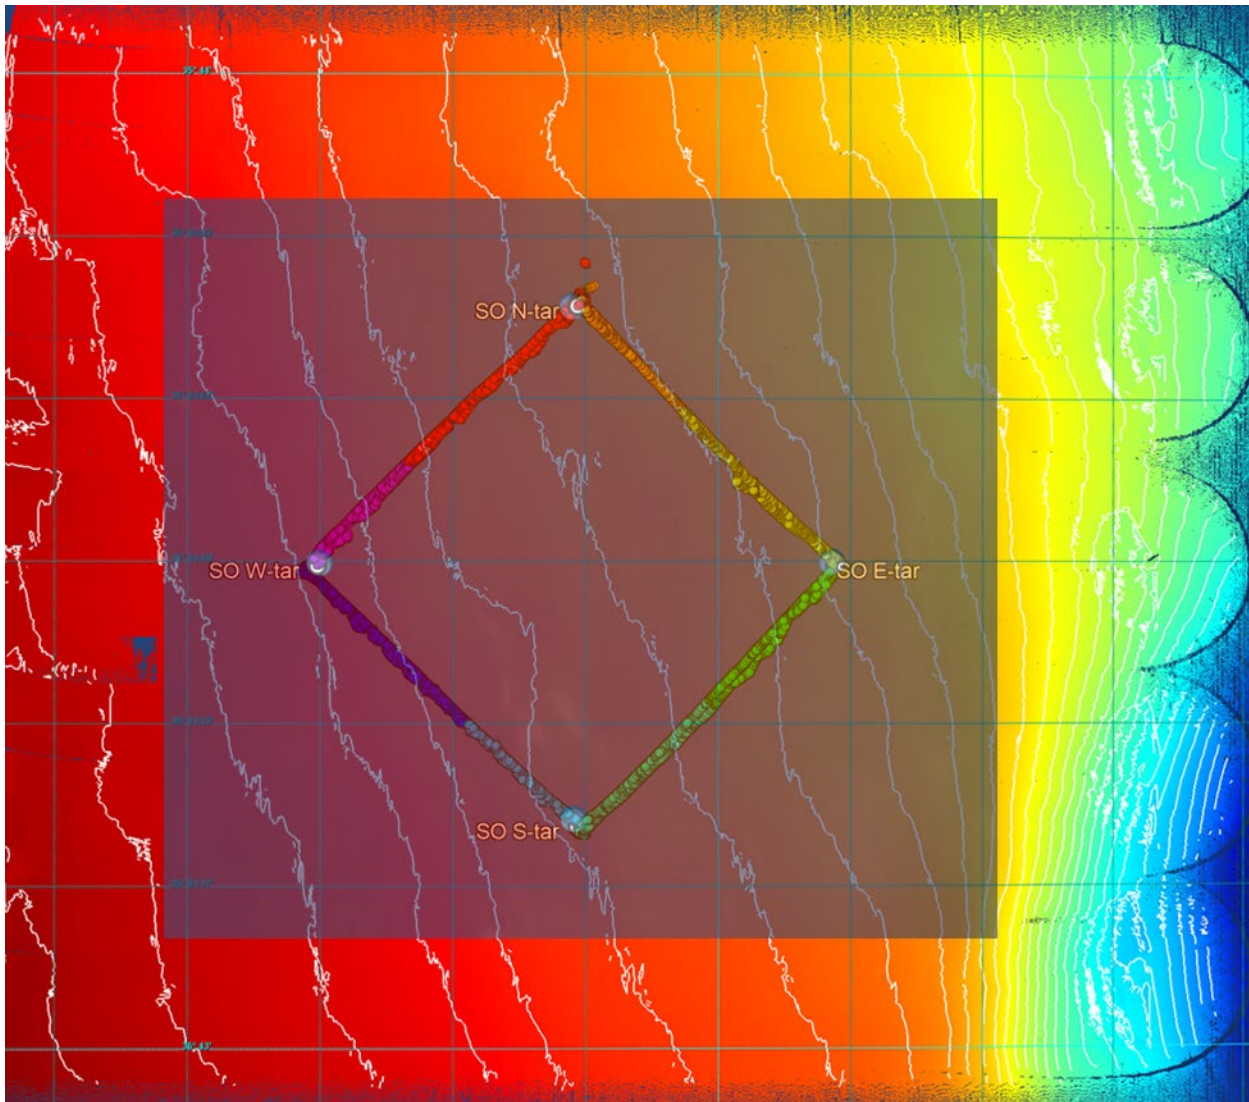
Figure 63: ROV Track at South Site

ROV inspection was completed at all anchor target sites, Figure 63 shows the ROV and depressor positions overlaid on the DTM. The camera data indicates a flat seabed at both sites consisting of sands and gravels (Figures 64 thru 68). No areas or features of concern (hard bottom, debris, cables, pipelines, wrecks, artifacts, marine habitat) in ROV sonar or imagery in vicinity of anchor targets.

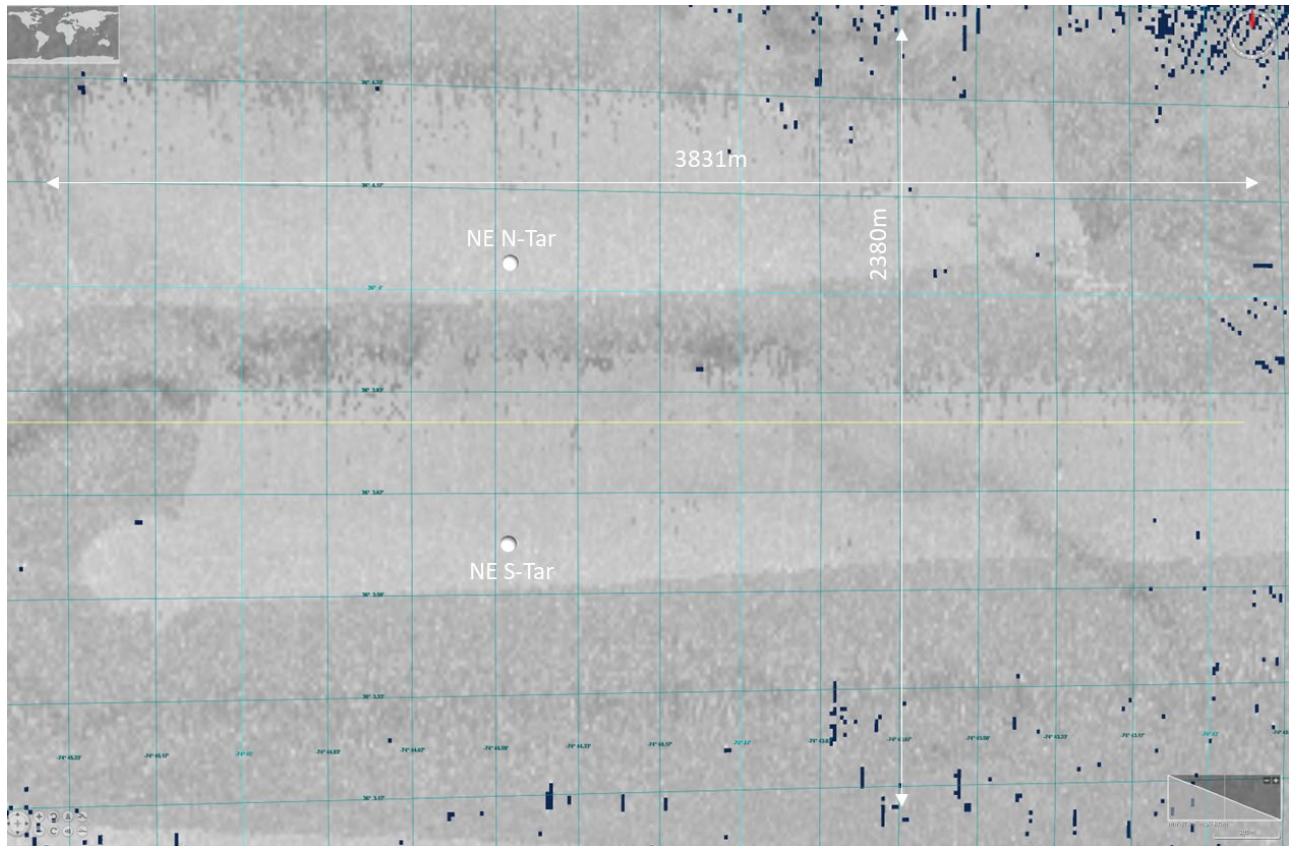
Figure 70: Northeast Site North & South Anchor Targets (N-Tar, S-Tar) Backscatter

Backscatter imagery at both the north and south anchor target sites indicate a homogeneous seabed, no visible hazards such as hard bottom, cables, pipelines, wrecks, or debris (Figure 70).

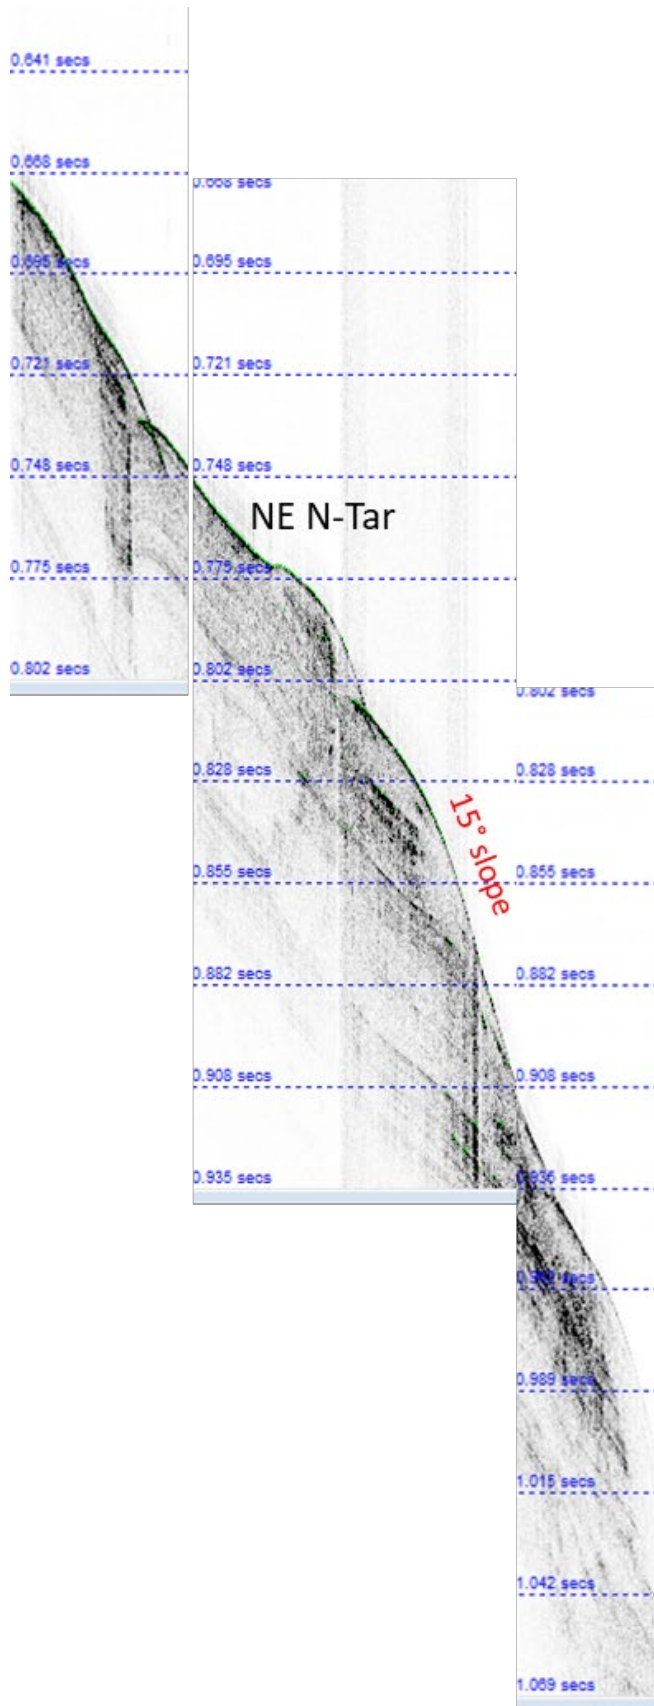
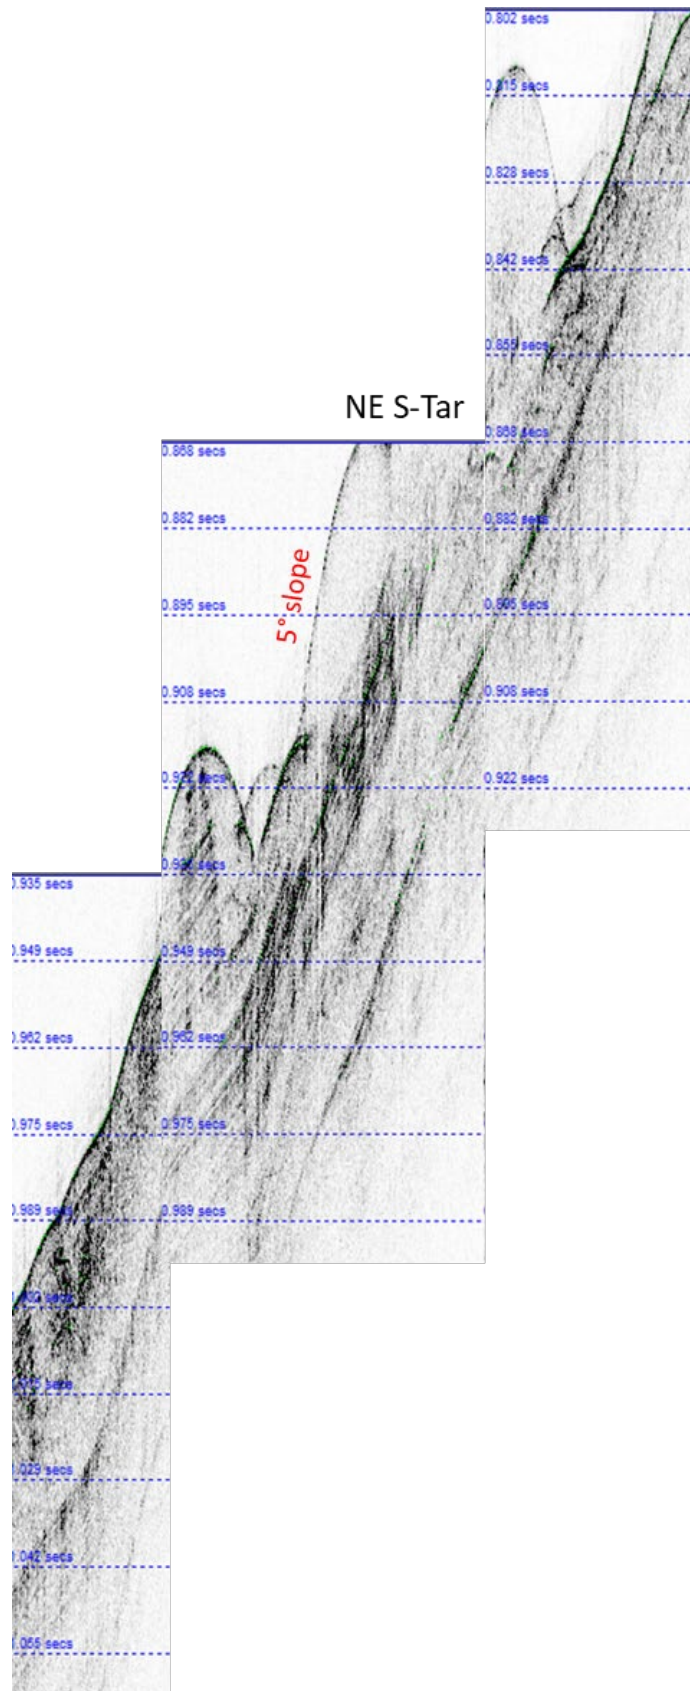
Subbottom profiles at both the north and south anchor target sites indicate a soft and homogeneous seabed with good penetration, some indication of harder sublayers that do not impact operations, no indication of hard bottom or hazards such as cables, pipelines, debris, or wrecks (Figures 71 & 72). As can be seen in the subbottom profile, this is a steeper site as the seabed crosses the shelfbreak. Slopes range from 5-15°, localized may be higher.

SOUTH	Survey and ROV data indicate the anchor sites are suitable for the deployment of dual moorings.	Flat, sandy seabed, no minor/major risks	Retain anchor targets as planned.
NORTHEAST	Bathymetry and subbottom show steeper slopes, no indication of hazards in backscatter, ROV video shows sandy flat bottom in vicinity of anchor target.	South anchor target surveyed but not ROV inspected; steeper slopes greater than 30° could be found away from anchor target areas.	Retain anchor targets as planned. Slopes at anchor targets are less than 30°. Conduct South anchor target ROV inspection prior to deployment. If slope impacts deployment or recovery, consider moving North anchor target away from ridge slope.
SOUTHEAST	Bathymetry and subbottom show significantly steeper slopes, no indication of hazards in backscatter, ROV video shows sandy flat bottom in vicinity of anchor target.	South anchor target surveyed but not ROV inspected; localized slopes steeper than 30° could be an anchor holding risk, slopes and channels could also be turbidity current risk leading to mooring loss.	Retain anchor targets as planned. Slopes at anchor targets are less than 30°. Conduct South anchor target ROV inspection prior to deployment. If slope impacts deployment or recovery, consider moving both targets to a shallower, less steep location.

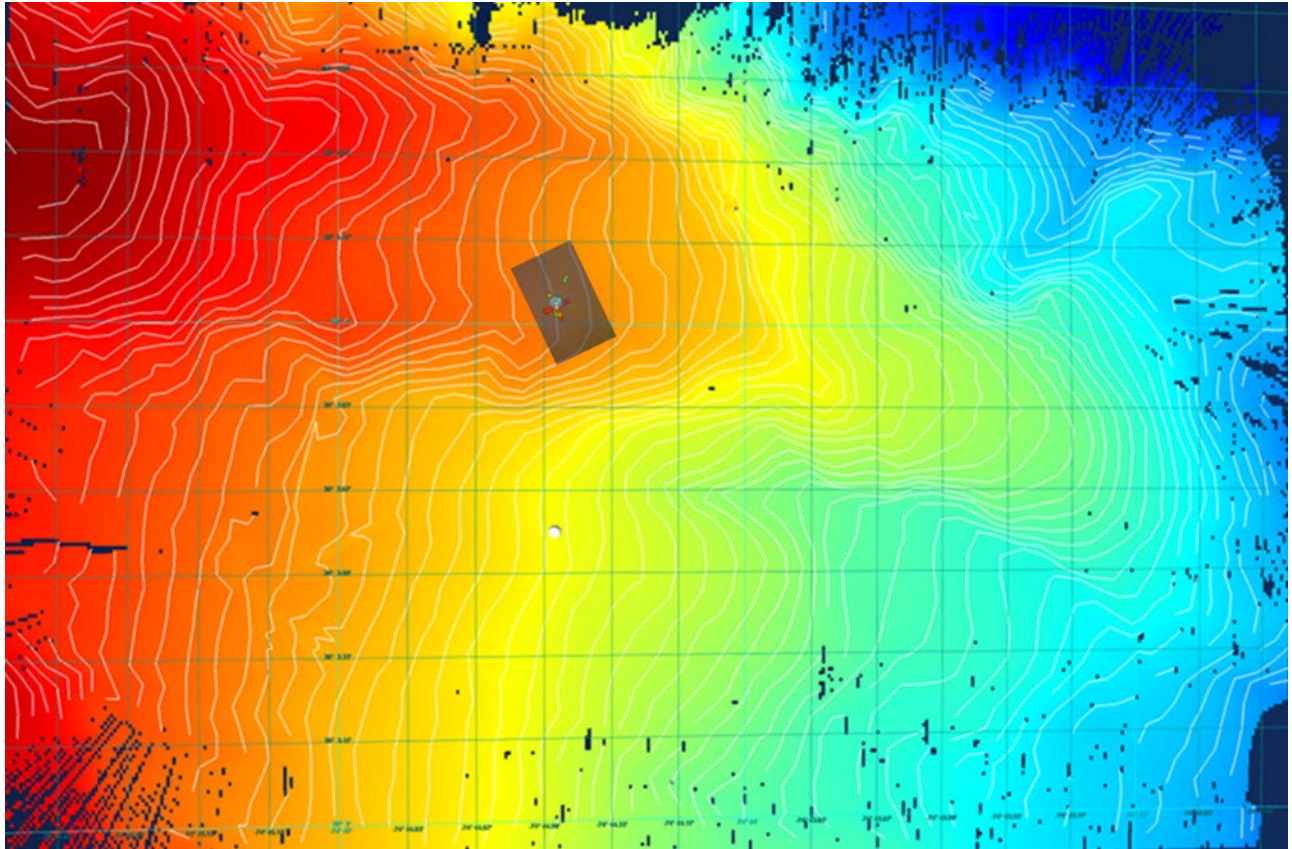
Figure 73: ROV Track at Northeast Site

ROV inspection was completed at the North anchor target only. Due to the risk of steep slopes and the need to maintain a constant depth, the ROV survey was halted after a depth discrepancy was found between the beacon and ROV depth sensor. Figure 73 shows the ROV and depressor positions overlaid on the DTM. The camera data indicates a flat seabed in the vicinity of the north anchor target consisting of a sandy seabed (Figures 74-75). No areas or features of concern (hard bottom, debris, cables, pipelines, wrecks, artifacts, marine habitat) in ROV sonar or imagery in vicinity of anchor targets.

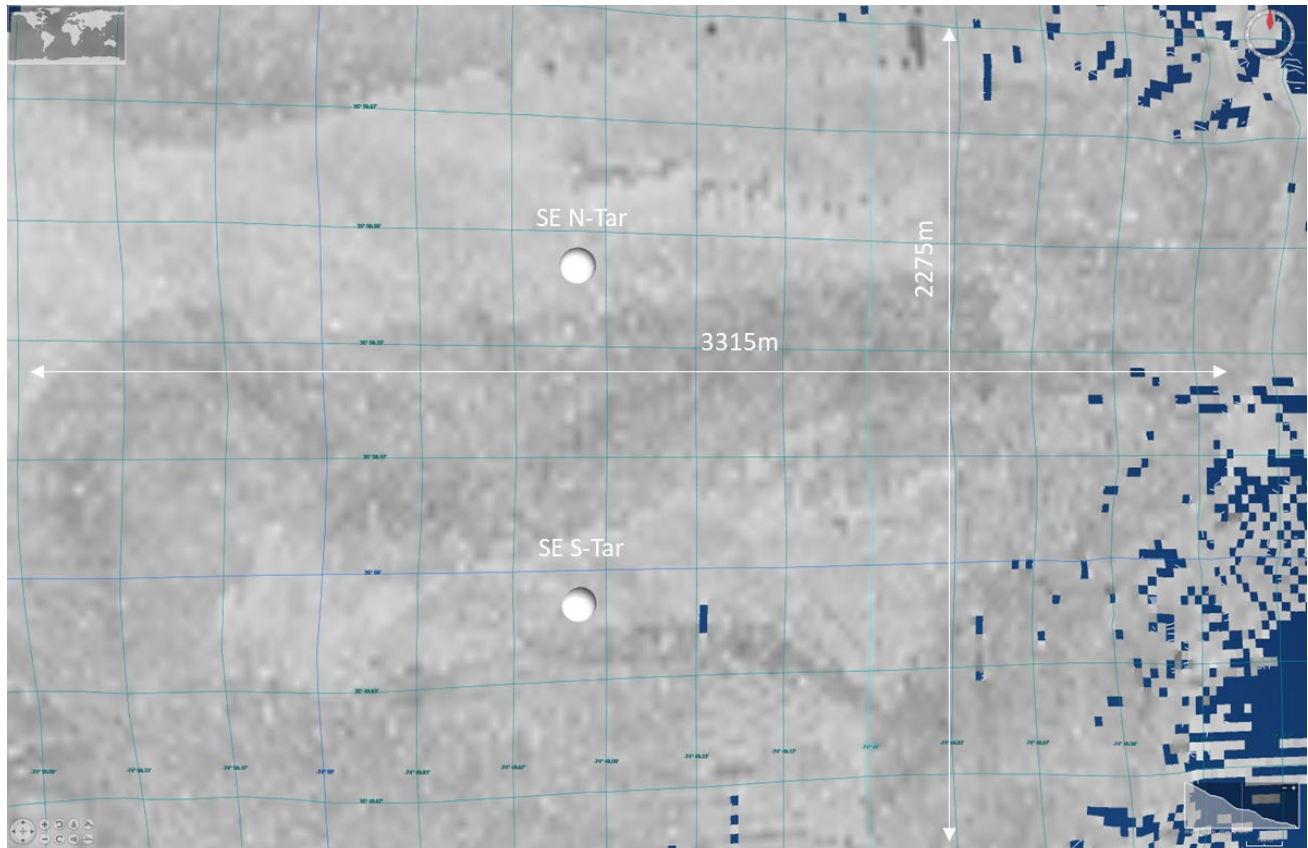
Figure 77: Southeast Site North & South Anchor Targets (N-Tar, S-Tar) Backscatter

Backscatter imagery at both the north and south anchor target sites indicate a homogeneous seabed, no visible hazards such as hard bottom, cables, pipelines, wrecks, or debris (Figure 77).

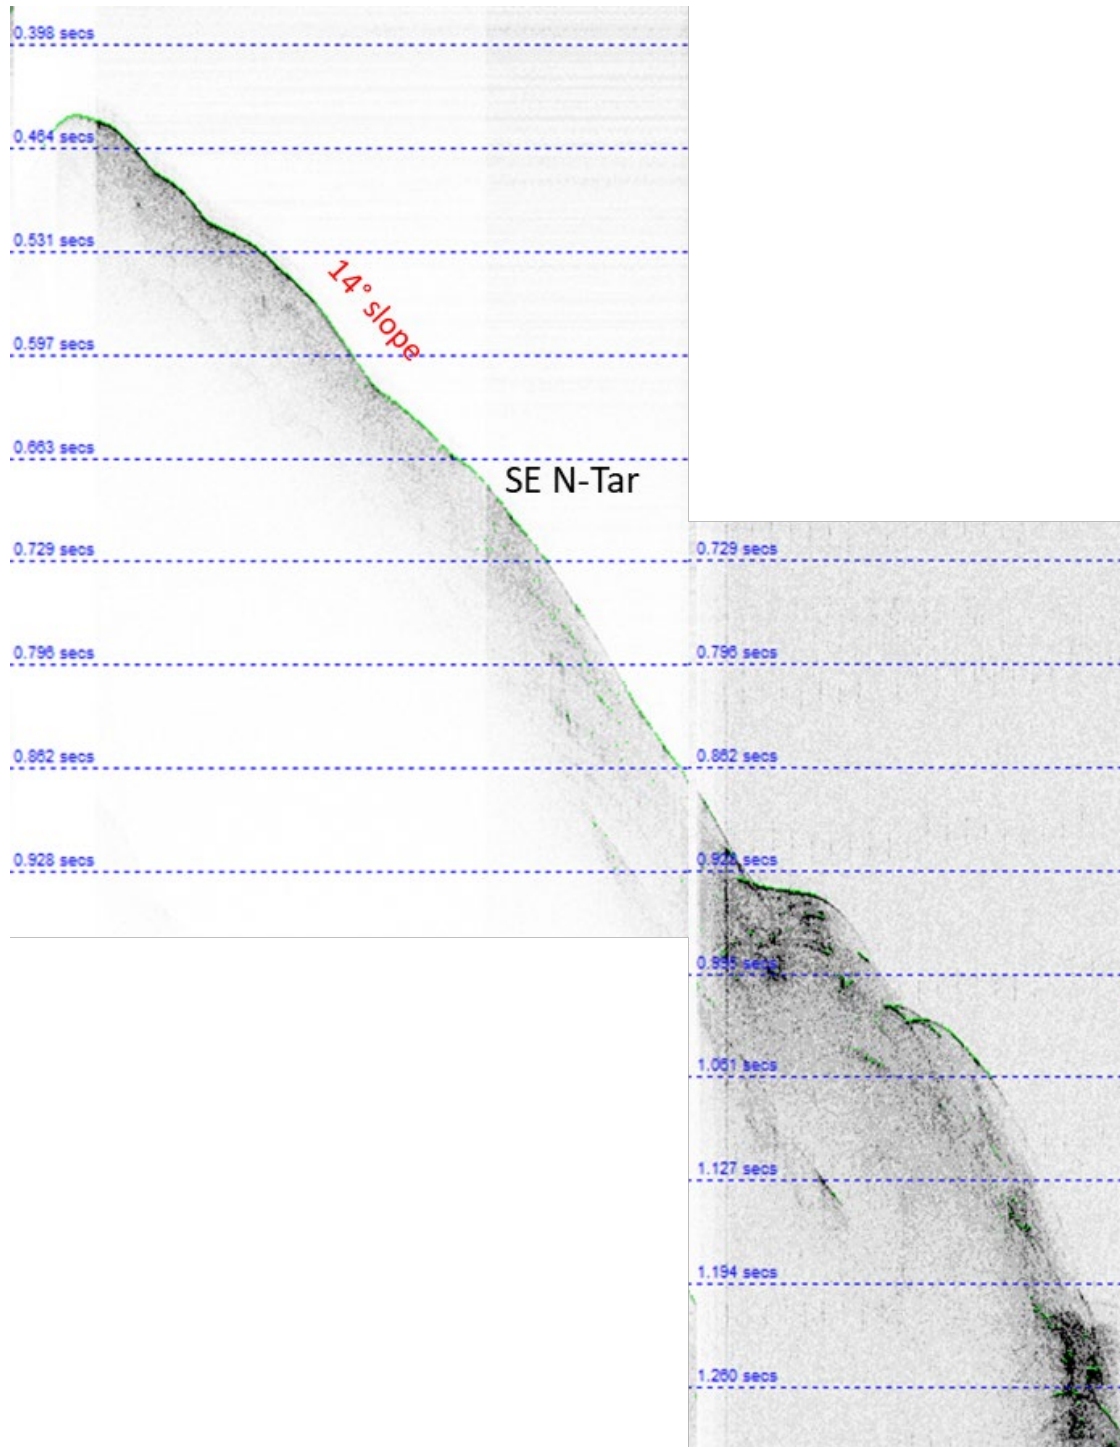
Figure 78: Southeast Site North Anchor Target (N-Tar) Subbottom

Subbottom profiles at both the north and south anchor target sites indicate a soft and homogeneous seabed with good penetration, some indication of harder sublayers that do not impact operations, no indication of hard bottom or hazards such as cables, pipelines, debris, or wrecks (Figures 78 & 79). As can be seen in the subbottom profile, this is a steeper site as the seabed crosses the shelfbreak. Slopes can range from 8-14°, localized will be higher.
