Appendix F: Pioneer MAB Seabed Survey and ROV Inspections

Pioneer MAB Seabed Survey & ROV Inspections

Control Number: 3210-00004

**Coastal and Global Scale Nodes
Ocean Observatories Initiative
Woods Hole Oceanographic Institution**

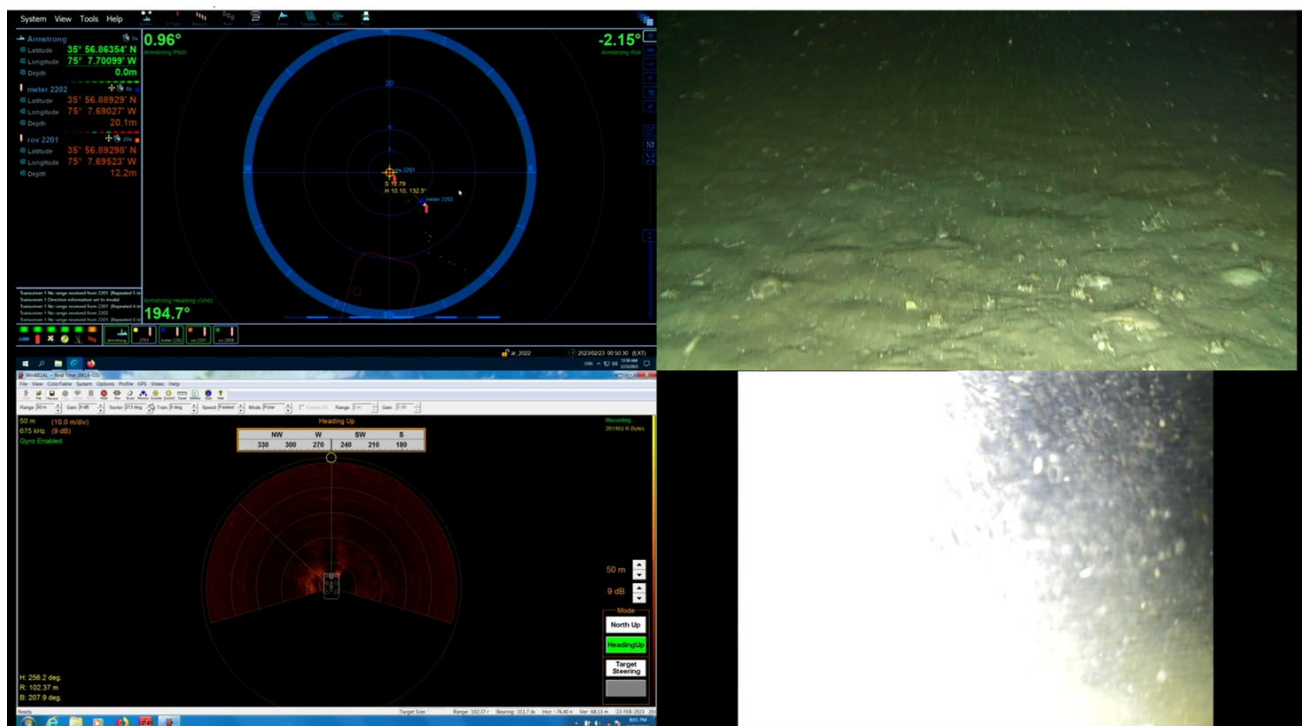
Figure 83: Area of Interest #1, Central Site: Shell and skeleton debris, sea star, scattered vertical worm tubes

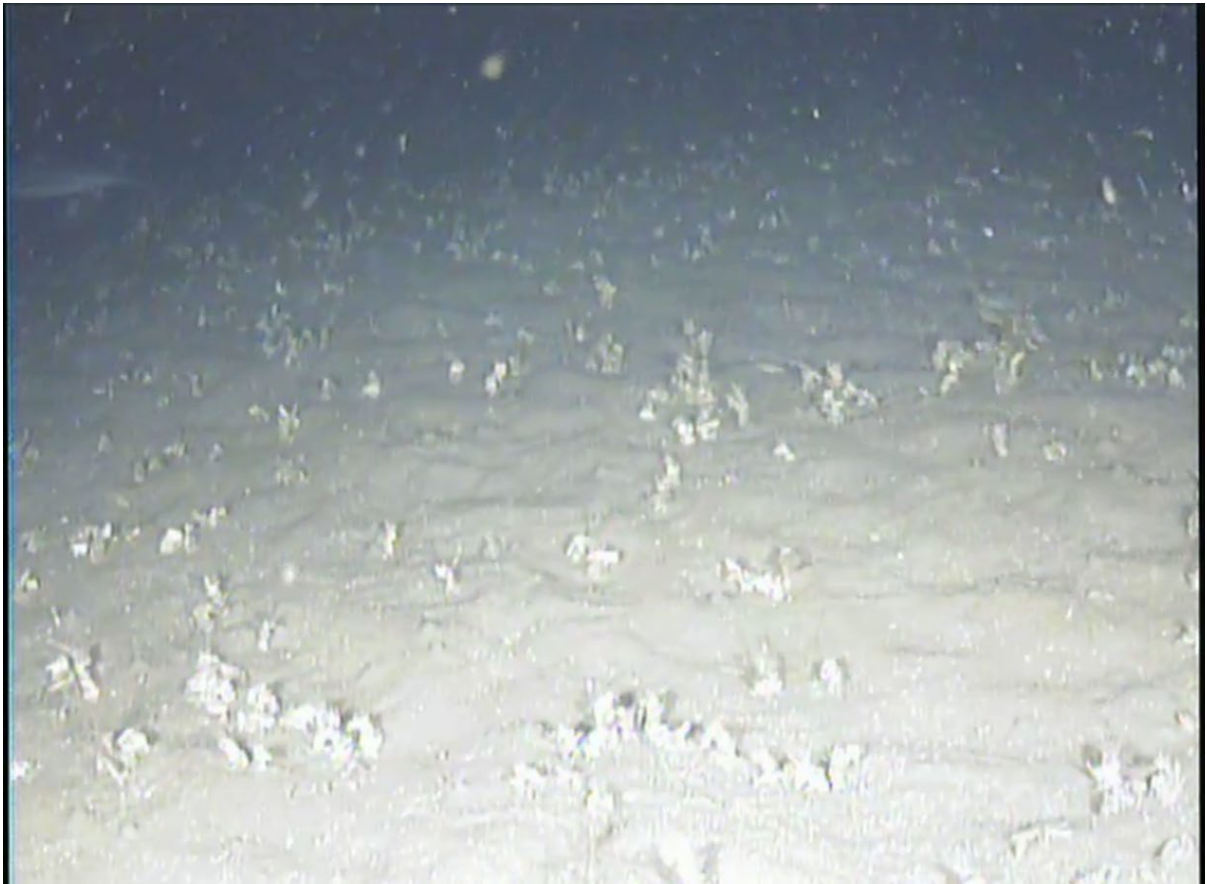
Figure 84: Area of Interest #1, Central Site: Shell and skeleton debris, sponges

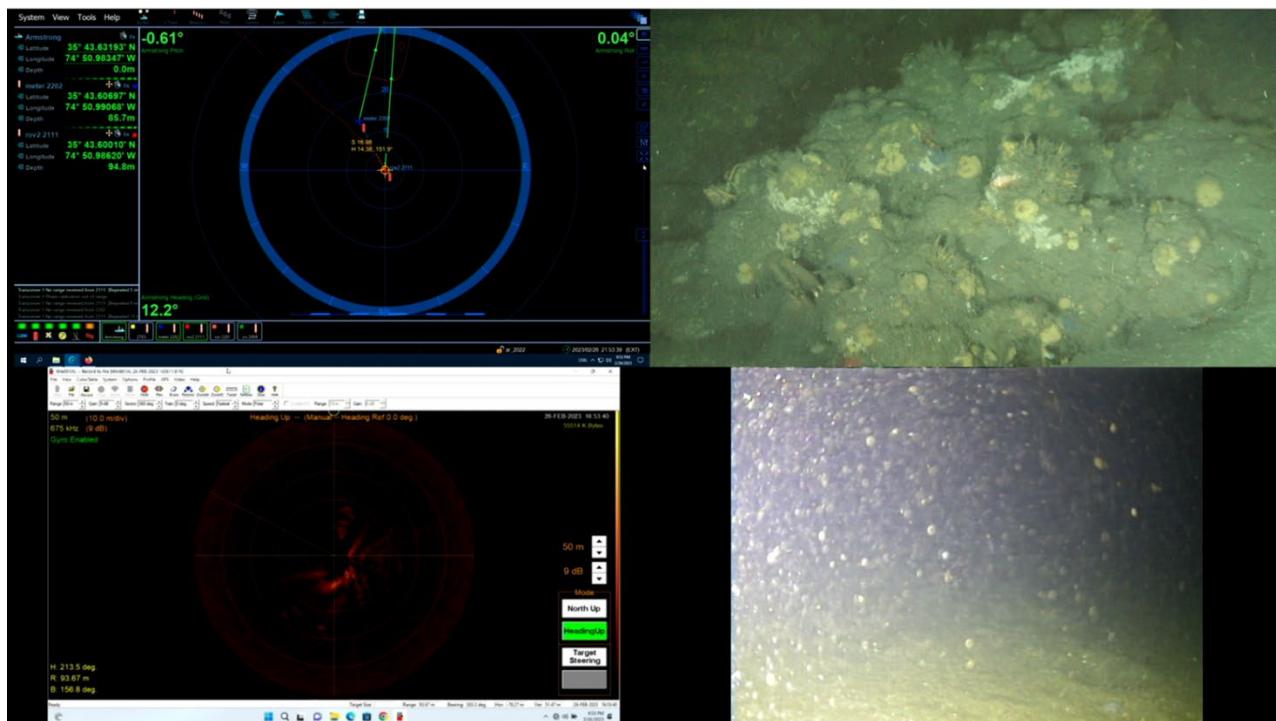
Figure 85: Area of Interest #2, South Site: Lithotherm-like substrate, sponges, Galatheid crabs, Bryozoan-like animals

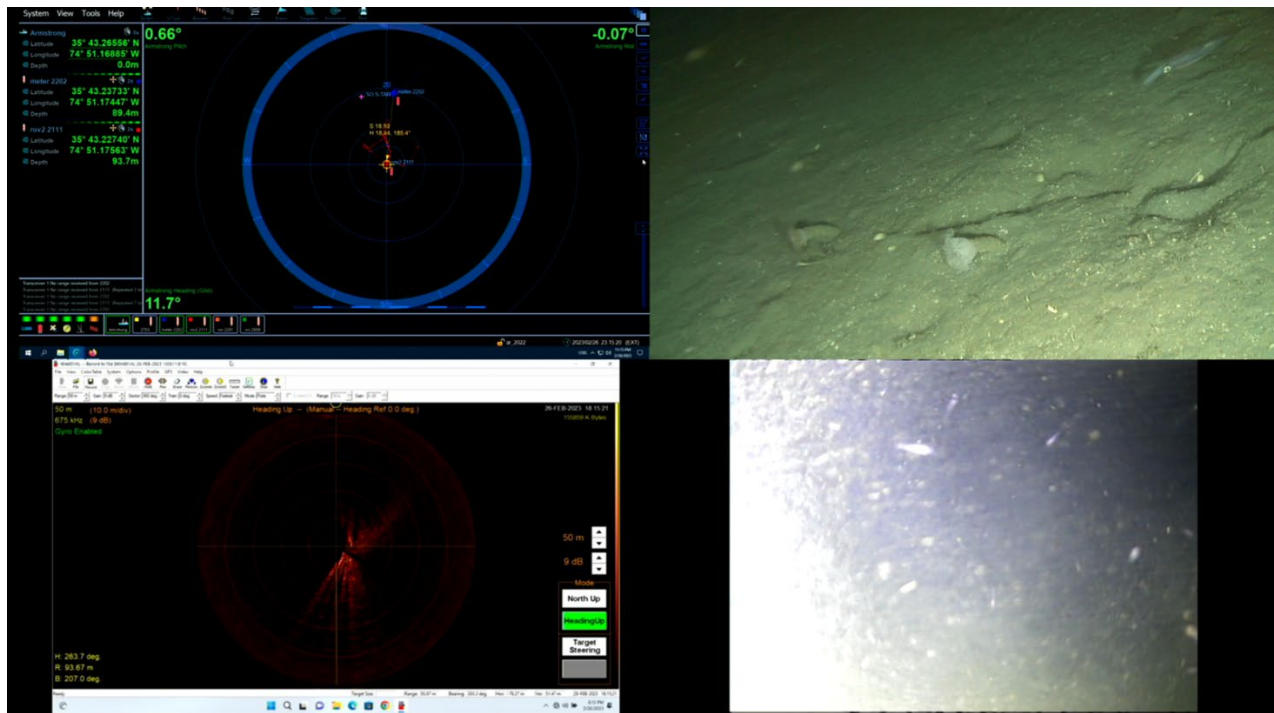
Figure 86: Area of Interest #3, South Site: Anemones (solitary hydroids), shell debris, squid, small Polychaete Hyalinoecia worm tubes

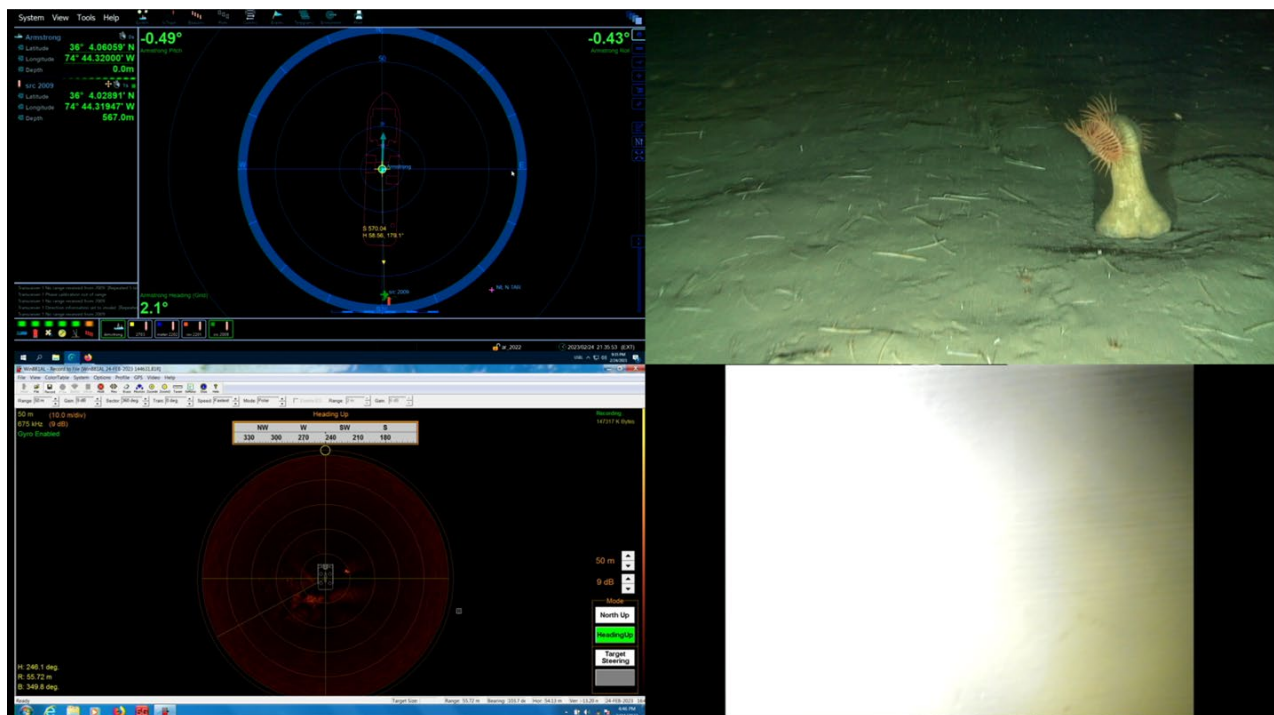
Figure 87: Area of Interest #4, Northeast Site: Actinoscyphia Venus Flytrap anemone, Polychaete Hyalinoecia worm tubes

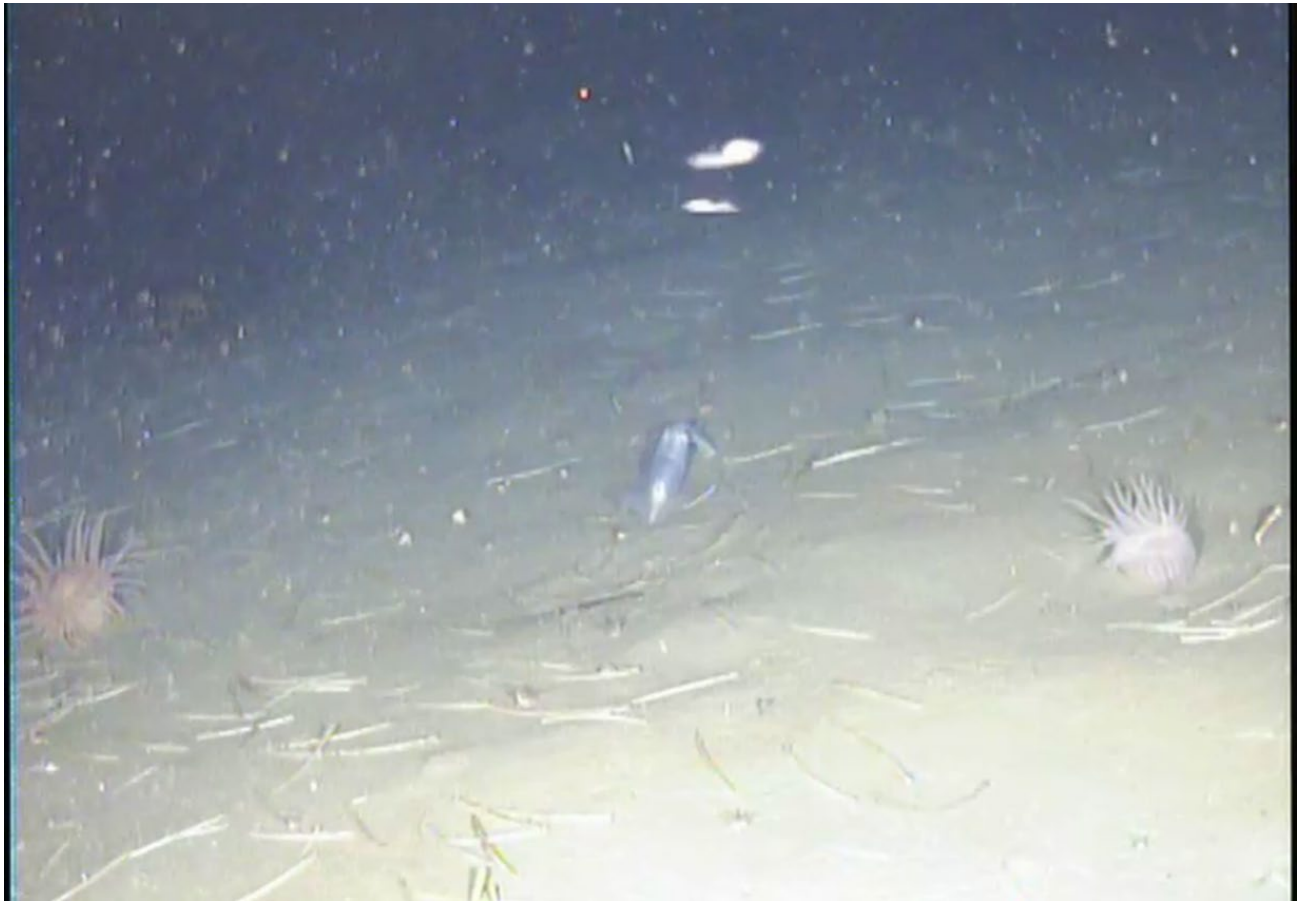
Figure 88: Area of Interest #4, Northeast Site: Anemones, squid, Polychaete Hyalinoecia worm tubes

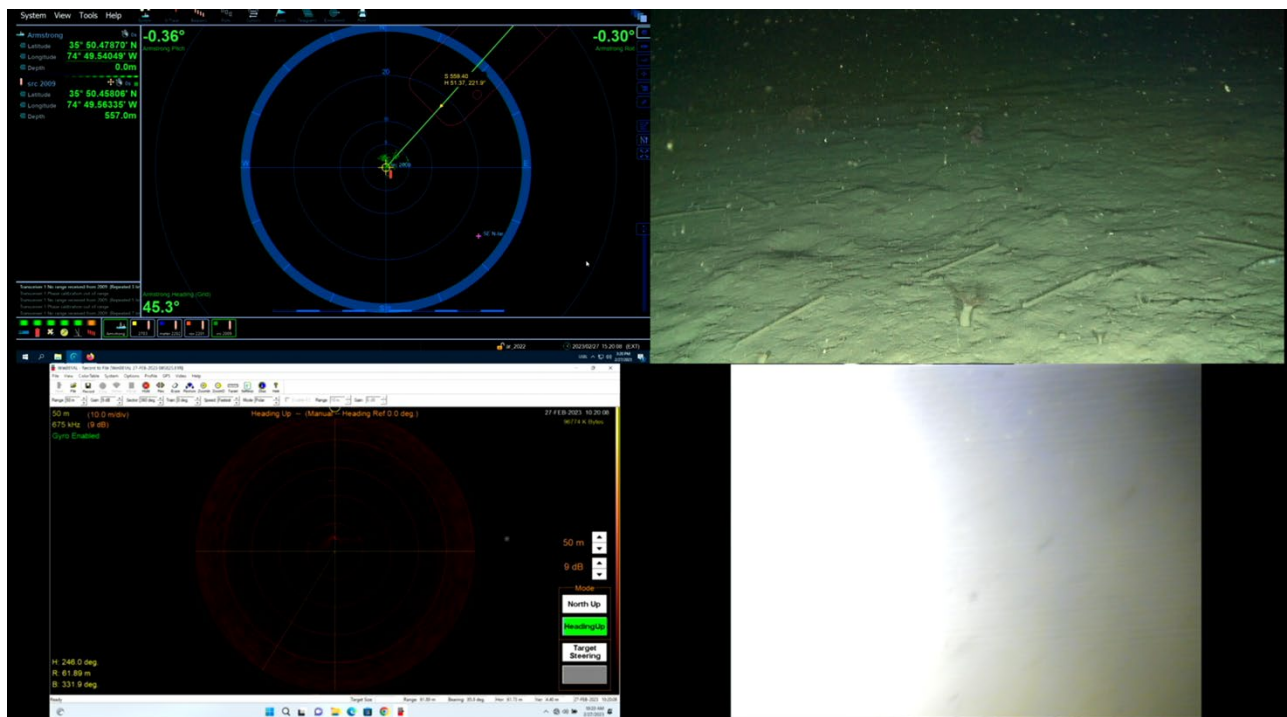
Figure 89: Area of Interest #5, Southeast Site: Polychaete Hyalinoecia worm tubes, tube anemones
