Pioneer MAB Seabed Survey & ROV Inspections

Control Number: 3210-00004

Date: 2024-01-29

Coastal and Global Scale Nodes
Ocean Observatories Initiative
Woods Hole Oceanographic Institution

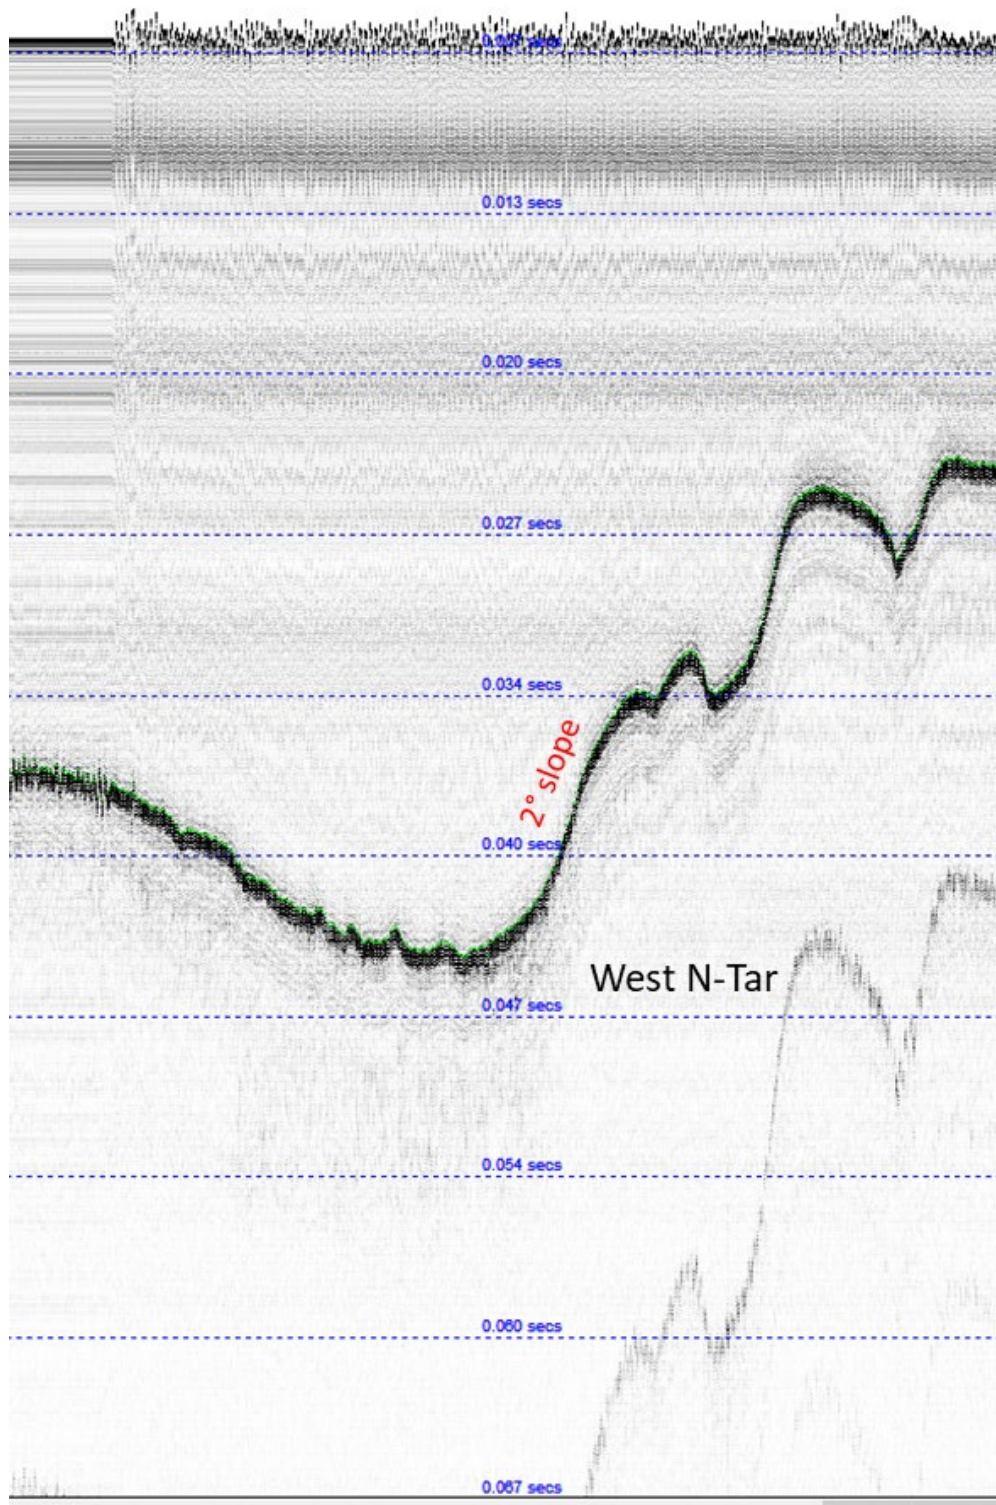
Figure 11: Western Site North Anchor Target (N-Tar) Subbottom

Subbottom profiles at both the north and south anchor target sites indicate a soft and homogeneous seabed with good penetration, no indication of hard bottom or hazards such as cables, pipelines, debris, or wrecks (Figures 11 & 12). Slopes are ~ 1.5 - 2° .

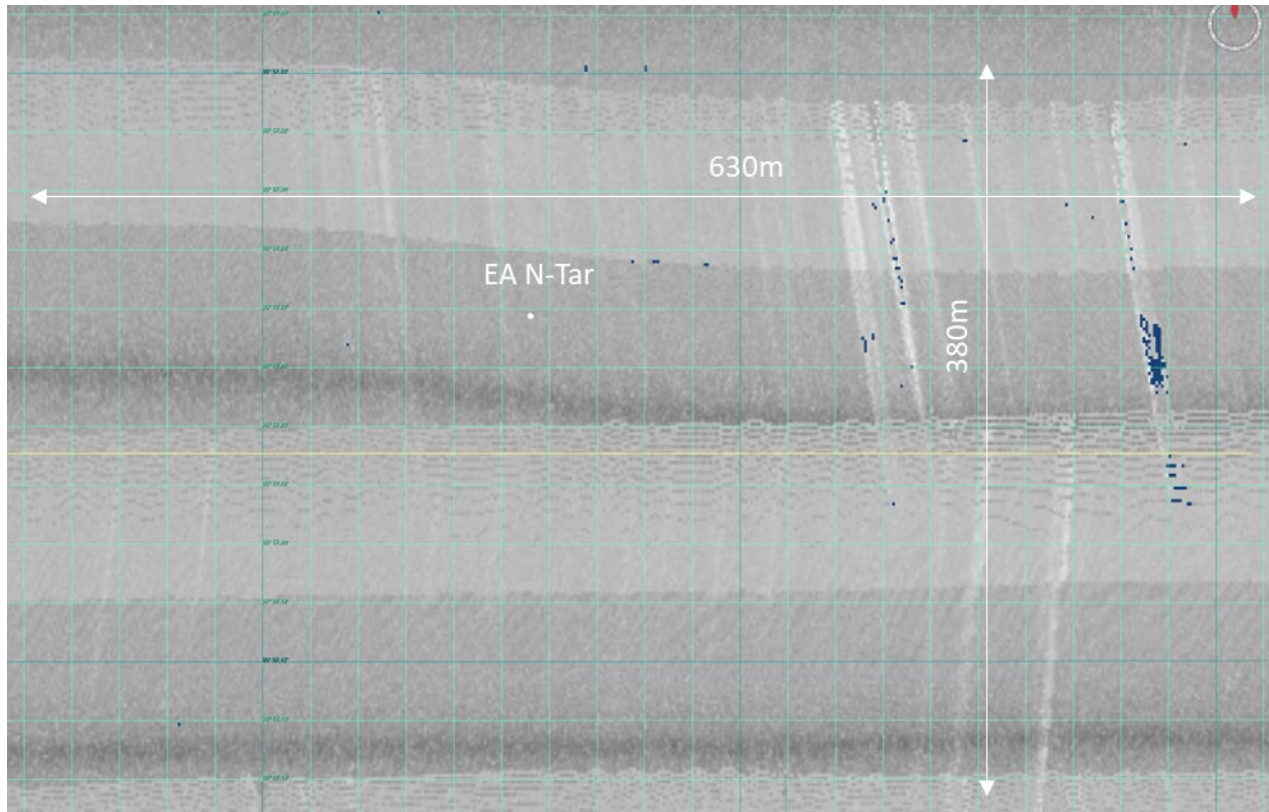
Figure 32: Eastern Site North Anchor Target (N-Tar) Backscatter

Backscatter imagery at both the north and south anchor target sites indicate a homogeneous seabed, no visible hazards such as hard bottom, cables, pipelines, wrecks, or debris (Figures 32 & 33).

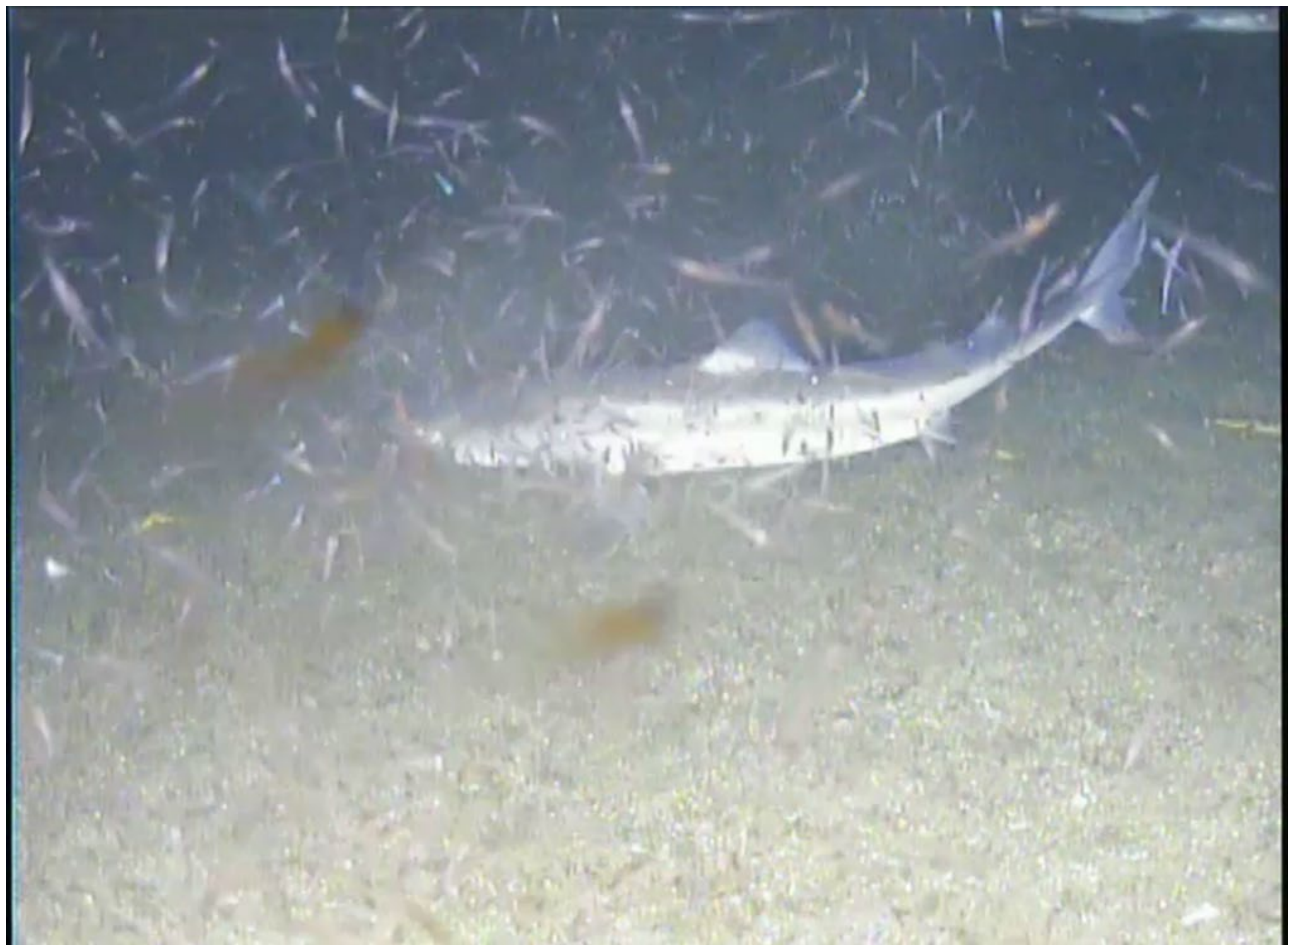
Figure 50: Sandy, Gravelly, Shelly Seabed Northern Site, North Anchor Target

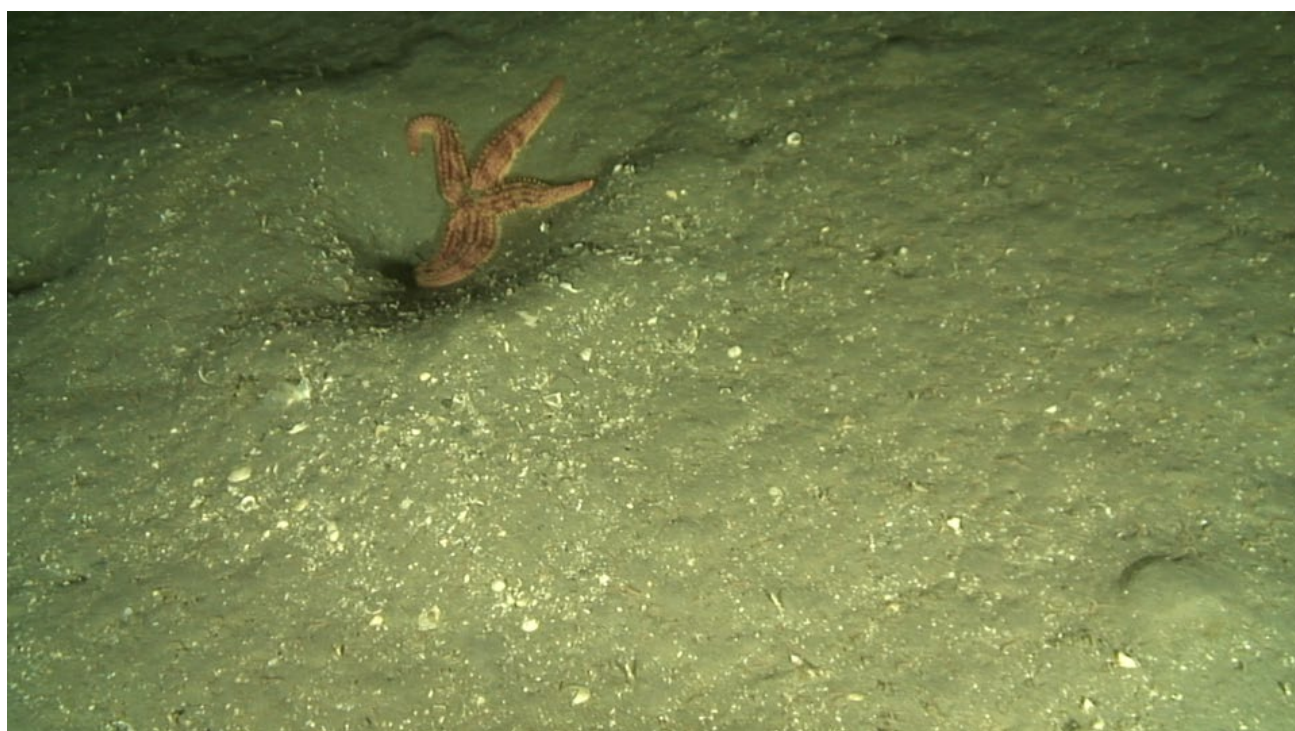
Figure 67: Sandy, Gravelly, Shelly Seabed Southern Site, South Anchor Target

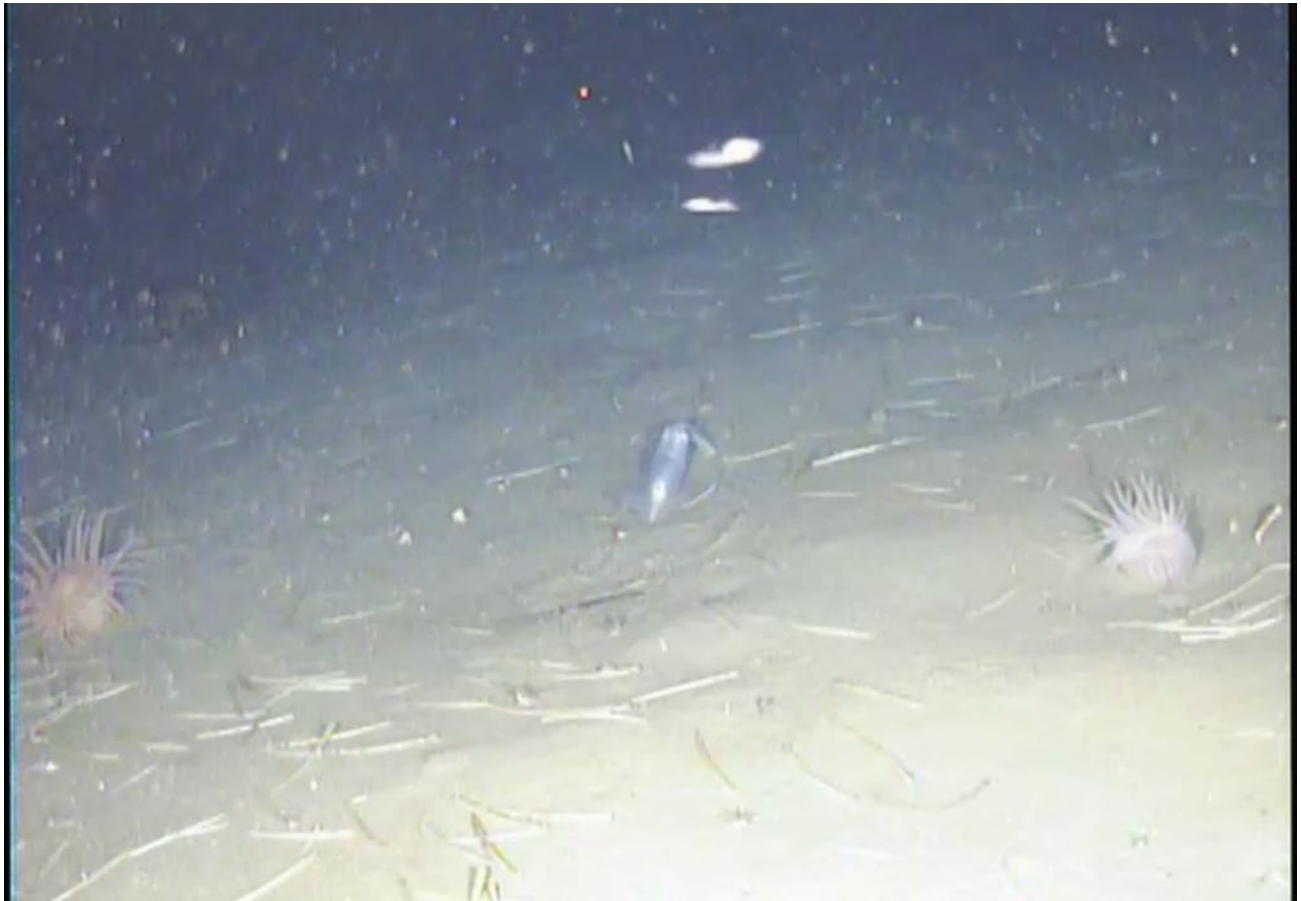
Figure A-6: Area of Interest #4, Northeastern (Old) Site: Anemones, squid, Polychaete Hyalinoecia worm tubes
